Date: September 14, 2020

RE: Site Visit
AltEn, LLC
1344 County Road 10
Mead, NE 68041

NDEE ID: 84069

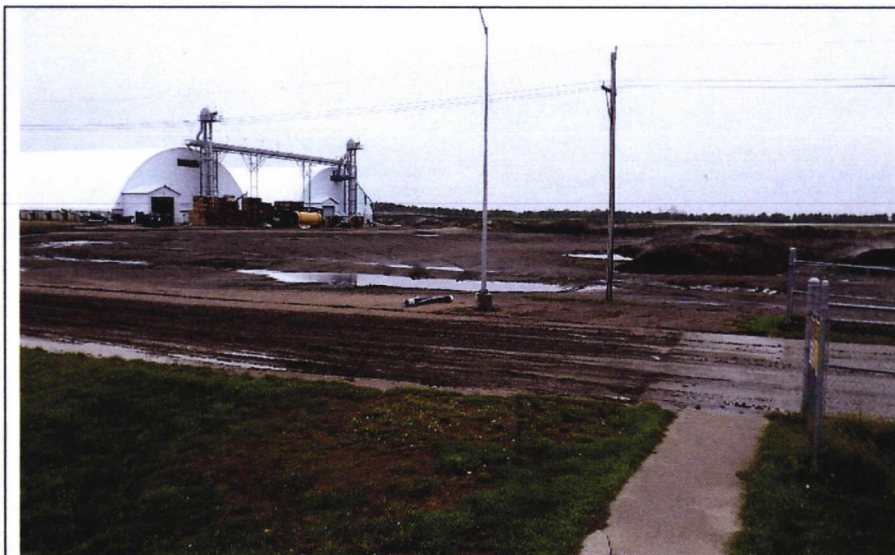
Photograph 1
Date: September 11, 2020
Photographer: Jason Holsten
Camera: Ricoh WG-50
IIS# 84069, IWM Permit # NE0204447
Subject: AltEn, LLC Site Visit

From the office building, looking north northwest, photograph showing distiller's grain (DG) being stored east and north of the white hoop buildings.

I confirmed that DG was being stockpiled in the following areas: north and east of the hoop buildings, northeast corner of the property, and west of the compost pads. In addition, DG was observed to be on all three compost pads. DG was observed to be stockpiled approximately between alleys G13 to G34 of the adjacent cattle pins. A map from the facility's permit application showing the compost pad layout in relation to the adjacent cattle pins is attached for reference (Attachment II). Based upon the color of the DG, it appeared newer material was placed between G20 and G34. Mr. Tingelhoff said DG was mistakenly taken to the compost pads. His staff was going to remove the DG this week but due to the wet weather that hadn't happened yet. Concerning the DG on the pads, he said they were waiting for approval for land application of this material. Some of the other DG on the pads was mixed with rocks and would be disposed at a landfill.

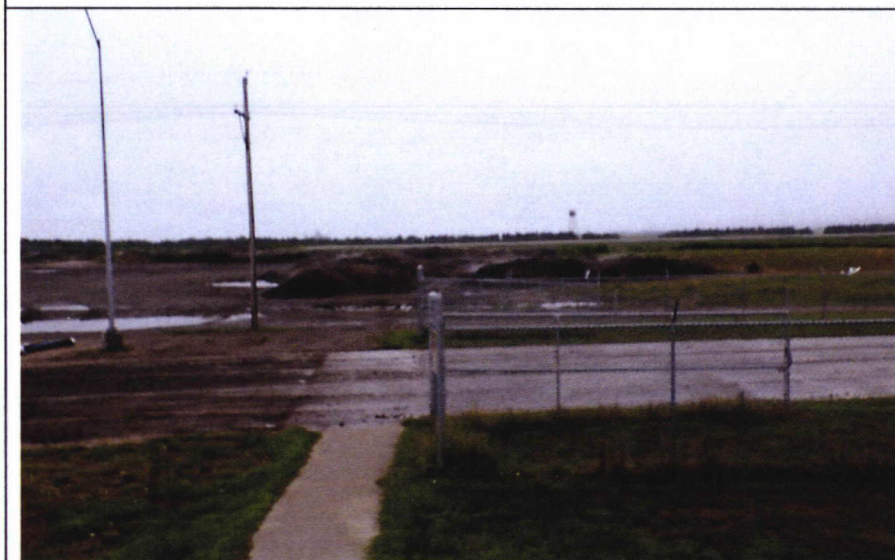
Photograph 2
Date: September 11, 2020
Photographer: Jason Holsten
Camera: Ricoh WG-50
IIS# 84069, IWM Permit # NE0204447
Subject: AltEn, LLC Site Visit

From the same vantage point as photograph 1, looking north, photograph showing DG being stored north of the office building.

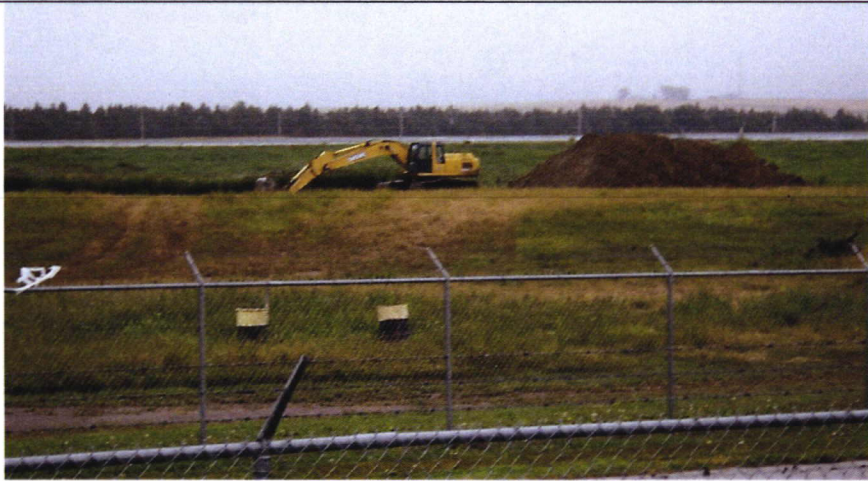
Photograph 3
Date: September 11, 2020
Photographer: Jason Holsten
Camera: Ricoh WG-50
IIS# 84069, IWM Permit # NE0204447
Subject: AltEn, LLC Site Visit

Looking northeast, photograph showing an excavator and some dirt work being done. Mr. Tingelhoff said the dirt was going to be used for a project.

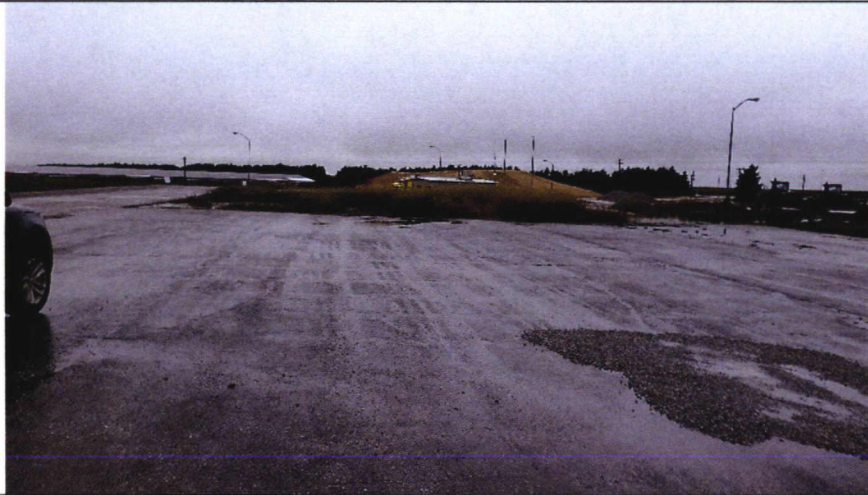
Photograph 4
Date: September 11, 2020
Photographer: Jason Holsten
Camera: Ricoh WG-50
IIS# 84069, IWM Permit # NE0204447
Subject: AltEn, LLC Site Visit

Looking southwest from the parking lot located west of the office building. Photograph taken to show that the super sacks of starch previously stored in this area have been removed. According to Mr. Tingelhoff, the sacks were disposed at Butler County landfill.

I observed that the super sacks of starch that had previously been stored west of the office building have been removed. Mr. Tingelhoff said all sacks had been disposed at the landfill and he said it was probably the Butler County landfill. He said this occurred since COVID and was probably in June or July. He said starch was still used in the ethanol process and came in 50-lb bags or cubic yard sacks. This starch is stored in the hoop buildings.

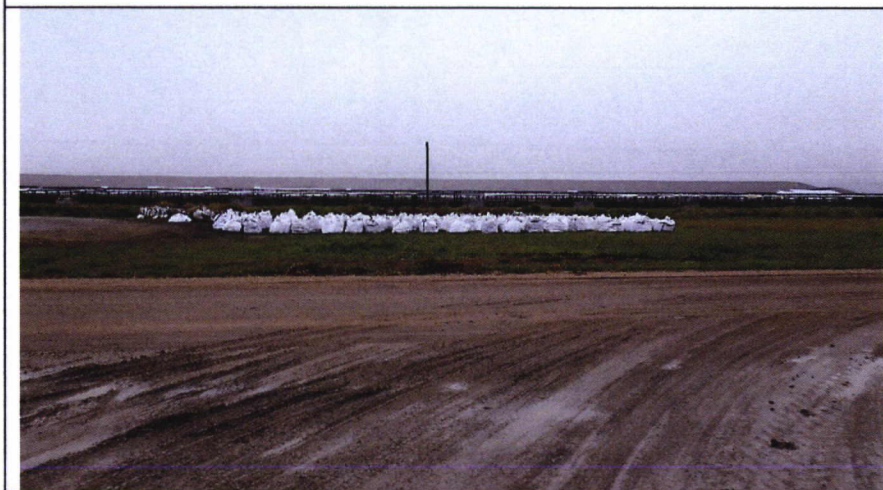
Photograph 6
Date: September 11, 2020
Photographer: Jason Holsten
Camera: Ricoh WG-50
IIS# 84069, IWM Permit # NE0204447
Subject: AltEn, LLC Site Visit

Looking south, photograph showing super sacks of biochar located west of the biochar unit.

Mr. Tingelhoff said the biochar unit had operated for a couple of weeks after they completed their testing but it is currently not operating. They have to replace a blower and are waiting for the part. He said they have sent out multiple loads of biochar and estimated there is 250-300 super sacks currently on site. He did not know who took the biochar or where it went. He said Greencycle manages the biochar operation and he'd have to find me a contact if I had any further questions. He could ask Tanner Shaw for this information.

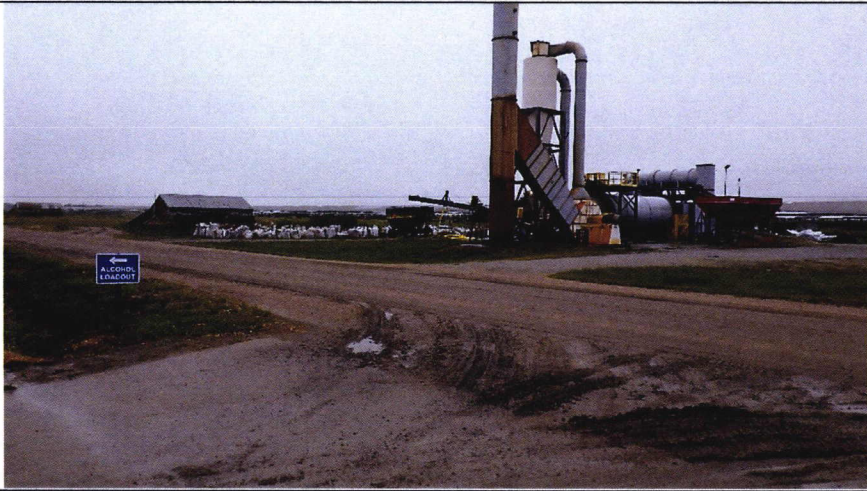
Photograph 7
Date: September 11, 2020
Photographer: Jason Holsten
Camera: Ricoh WG-50
IIS# 84069, IWM Permit # NE0204447
Subject: AltEn, LLC Site Visit

Looking southeast, photograph showing the biochar unit as well as super sacks of biochar located east of the unit.

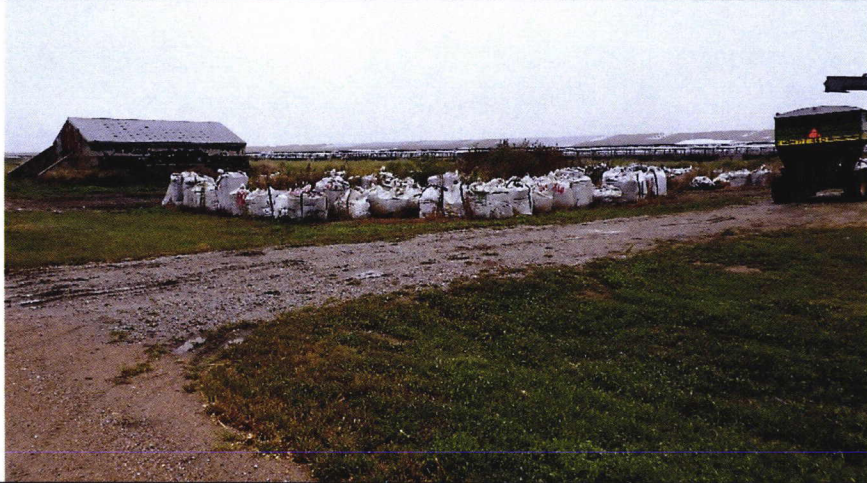
Photograph 8
Date: September 11, 2020
Photographer: Jason Holsten
Camera: Ricoh WG-50
IIS# 84069, IWM Permit # NE0204447
Subject: AltEn, LLC Site Visit

Looking southeast, photograph showing a closer view of the super sacks of biochar mentioned in photograph 7.

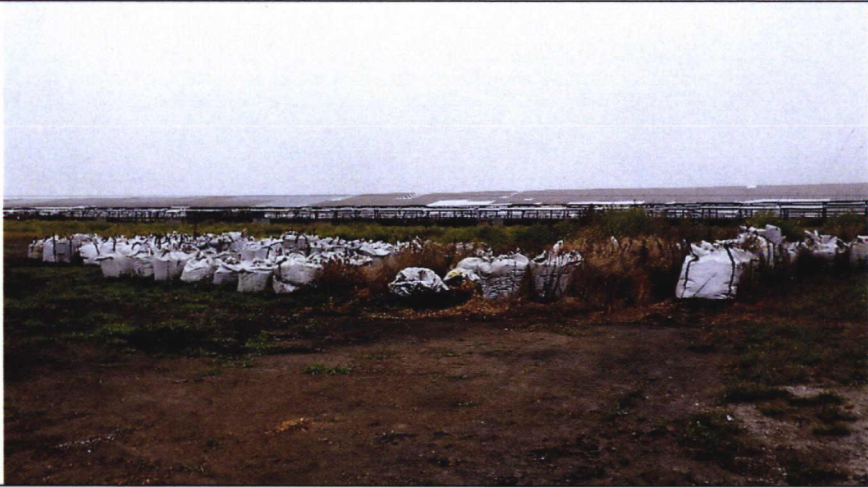
Photograph 9
Date: September 11, 2020
Photographer: Jason Holsten
Camera: Ricoh WG-50
IIS# 84069, IWM Permit # NE0204447
Subject: AltEn, LLC Site Visit

Looking southeast, photograph showing additional super sacks of biochar located on the east end of the biochar unit.

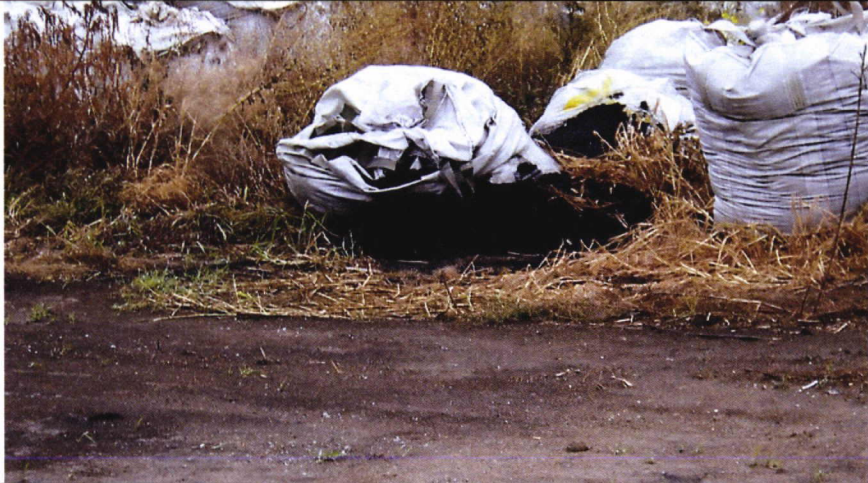
Photograph 10
Date: September 11, 2020
Photographer: Jason Holsten
Camera: Ricoh WG-50
IIS# 84069, IWM Permit # NE0204447
Subject: AltEn, LLC Site Visit

Photograph showing a closer view of some of the super sacks of biochar mentioned in photograph 9 that have spilled their contents.

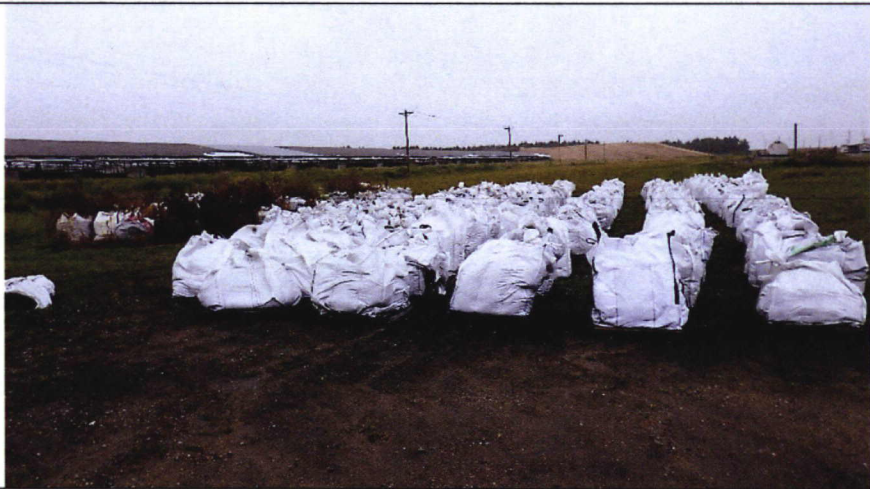
Photograph 11
Date: September 11, 2020
Photographer: Jason Holsten
Camera: Ricoh WG-50
IIS# 84069, IWM Permit # NE0204447
Subject: AltEn, LLC Site Visit

Looking west, photograph showing super sacks of biochar located west of the biochar unit.

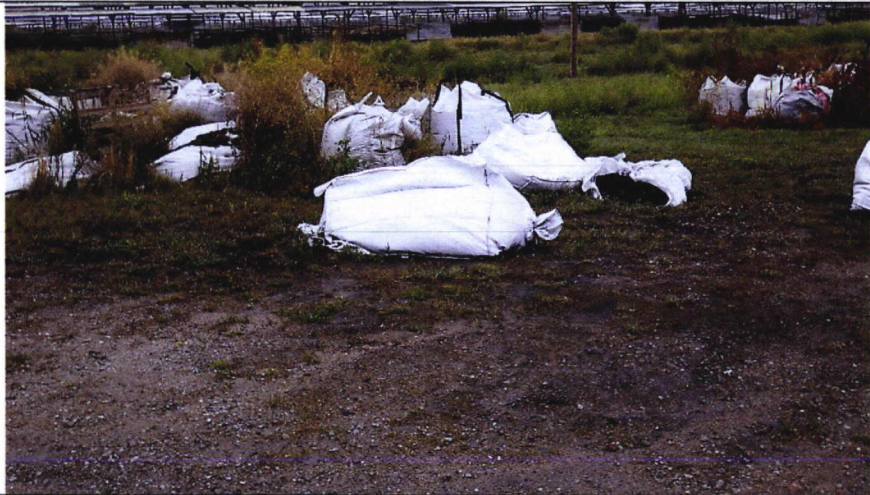
Photograph 12
Date: September 11, 2020
Photographer: Jason Holsten
Camera: Ricoh WG-50
IIS# 84069, IWM Permit # NE0204447
Subject: AltEn, LLC Site Visit

Photograph showing some super sacks of biochar located on the west side of the biochar unit that have spilled their contents.

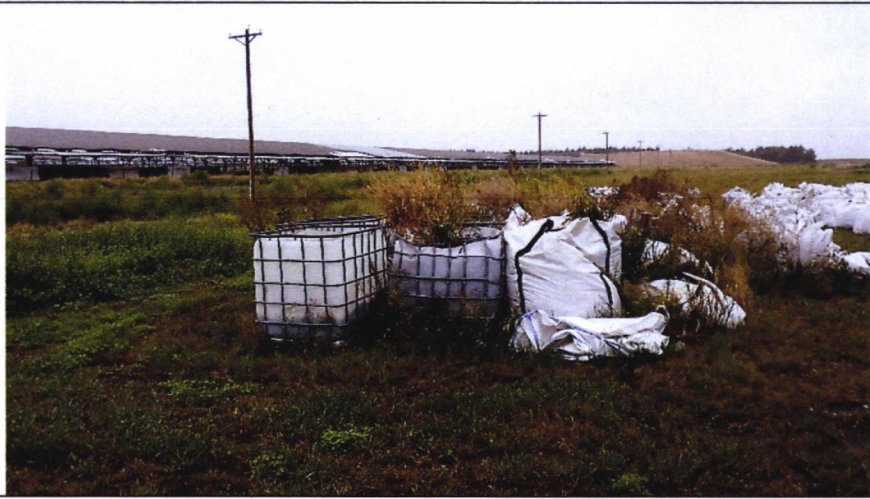
Photograph 13
Date: September 11, 2020
Photographer: Jason Holsten
Camera: Ricoh WG-50
IIS# 84069, IWM Permit # NE0204447
Subject: AltEn, LLC Site Visit

Looking west southwest, photograph showing numerous poly totes that have had their tops cut off. Located inside the totes was biochar and vegetation was growing in many of the totes.

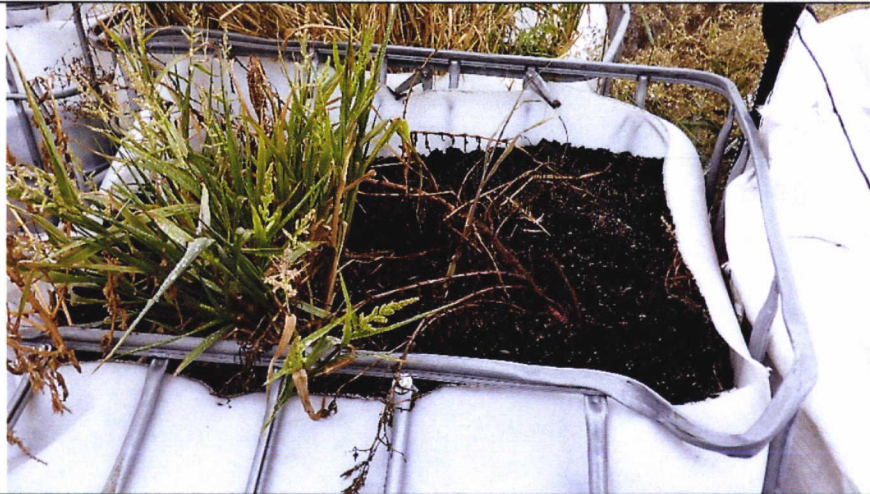
Photograph 14
Date: September 11, 2020
Photographer: Jason Holsten
Camera: Ricoh WG-50
IIS# 84069, IWM Permit # NE0204447
Subject: AltEn, LLC Site Visit

Photograph showing a closer view of one of the poly totes mentioned in photograph 13.

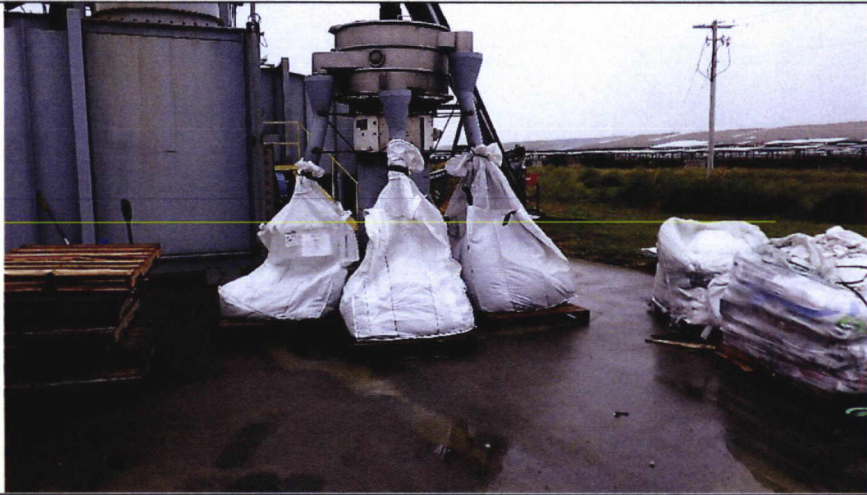
Photograph 15
Date: September 11, 2020
Photographer: Jason Holsten
Camera: Ricoh WG-50
IIS# 84069, IWM Permit # NE0204447
Subject: AltEn, LLC Site Visit

Looking east southeast, photograph showing three super sacks staged to collect biochar from the biochar unit.

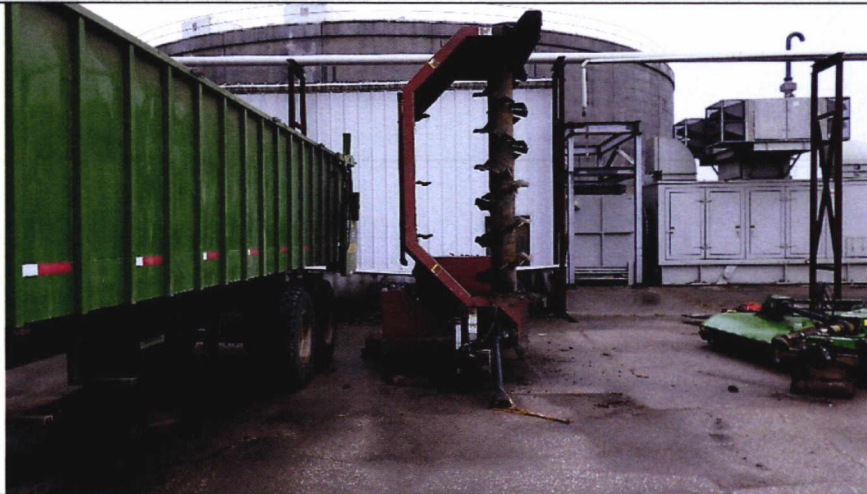
Photograph 16
Date: September 11, 2020
Photographer: Jason Holsten
Camera: Ricoh WG-50
IIS# 84069, IWM Permit # NE0204447
Subject: AltEn, LLC Site Visit

Photograph showing a piece of equipment used to turn windrows of DG.

In all areas, I observed DG to be in either piles and/or windrows of varying size. Mr. Tingelhoff explained that they crown the windrows to help with runoff. He said in the past, rainwater would pond on top of the DG stockpiles which he believed contributed to the odor problems. He said a compost turner is used now to help dry out the DG and Odor X is applied to help limit odors. He also said the facility is not composting any of the DG. I estimated many of the windrows to be between 10-15 feet high.

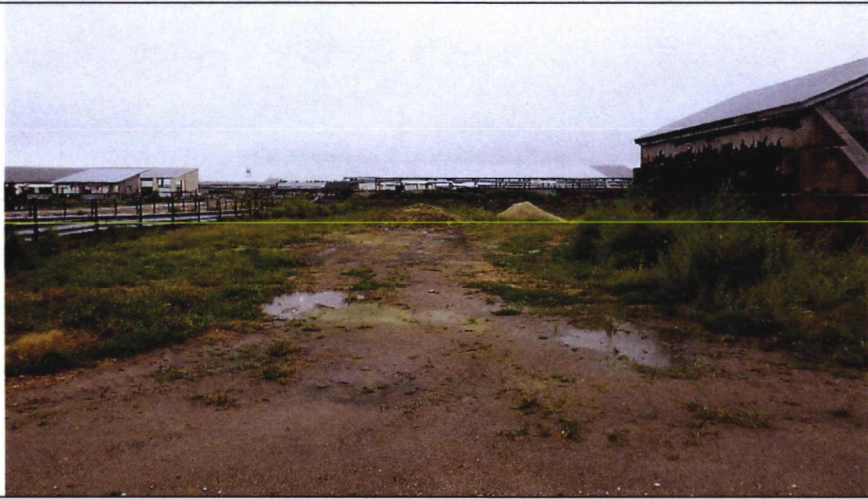
Photograph 17
Date: September 11, 2020
Photographer: Jason Holsten
Camera: Ricoh WG-50
IIS# 84069, IWM Permit # NE0204447
Subject: AltEn, LLC Site Visit

Looking south, photograph showing DG stockpiled east of compost pad 1.

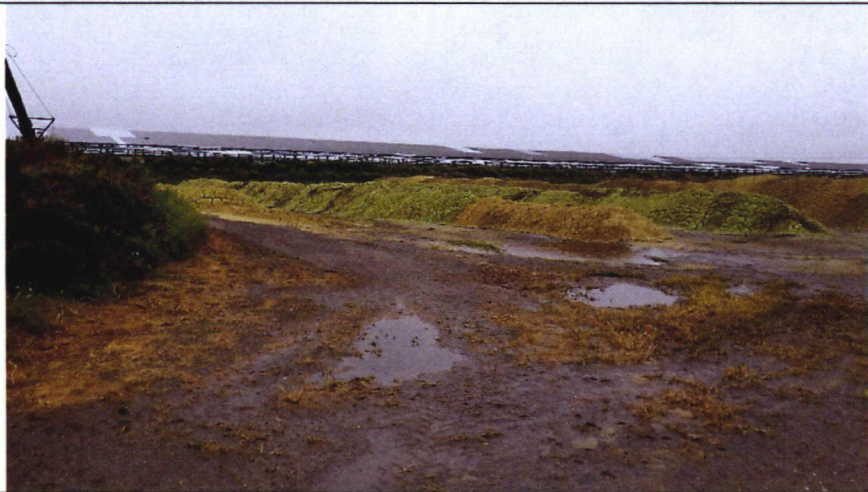
Photograph 18
Date: September 11, 2020
Photographer: Jason Holsten
Camera: Ricoh WG-50
IIS# 84069, IWM Permit # NE0204447
Subject: AltEn, LLC Site Visit

Looking southwest, photograph showing rows of DG stockpiled on compost pad 1.

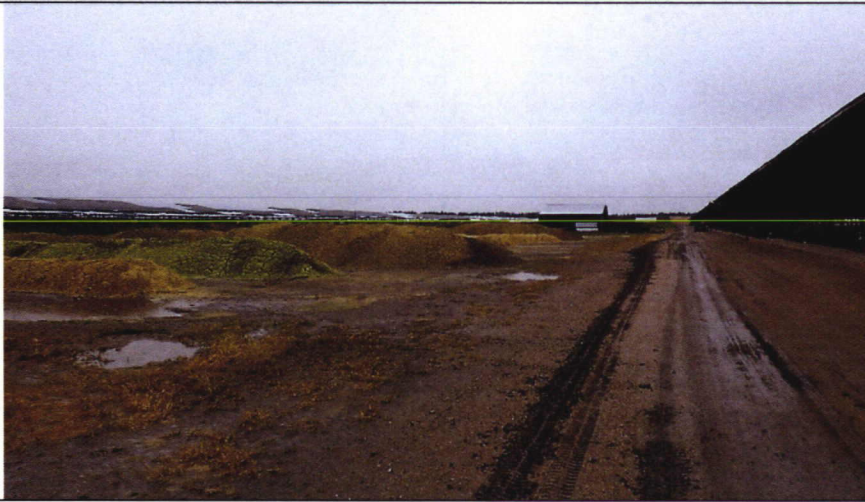
Photograph 19
Date: September 11, 2020
Photographer: Jason Holsten
Camera: Ricoh WG-50
IIS# 84069, IWM Permit # NE0204447
Subject: AltEn, LLC Site Visit

Looking west, photograph showing DG stockpiled on compost pads 1 and 2.

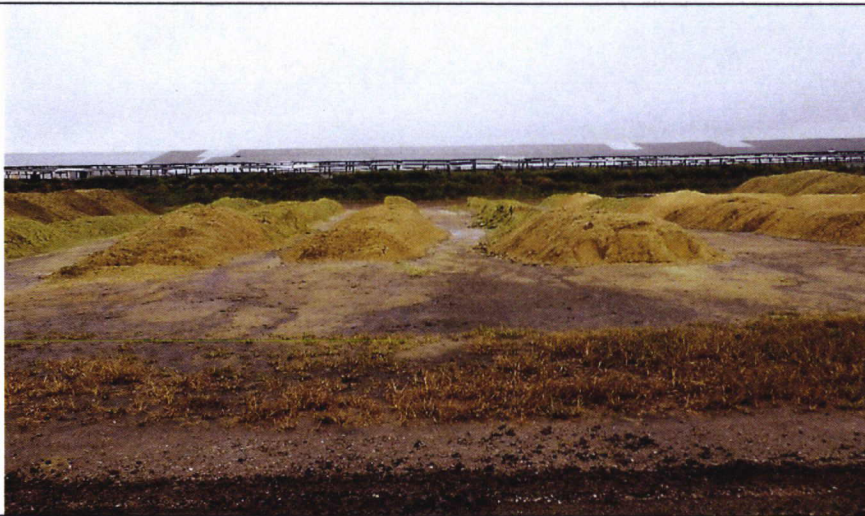
Photograph 20
Date: September 11, 2020
Photographer: Jason Holsten
Camera: Ricoh WG-50
IIS# 84069, IWM Permit # NE0204447
Subject: AltEn, LLC Site Visit

Looking south, photograph showing rows of DG stockpiled on compost pad 1.

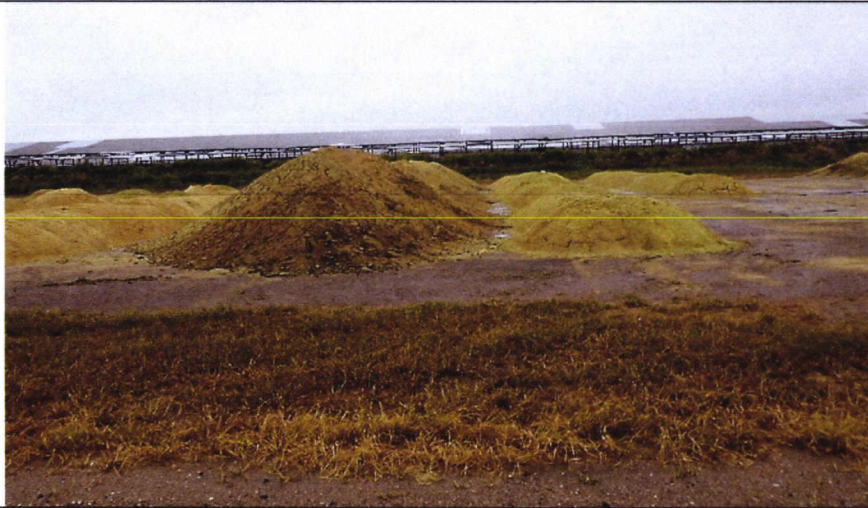
Photograph 21
Date: September 11, 2020
Photographer: Jason Holsten
Camera: Ricoh WG-50
IIS# 84069, IWM Permit # NE0204447
Subject: AltEn, LLC Site Visit

Looking south, photograph showing the size difference of some rows of DG observed on compost pads 1 and 2.

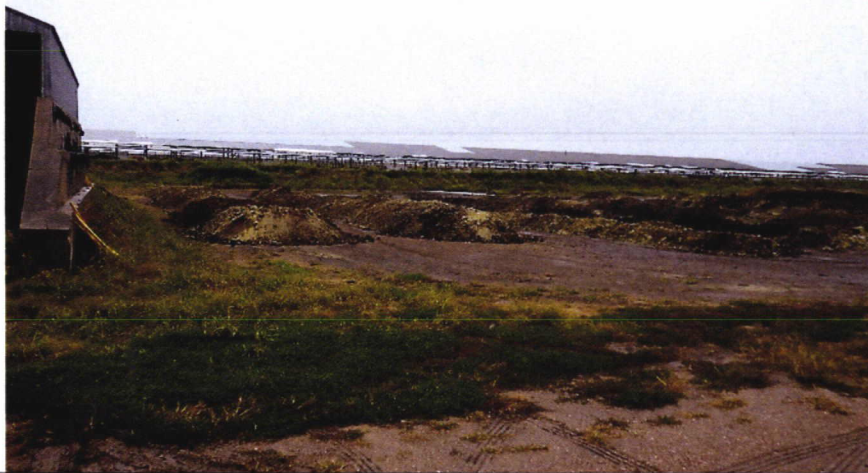
Photograph 22
Date: September 11, 2020
Photographer: Jason Holsten
Camera: Ricoh WG-50
IIS# 84069, IWM Permit # NE0204447
Subject: AltEn, LLC Site Visit

Looking south southwest, photograph showing DG stockpiled on compost pads 2 and 3.

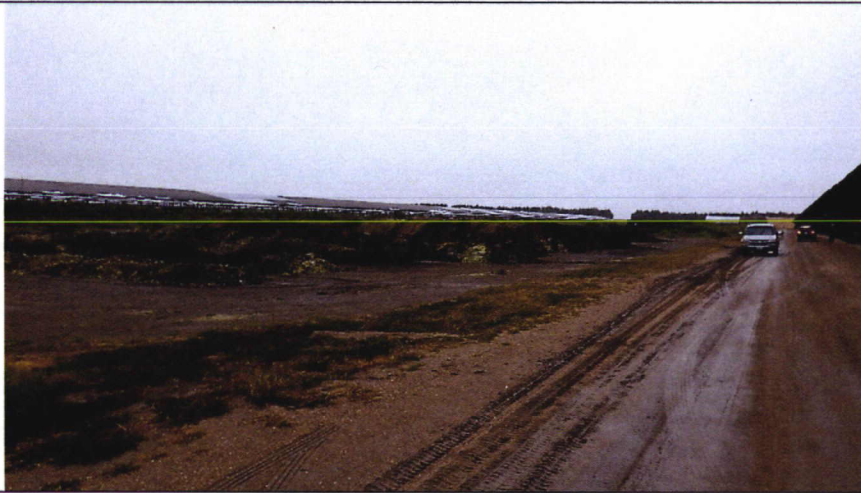
Photograph 23
Date: September 11, 2020
Photographer: Jason Holsten
Camera: Ricoh WG-50
IIS# 84069, IWM Permit # NE0204447
Subject: AltEn, LLC Site Visit

Looking west southwest, photograph showing DG stockpiled on compost pads 2 and 3.

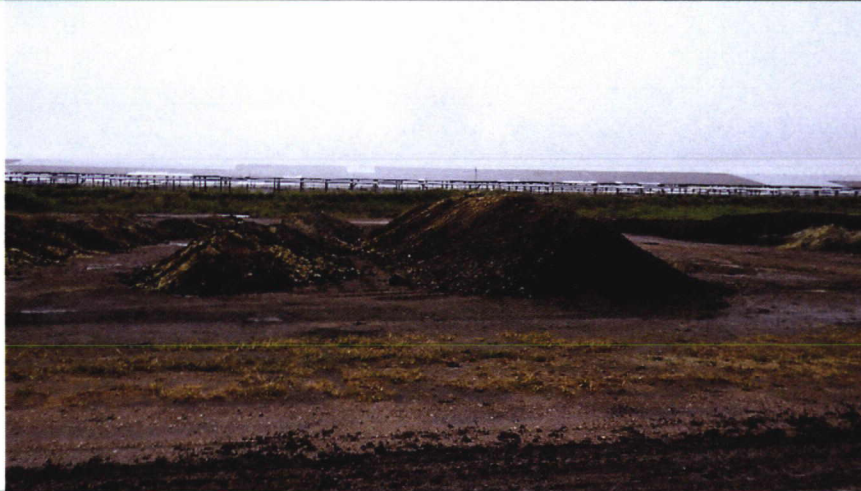
Photograph 24
Date: September 11, 2020
Photographer: Jason Holsten
Camera: Ricoh WG-50
IIS# 84069, IWM Permit # NE0204447
Subject: AltEn, LLC Site Visit

Photograph showing rows of DG stockpiled on compost pad 3.

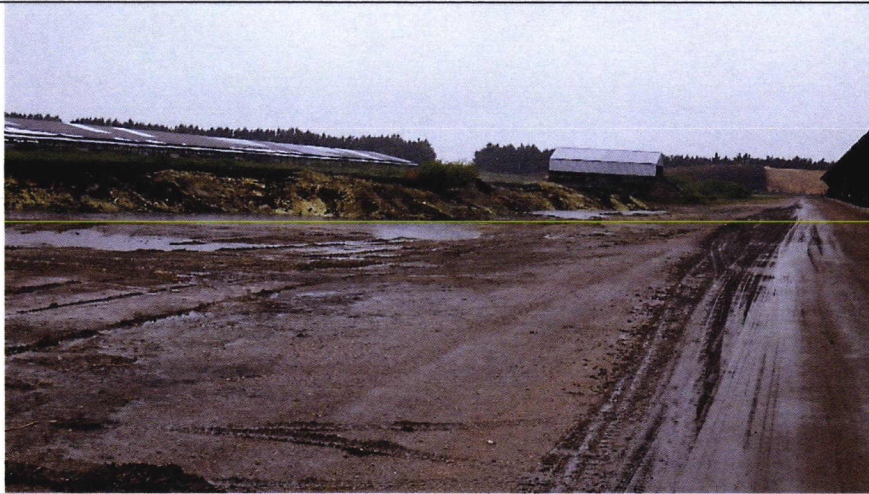
Photograph 25
Date: September 11, 2020
Photographer: Jason Holsten
Camera: Ricoh WG-50
IIS# 84069, IWM Permit # NE0204447
Subject: AltEn, LLC Site Visit

Looking west, photograph showing DG stockpiled on compost pad 3 and in an area west of pad 3.

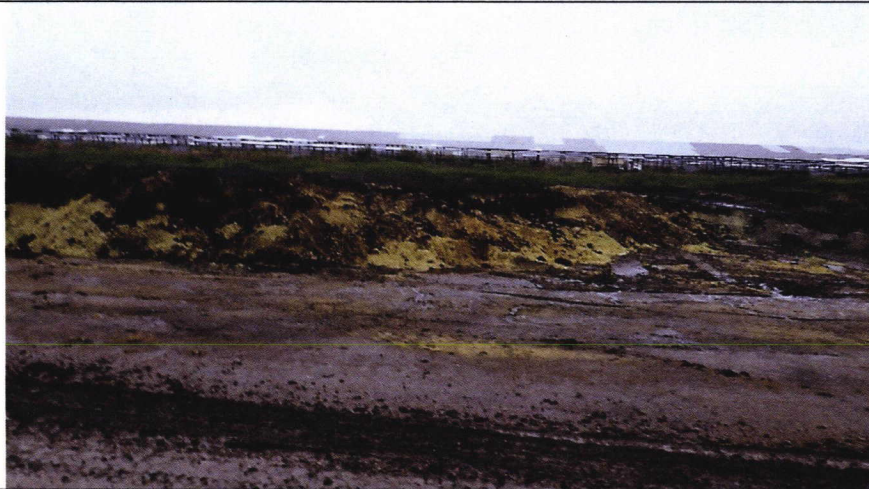
Photograph 26
Date: September 11, 2020
Photographer: Jason Holsten
Camera: Ricoh WG-50
IIS# 84069, IWM Permit # NE0204447
Subject: AltEn, LLC Site Visit

Looking south, photograph showing DG stockpiled in an area west of compost pad 3.

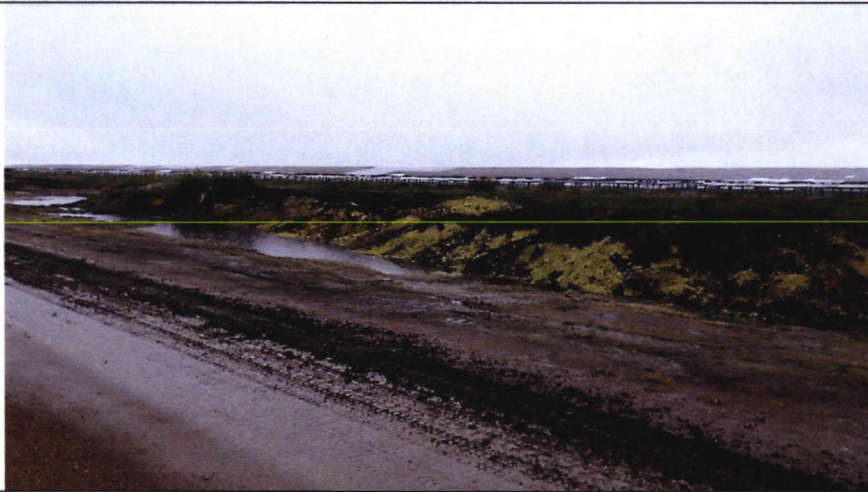
Photograph 27
Date: September 11, 2020
Photographer: Jason Holsten
Camera: Ricoh WG-50
IIS# 84069, IWM Permit # NE0204447
Subject: AltEn, LLC Site Visit

Looking southeast, from near the western edge of where compost was being stockpiled. This area was near alley "G13" of the adjacent cattle pens.

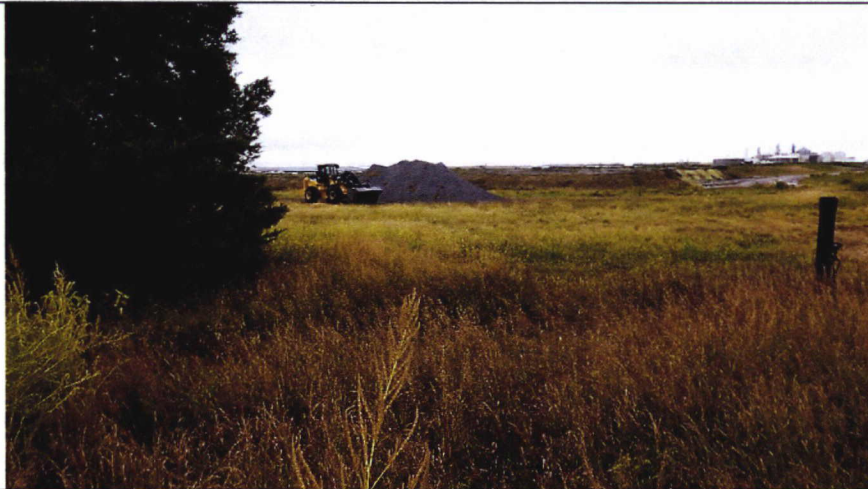
Photograph 28
Date: September 11, 2020
Photographer: Jason Holsten
Camera: Ricoh WG-50
IIS# 84069, IWM Permit # NE0204447
Subject: AltEn, LLC Site Visit

Looking west southwest, photograph showing DG being stockpiled in an area located on the northeast corner of AltEn property. Also observed was what appeared to be a pile of fly ash located next to a front end loader. Mr. Tingelhoff was unsure what the material was and didn't know whose property it was on. It could belong to Mead Cattle or the surrounding agriculture property owner.

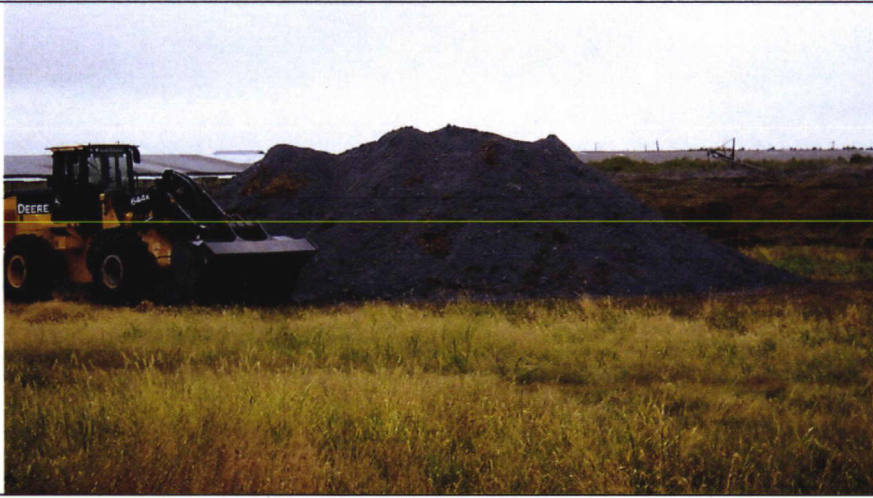
Photograph 29
Date: September 11, 2020
Photographer: Jason Holsten
Camera: Ricoh WG-50
IIS# 84069, IWM Permit # NE0204447
Subject: AltEn, LLC Site Visit

Photograph showing the size of the presumably fly ash pile in relation to the front end loader.

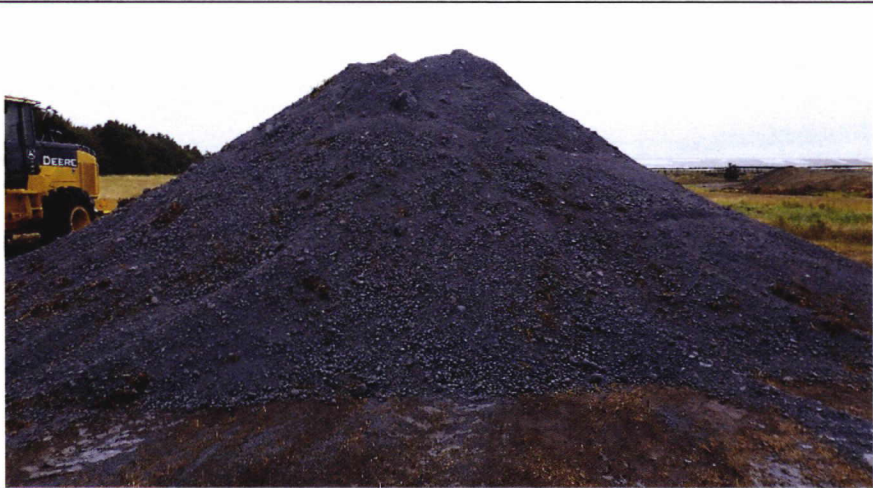
Photograph 30
Date: September 11, 2020
Photographer: Jason Holsten
Camera: Ricoh WG-50
IIS# 84069, IWM Permit # NE0204447
Subject: AltEn, LLC Site Visit

Photograph showing a closer view of the presumably fly ash pile.

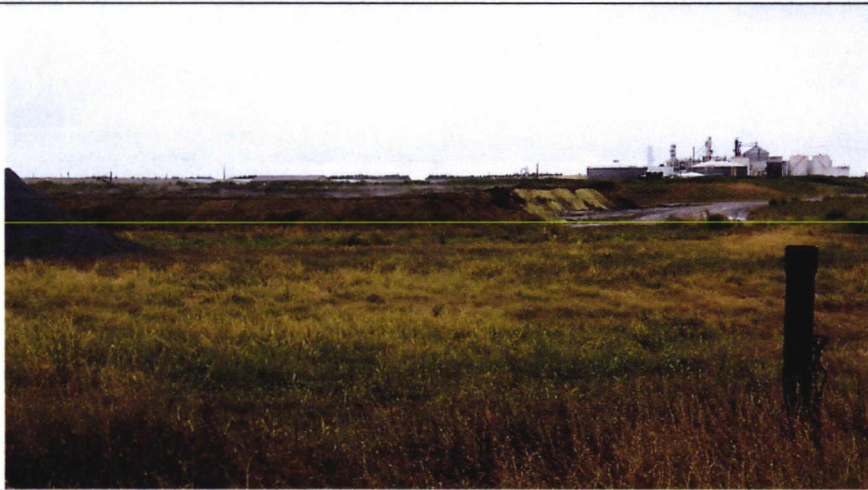
Photograph 31
Date: September 11, 2020
Photographer: Jason Holsten
Camera: Ricoh WG-50
IIS# 84069, IWM Permit # NE0204447
Subject: AltEn, LLC Site Visit

Looking southeast, photograph showing the DG being stockpiled at the northeast corner of AltEn property.

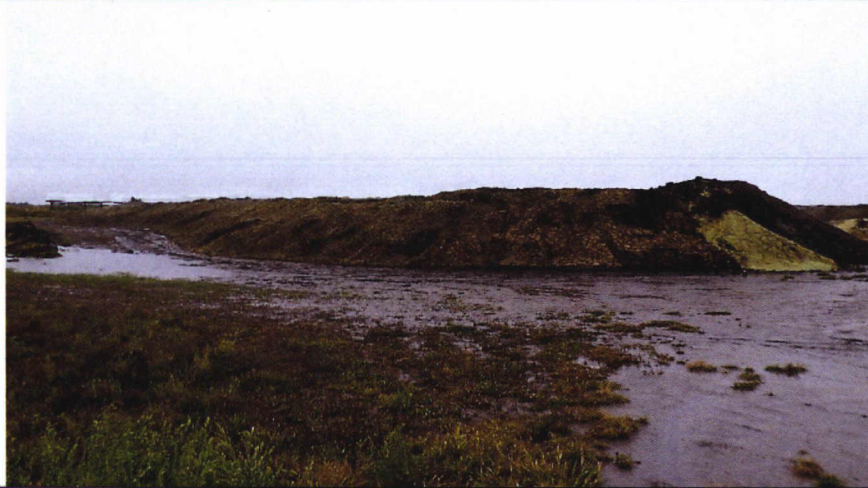
Photograph 32
Date: September 11, 2020
Photographer: Jason Holsten
Camera: Ricoh WG-50
IIS# 84069, IWM Permit # NE0204447
Subject: AltEn, LLC Site Visit

Looking primarily south, photograph showing the eastern edge of the DG being stockpiled at the northeast corner of AltEn property.

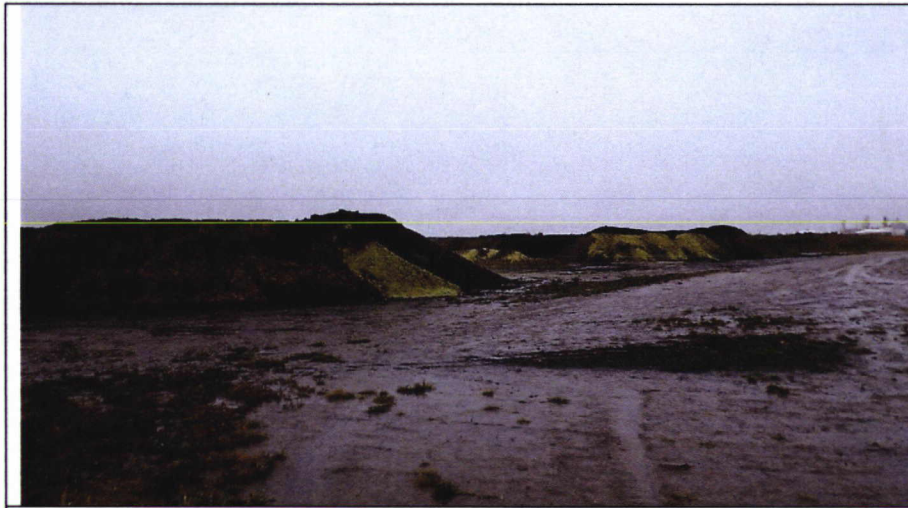
Photograph 33
Date: September 11, 2020
Photographer: Jason Holsten
Camera: Ricoh WG-50
IIS# 84069, IWM Permit # NE0204447
Subject: AltEn, LLC Site Visit

Looking southeast, photograph showing the DG being stockpiled at the northeast corner of AltEn property.

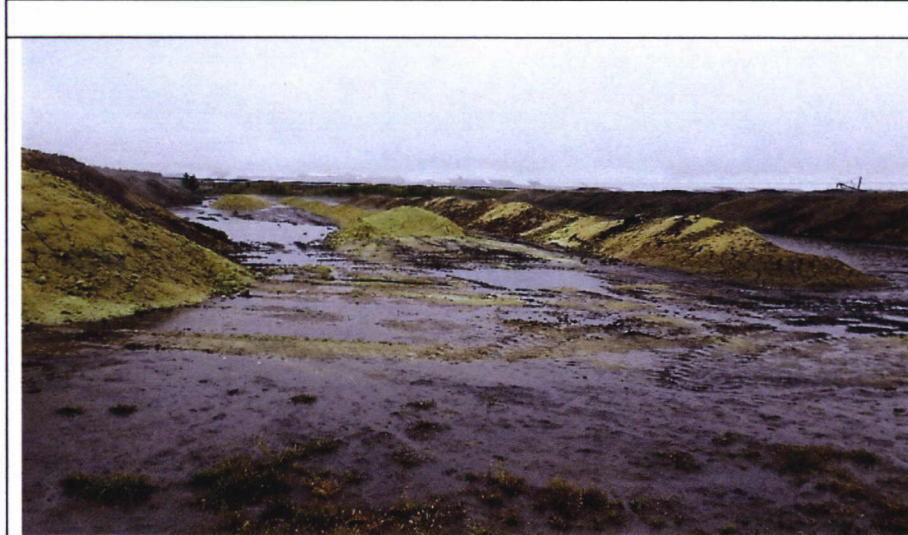
Photograph 34
Date: September 11, 2020
Photographer: Jason Holsten
Camera: Ricoh WG-50
IIS# 84069, IWM Permit # NE0204447
Subject: AltEn, LLC Site Visit

Looking south, photograph showing rows of DG being stockpiled at the northeast corner of AltEn property.

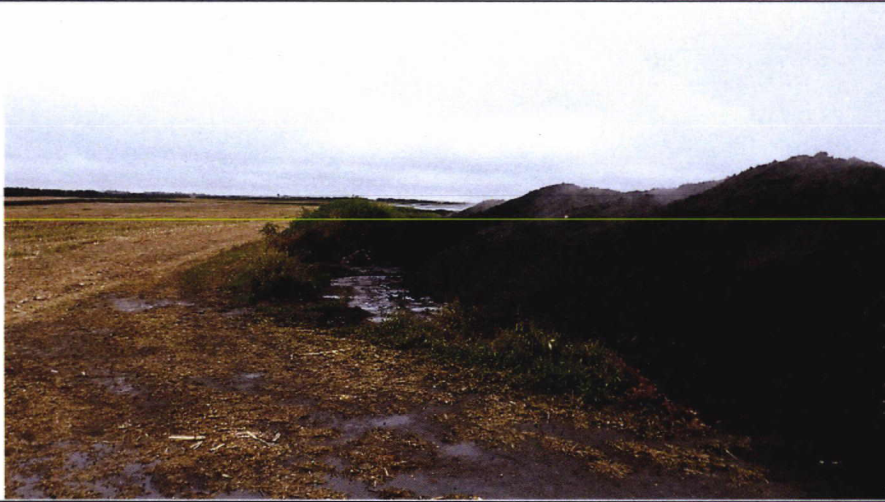
Photograph 35
Date: September 11, 2020
Photographer: Jason Holsten
Camera: Ricoh WG-50
IIS# 84069, IWM Permit # NE0204447
Subject: AltEn, LLC Site Visit

Looking east, photograph showing the northern edge of the DG being stockpiled at the northwest corner of AltEn property. This location is adjacent to and east of County Road 10.

Other site observations: prior to arriving at the facility I drove down County Road 10 which runs parallel with the stockpiled DG located at the northwest corner of AltEn property, north of the hoop buildings. There was a very strong pungent odor in the area. Weather conditions for the day were fog/mist/rain and east southeast wind 5-10 mph. Temperature was 55°F. Weather conditions were obtained from the 3-day history of the National Weather Service website after I returned to the office and were for the Wahoo, NE area.

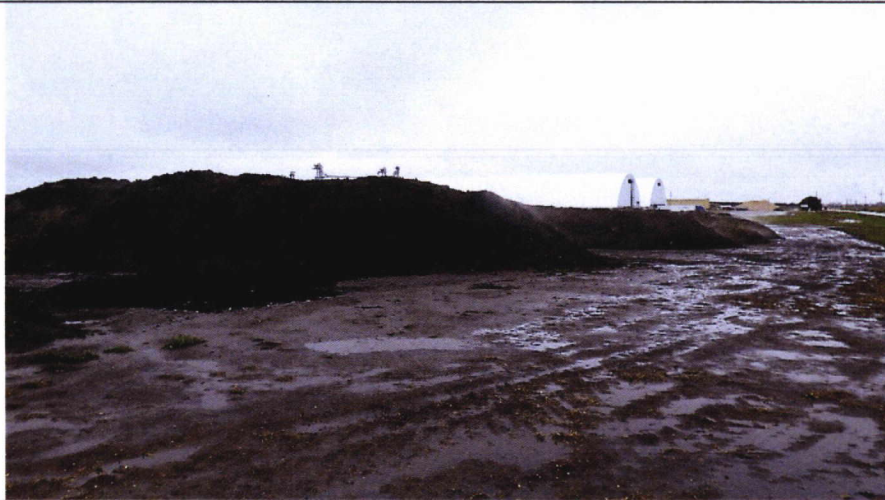
Photograph 36
Date: September 11, 2020
Photographer: Jason Holsten
Camera: Ricoh WG-50
IIS# 84069, IWM Permit # NE0204447
Subject: AltEn, LLC Site Visit

From the same vantage point as photograph 35, looking south, photograph showing the western edge of the DG being stockpiled at the northwest corner of AltEn property, north of the hoop buildings and parallel with County Road 10.

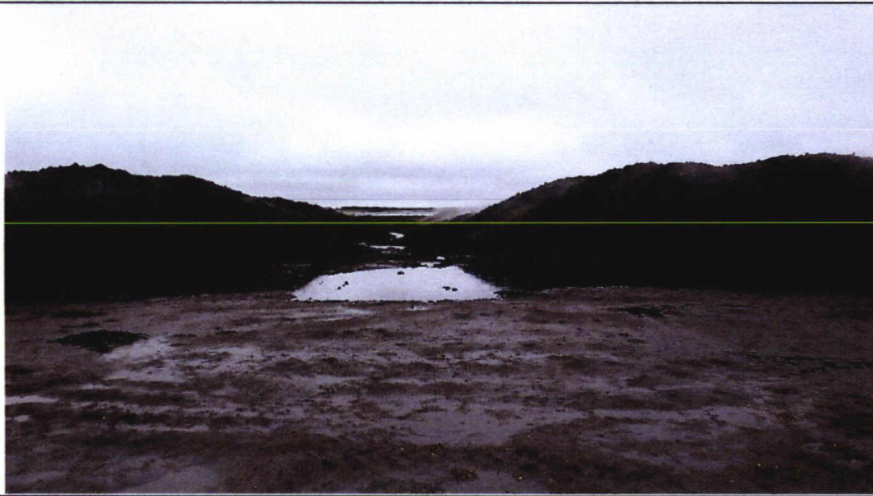
Photograph 37
Date: September 11, 2020
Photographer: Jason Holsten
Camera: Ricoh WG-50
IIS# 84069, IWM Permit # NE0204447
Subject: AltEn, LLC Site Visit

Looking east, photograph showing the rows of DG stockpiled in the northwest corner of AltEn property.

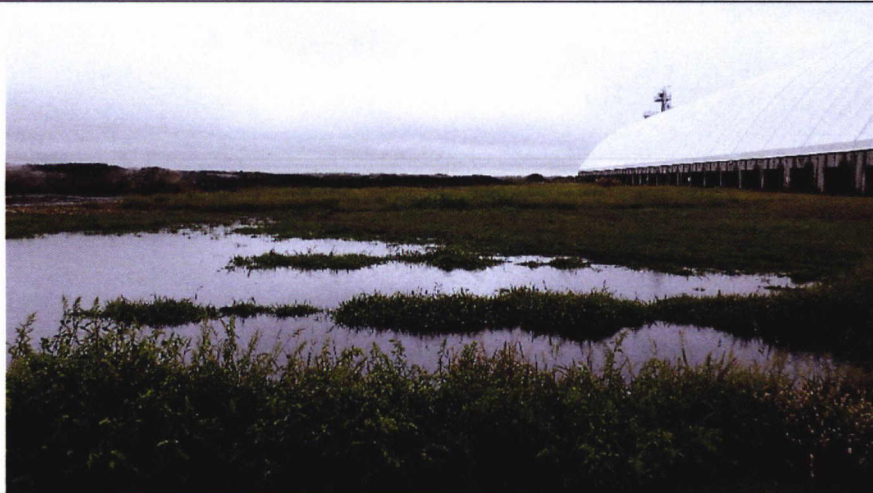
Photograph 38
Date: September 11, 2020
Photographer: Jason Holsten
Camera: Ricoh WG-50
IIS# 84069, IWM Permit # NE0204447
Subject: AltEn, LLC Site Visit

Looking east along the north side of the northern most hoop building. Photograph showing DG being stockpiled north of the hoop buildings.

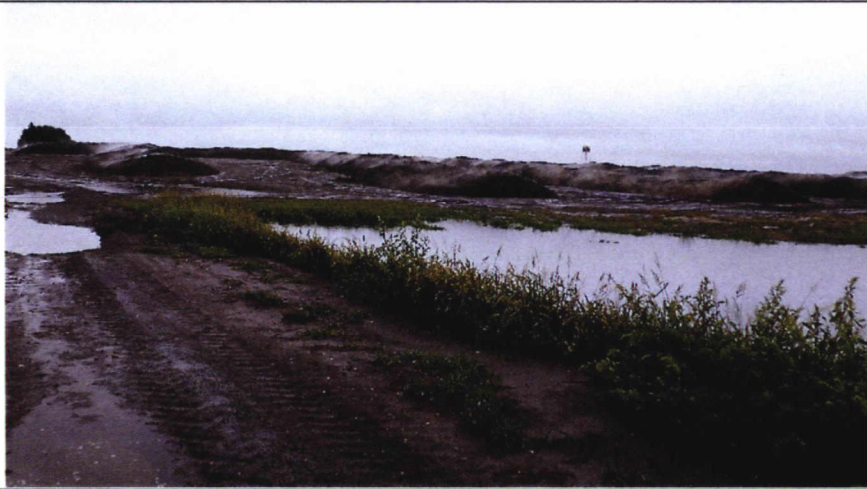
Photograph 39
Date: September 11, 2020
Photographer: Jason Holsten
Camera: Ricoh WG-50
IIS# 84069, IWM Permit # NE0204447
Subject: AltEn, LLC Site Visit

From the same vantage point as photograph 38, looking north, photograph showing rows of DG being stockpiled at the northwest corner of AltEn property.

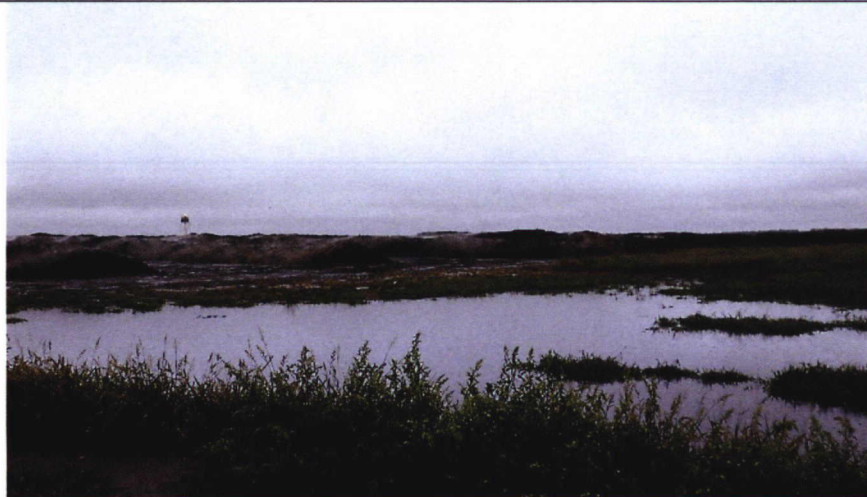
Photograph 40
Date: September 11, 2020
Photographer: Jason Holsten
Camera: Ricoh WG-50
IIS# 84069, IWM Permit # NE0204447
Subject: AltEn, LLC Site Visit

Looking northeast, from the same vantage point as photographs 38 and 39, photograph showing DG being stockpiled at the northwest corner of AltEn property.

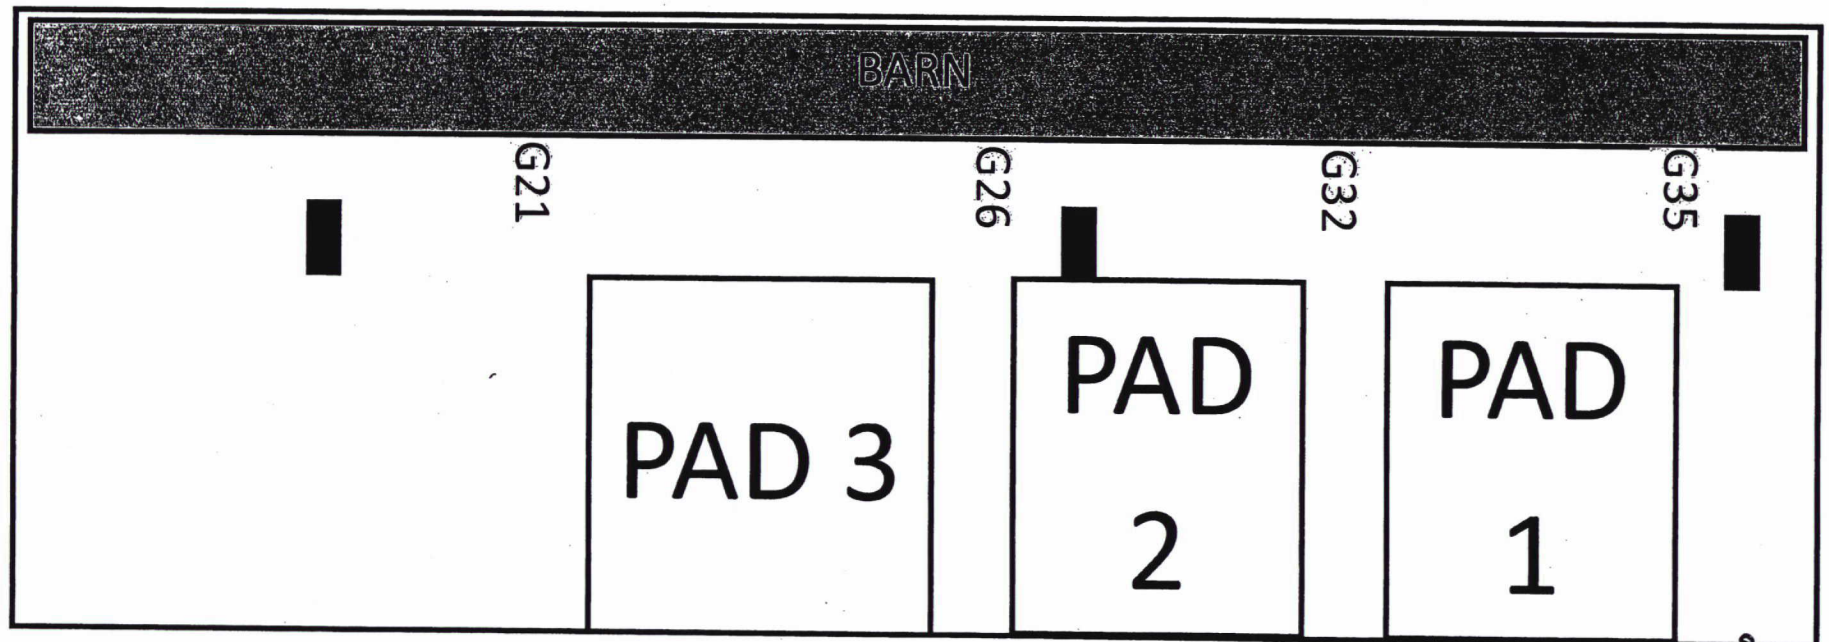
Compost Map (not to scale)

The yellow numbers are the numbers on the barn.
