Daily Observation Form – PM REPORT
AltEn LLC – Mead, NE Release
Facility ID: 84069; State Spill Report Number: 021221-NH-845
Date: February 20, 2021
Weather: Clear and sunny, 23 °F

ALTEN SITUATIONAL AWARENESS (FEB 2021)

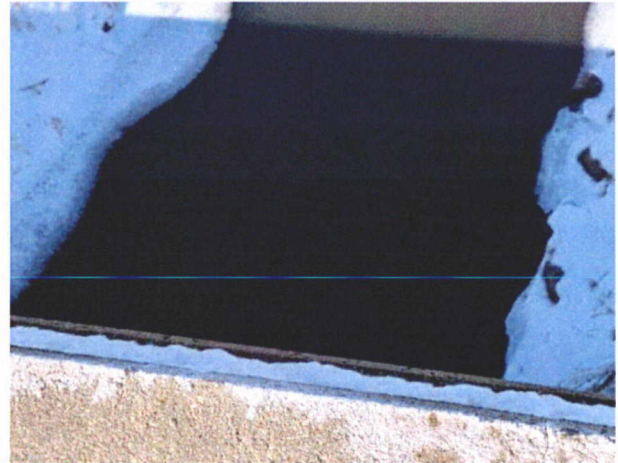
STOP 1 – Hwy 66 West of Ashland Gun Club

Water is flowing at this location. Ice and snow are visible at each bank.

No suspect odor present. No obvious signs of contamination (visual and/or olfactory) observed in water or on banks

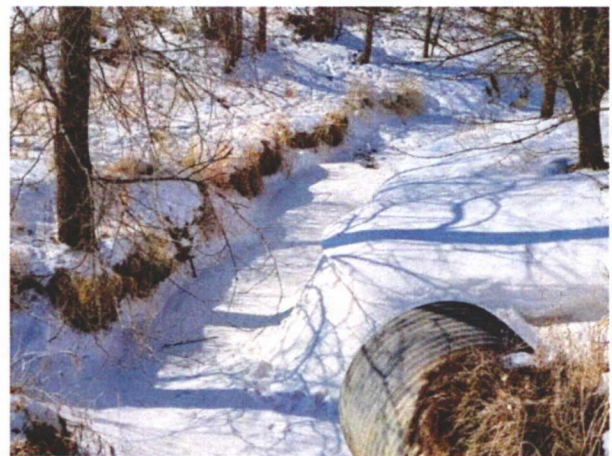
STOP 2 – North of the intersection of County Roads 6 & F

No visible water flow at this location. Ice and snow covered observed.

No suspect/obvious odor noted. Slight yellowish discoloration observed at surface, which appears to be natural.

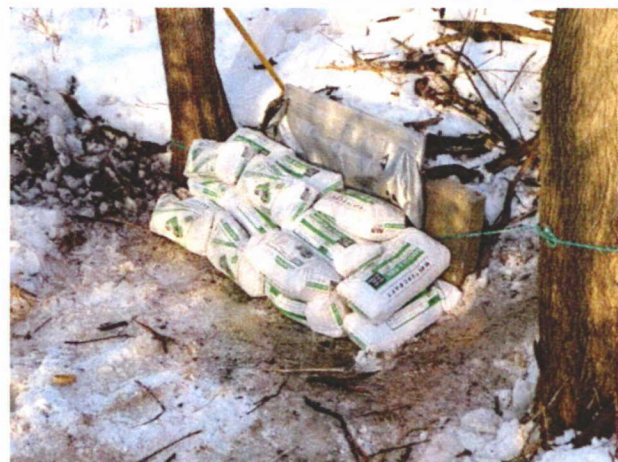
STOP 3 – Road 7/Hwy 66

Ice and snow observed at this location. No obvious signs of contamination (visual and/or olfactory) observed.

Clean Harbors has completed insertion of balloon barricade in culvert. Observed a tarp-covered board reinforced by sandbags.

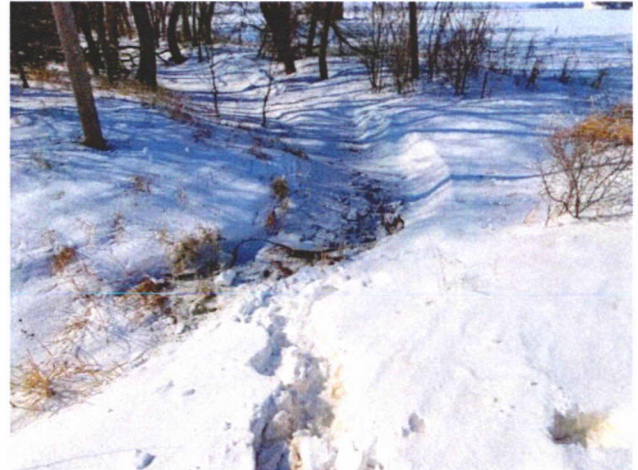
STOP 4 – County Road 8, North of Road H
41.1677657, -96.4447025
Time: 1446

Ice and snow cover observed at this location.

No obvious odor noted. Yellowish brown discolored ice observed at surface.

Observed breakage of ice that was not observed in the morning. No active work was observed at the time of the site visit.

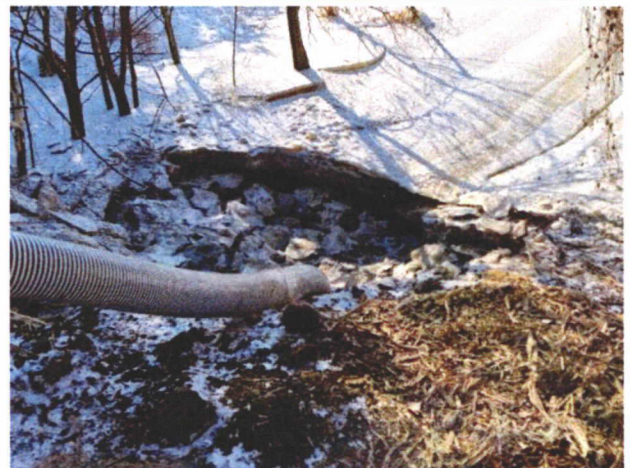
STOP 5 – UNL Eastern Extension – North of County Roads 9 & J
41.1862613, -96.4638642
Time: 1500

A manure odor was noted. Yellowish brown discolored ice and liquid observed on the west side of the waterway structure.

Pump in place and operating. Upon close observation liquid does not appear to be moving through the suction hose potentially due to limited liquid in the drainageway.

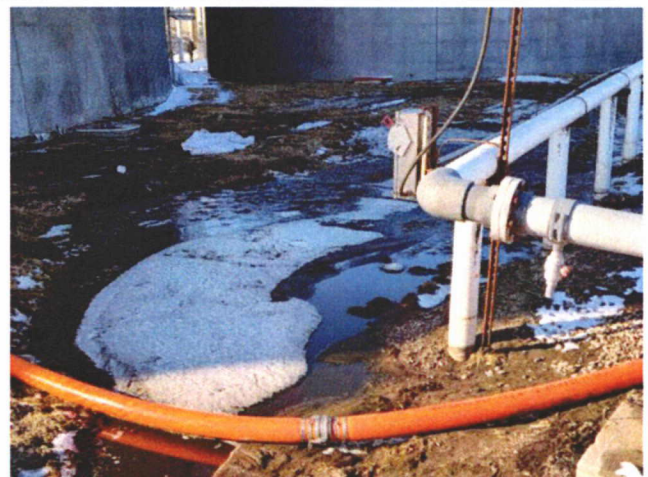
STOP 6 – AltEn LLC Facility Digesters
41.1952368, -96.4766895
Time: 1535

No active discharge observed from Digester 1. Partially melted impacted material observed on the eastside of Digester 1.

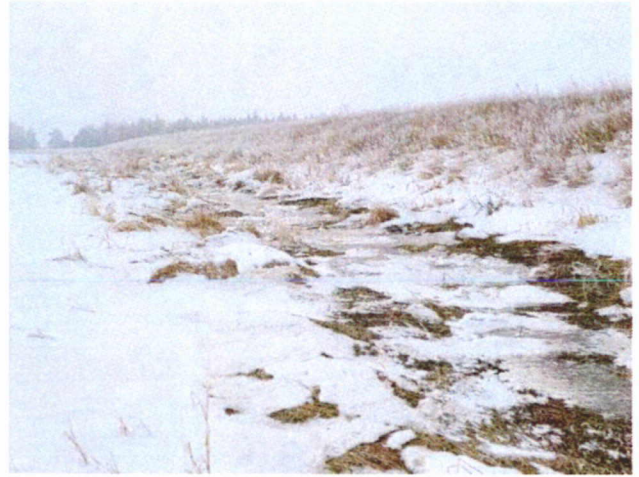
**Drainageway between Stop 5 and Stop 6
41.188525, -96.465052**

Observed limited frozen pockets of impacted material. No flow was observed.

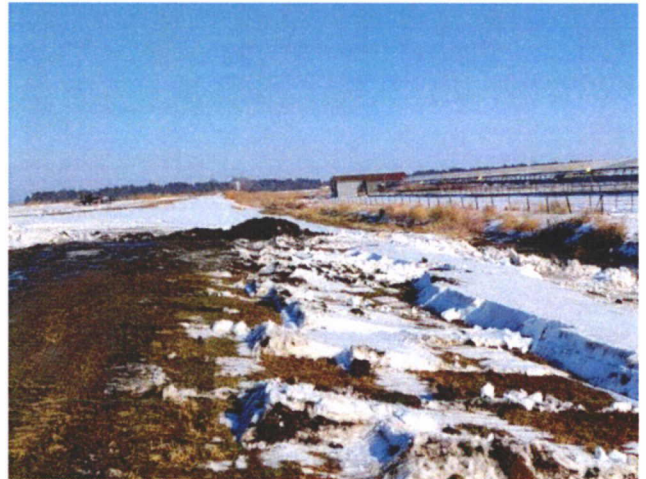
**STOP 6 – AltEn LLC Facility Drainageway
41.1955919, -96.472195**

Excavator no longer observed at this location.

Impacted material removed from drainageway in the morning was not observed. Based on conversations earlier in the day with Mr. Scott Tingelhoff of AltEn LLC, the plan was to dispose impacted material in the 6 mil lagoon.
