Daily Observation Form – AM REPORT
AltEn LLC – Mead, NE Release
Facility ID: 84069; State Spill Report Number: 021221-NH-845
Date: February 22, 2021
Weather: Clear and sunny, 32°F

STOP 1 – Hwy 66 West of Ashland Gun Club

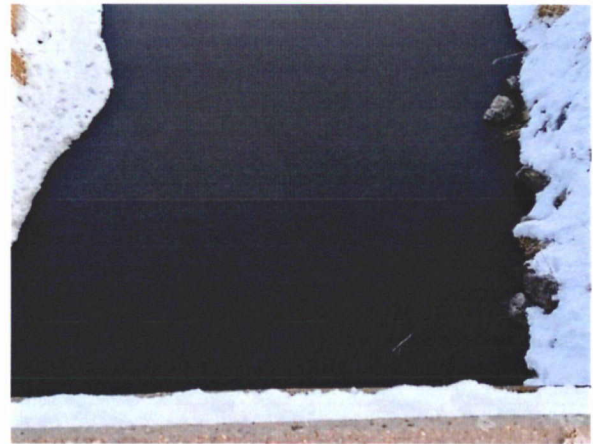
Water is flowing at this location. Ice and snow are visible at each bank.

No obvious signs of contamination (visual and/or olfactory) observed in water or on banks.

Photo Direction: Looking north.

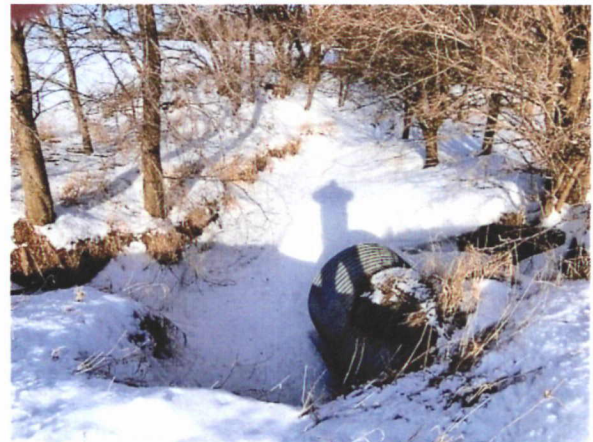
STOP 2 – North of the intersection of County Roads 6 & F

No visible water flow at this location. Ice and snow covered.

No obvious signs of contamination (visual and/or olfactory) observed in water or on banks.

Photo Direction: Looking northwest.

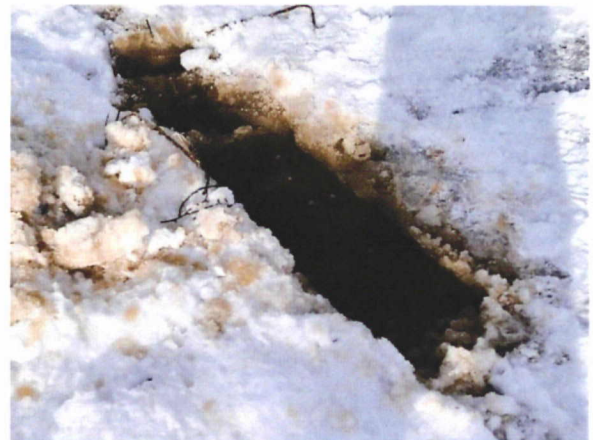
STOP 3 – Road 7/Hwy 66

Obvious signs of contamination (visual and/or olfactory) observed on the west side of Stop 3 in water and on sides of penetration in ice.

Photo Direction: Looking northwest.

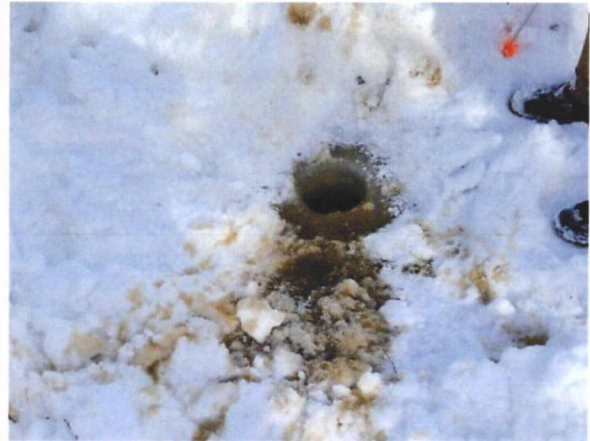
STOP 3 – Road 7/Hwy 66

Obvious signs of contamination (visual and/or olfactory) observed on the east side of Stop 3 in water and on sides of penetration.

Terracon on-site with Dave Bubb and Greg Michl of the NDEE. Mr. Bubb and Mr. Michl advanced an auger bit through the ice at this location.

Photo Direction: Looking north.

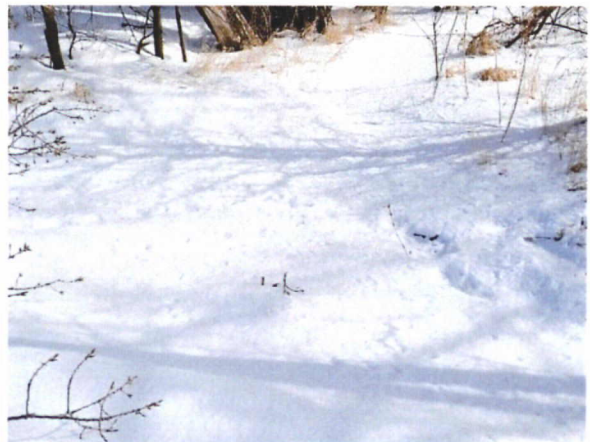
STOP 4 – County Road 8, North of Road H

No visible water flow on the west side of this location. Ice and snow covered.

No obvious signs of contamination (visual and/or olfactory) observed in water or on banks.

Photo Direction: Looking east.

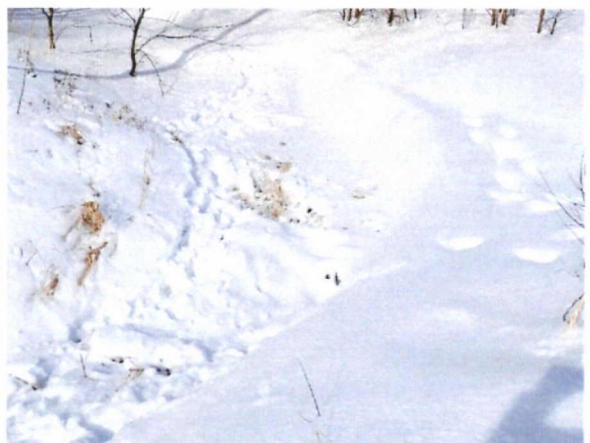
STOP 4 – County Road 8, North of Road H

No visible water flow on the east side of this location. Ice and snow covered.

Obvious signs of contamination (visual) observed at penetration in ice. No olfactory signs of contamination noted.

Photo Direction: Looking west.

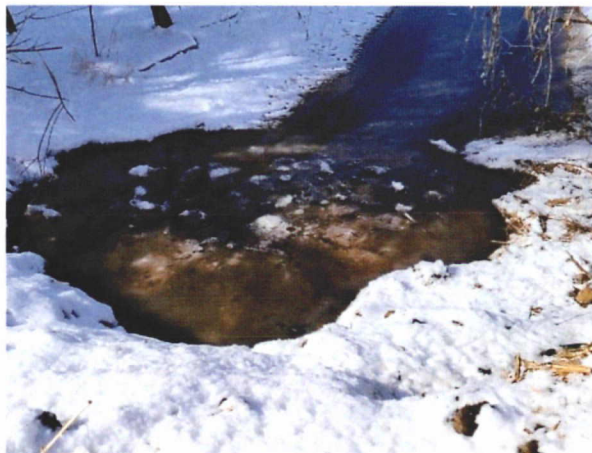
**STOP 5 – UNL Eastern Extension – North
of County Roads 9 & J**
GPS: 41.1862613, -96.4638642
Time: 1105

Obvious signs of contamination (visual and/or
olfactory) observed on the west side in water
and on sides of penetration in ice.

Photo Direction: Looking west.

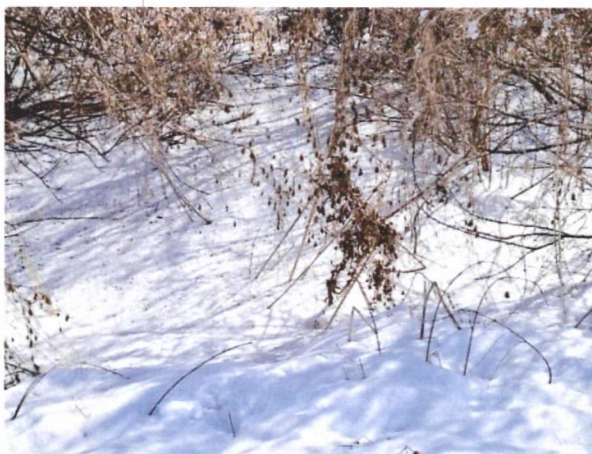
**STOP 5 – UNL Eastern Extension – North
of County Roads 9 & J**
GPS: 41.1862613, -96.4638642
Time: 1105

No obvious signs of contamination (visual)
observed on the east side of the location.

Photo Direction: Looking east.

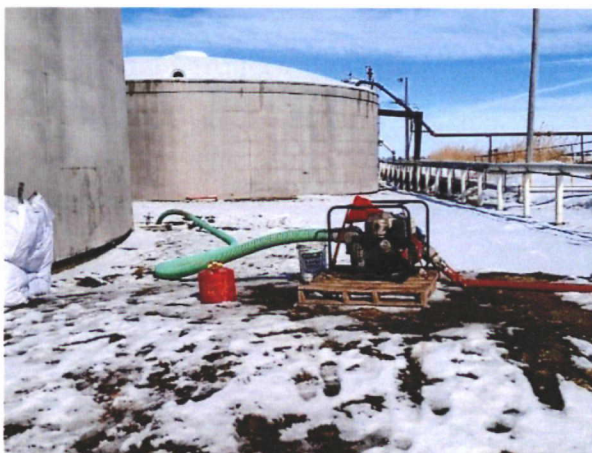
STOP 6 – AltEn LLC Facility Digesters
GPS: 41.1952368, -96.4766895
Time: 1125

Ice and snow observed at this location.

A pump set on a pallet is located between
Digester 1 and the south lagoon. Suction
hose placed in the pipe/valve well of digester
1 with discharge to the lagoon. The pump is
not actively running at the time of the site
visit.

No active work was observed at the time of
the site visit.

Photo Direction: Looking north.
