Daily Observation Form – PM REPORT
AltEn LLC – Mead, NE Release
Facility ID: 84069; State Spill Report Number: 021221-NH-845
Date: February 22, 2021
Weather: Clear and sunny, 45 °F

Daily Observation Form – PM REPORT

AltEn LLC – Mead, NE Release

Facility ID: 84069; State Spill Report Number: 021221-NH-845

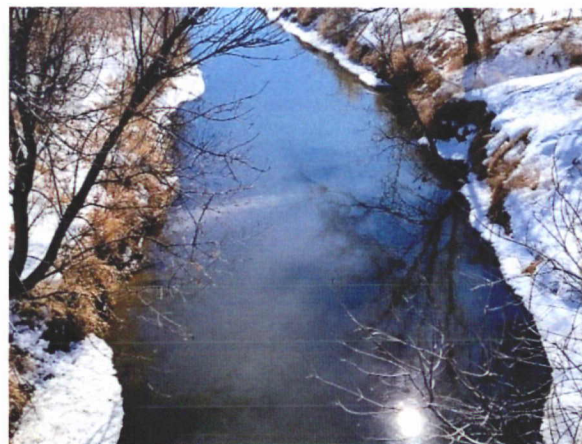
STOP 1 – Hwy 66 West of Ashland Gun Club

Water is flowing at this location. Ice and snow are visible at each bank.

No suspect odor present. No obvious signs of contamination (visual and/or olfactory) observed in water or on banks

No active work was observed at the time of the site visit.

Photo Direction: Looking south.

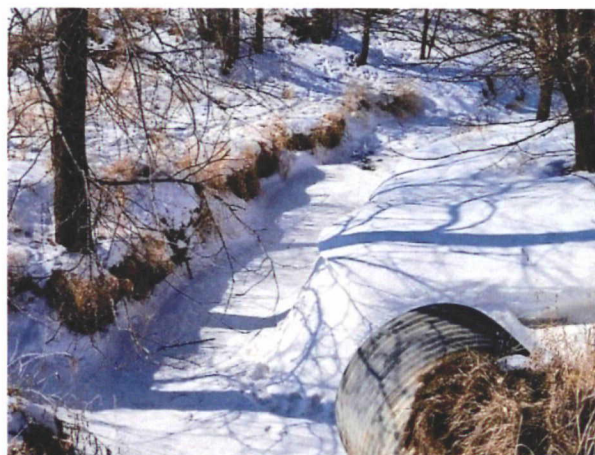
STOP 2 – North of the intersection of County Roads 6 & F

No visible water flow at this location. Ice and snow cover observed.

No suspect/obvious odor noted. Slight yellowish discoloration observed at surface, which appears to be natural.

No active work was observed at the time of the site visit.

Photo Direction: Looking northwest.

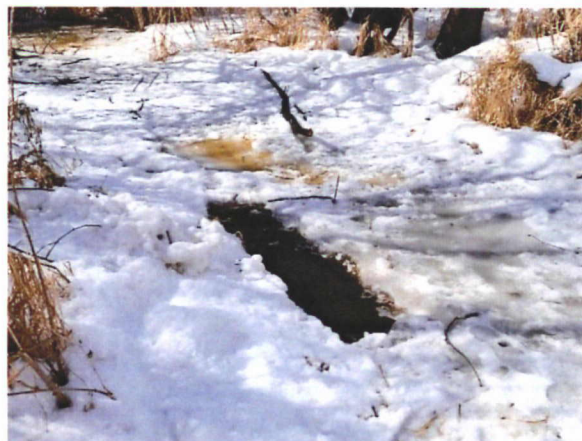
STOP 3 – Road 7/Hwy 66

Obvious signs of contamination (visual and/or olfactory) observed on the west side of Stop 3 in water and on sides of penetration in ice. More liquid discoloration observed surrounding penetration since morning visit.

No active work was observed at the time of the site visit.

Photo Direction: Looking northwest.

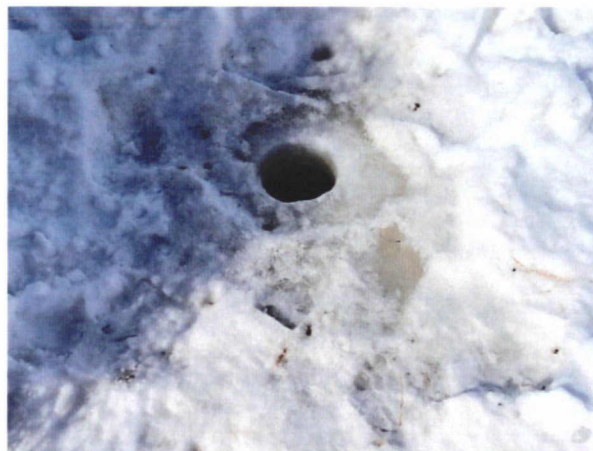
STOP 3 – Road 7/Hwy 66

Obvious signs of contamination (visual and/or olfactory) observed on the east side of Stop 3 in water and on sides of penetration.

No visible or audible signs of water flow observed in the penetration at this location.

Photo Direction: Looking north.

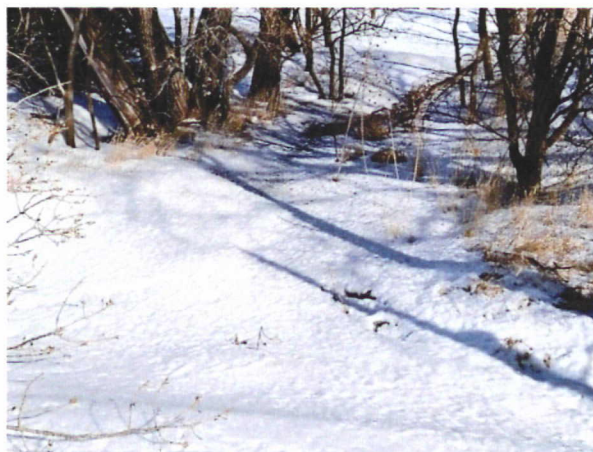
STOP 4 – County Road 8, North of Road H

No visible water flow on the east side at this location. Ice and snow covered.

No obvious signs of contamination (visual and/or olfactory) observed in water or on banks.

No active work was observed at the time of the site visit.

Photo Direction: Looking east.

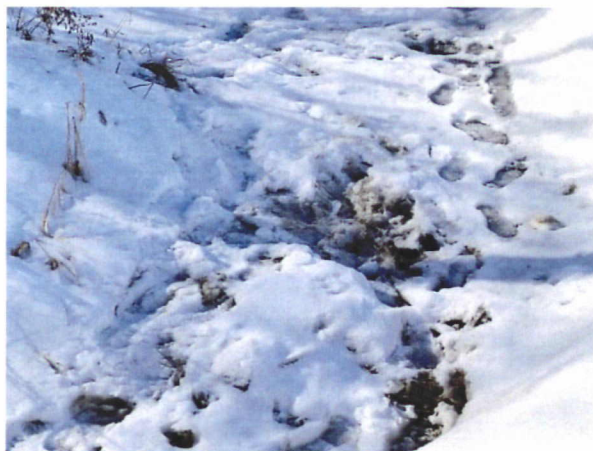
STOP 4 – County Road 8, North of Road H

No visible water flow on the west side at this location. Ice and snow covered.

Obvious signs of contamination (visual) observed at penetrations in ice. No olfactory signs of contamination noted.

Photo Direction: Looking northwest.

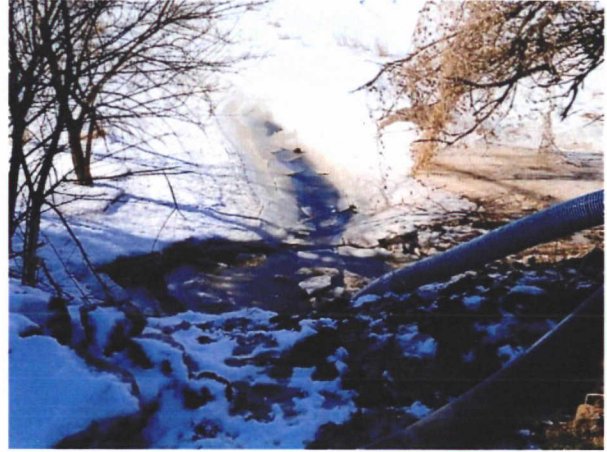
**STOP 5 – UNL Eastern Extension – North
of County Roads 9 & J**
GPS: 41.1862613, -96.4638642
Time: 1450

Equipment onsite actively pumping impacted material from west side of the location.

Obvious signs of contamination (visual and/or olfactory) observed in water and on sides of penetration in ice.

Photo Direction: Looking west.

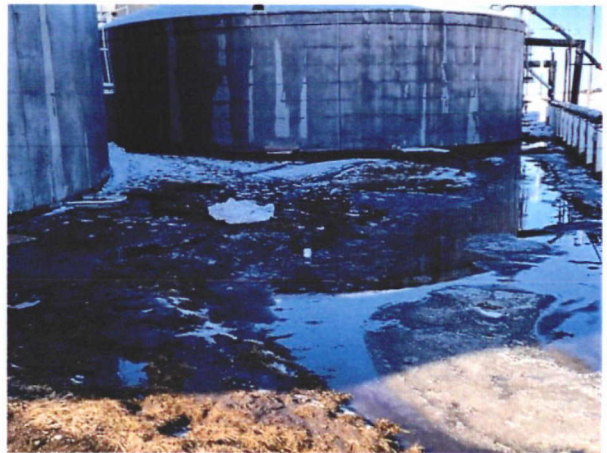
STOP 6 – AltEn LLC Facility Drainageway
41.1955919, -96.472195
Time: 1515

Pump observed at this location this morning no longer onsite between Digester 1 and the south lagoon.

No active work was observed at the time of the site visit.

Photo Direction: Looking north.

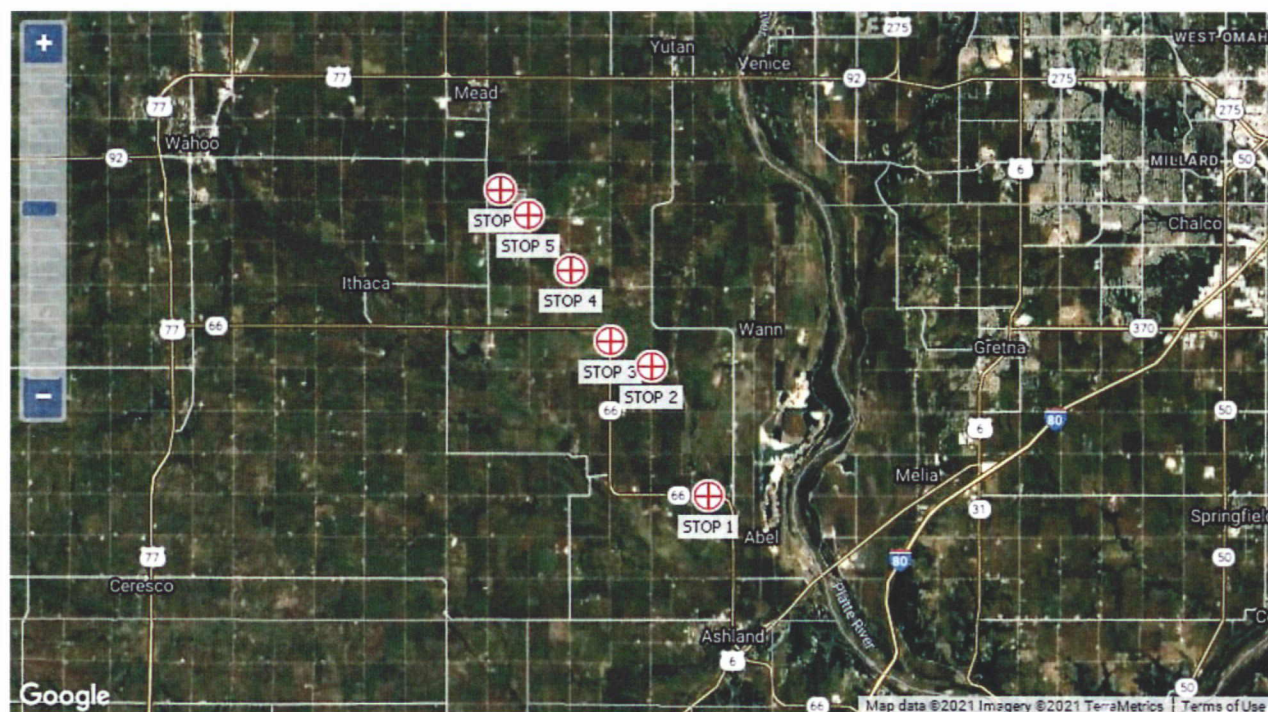
ALTEN SITUATIONAL AWARENESS (FEB 2021)

- DAILY TRIPS (One Person) - This could be twice per day as things warm up.
- 6 Stops
- Visual Observations recorded
- Immediate Notification/Action if changes are observed.
 - Sampling
 - Initiate a Response Contractor
- Record observations on a custom/standard form.
