Daily Observation Form – AM REPORT
AltEn LLC – Mead, NE Release
Facility ID: 84069; State Spill Report Number: 021221-NH-845
Date: February 20, 2021
Weather: Heavy fog, 16 °F.

STOP 1 – Hwy 66 West of Ashland Gun Club

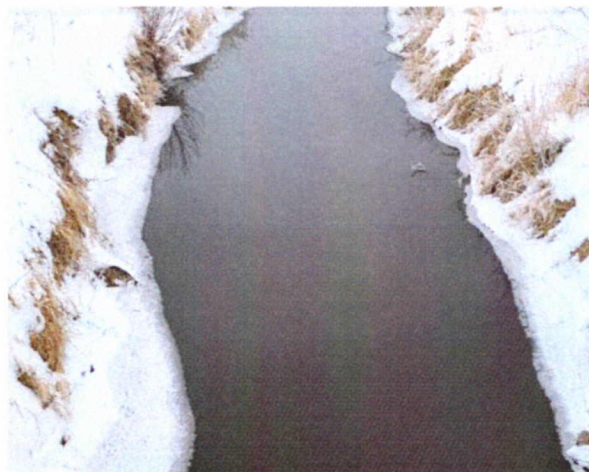
Water is flowing at this location. Ice and snow are visible at each bank.

No obvious signs of contamination (visual and/or olfactory) observed in water or on banks.

Photo Direction: Looking north.

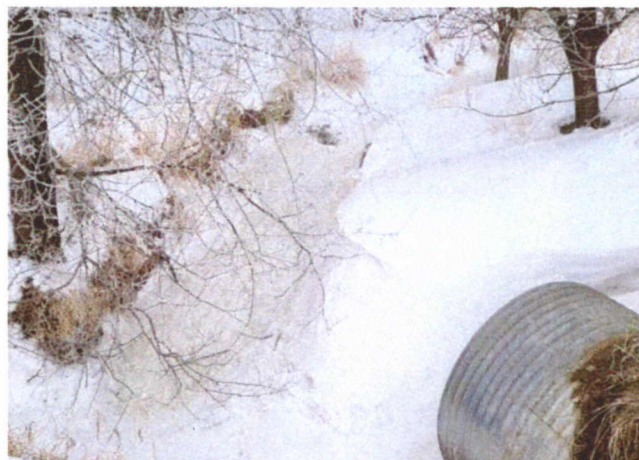
STOP 2 – North of the intersection of County Roads 6 & F

No visible water flow at this location. Ice and snow covered.

No obvious odor noted. Slight yellowish discoloration observed at surface, which appears to be natural.

Photo Direction: Looking northwest.

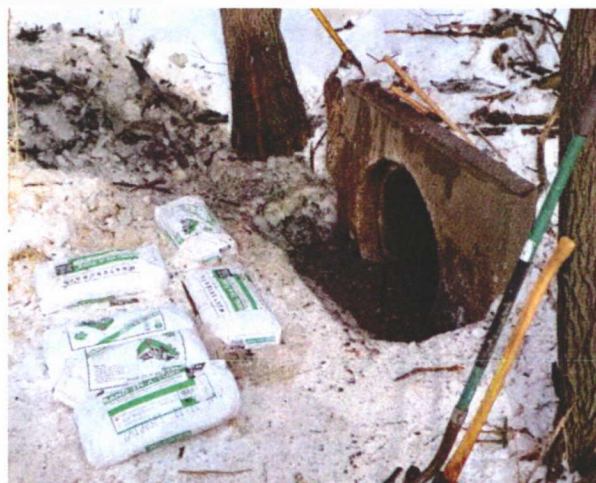
STOP 3 – Road 7/Hwy 66

Ice and snow observed at this location. No obvious signs of contamination (visual and/or olfactory) observed.

Clean Harbors in process of preparing culvert for inflated balloon barricade insertion followed by wood barricade and sandbags.

Photo Direction: Looking northeast.

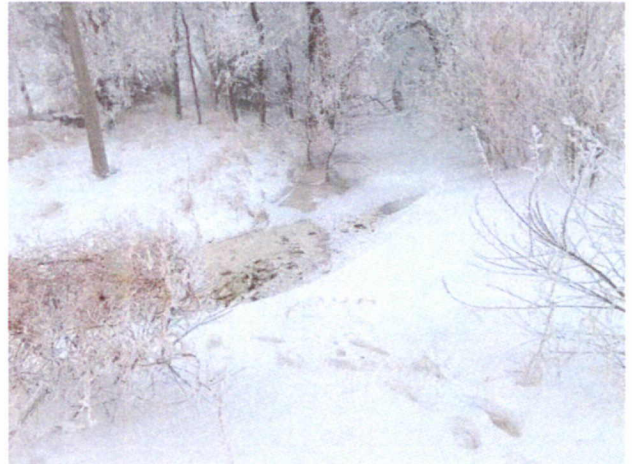
STOP 4 – County Road 8, North of Road H
GPS: 41.1677657, -96.4447025
Time: 0915

Ice and snow cover observed at this location.

No obvious odor noted. Yellowish brown discolored ice observed at surface.

Photo Direction: Looking east.

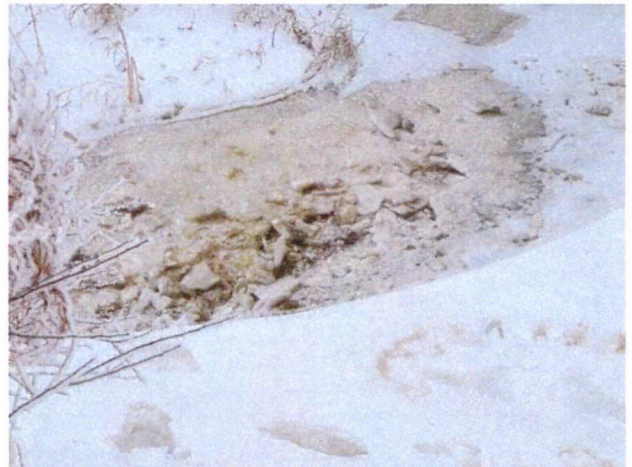
Photo Direction: Looking east.

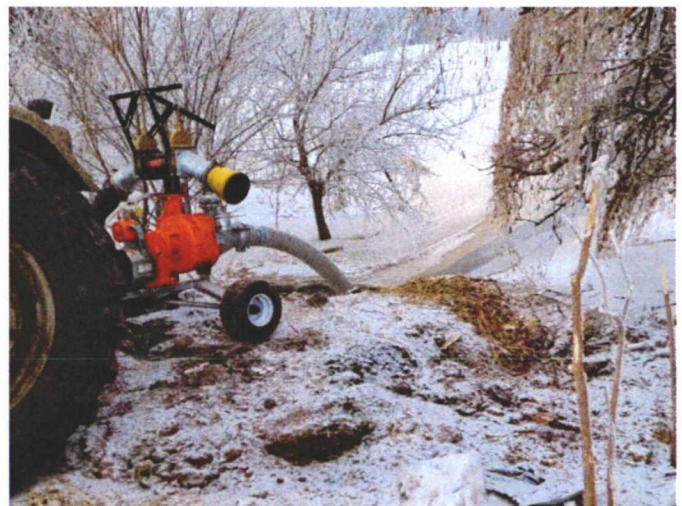
STOP 5 – UNL Eastern Extension – North of County Roads 9 & J
GPS: 41.1862613, -96.4638642
Time: 0945

Ice and snow cover observed at this location. AltEn LLC response crew had removed an area of ice with a backhoe. A manure odor was noted. Yellowish brown discolored ice and liquid observed on the west side of the waterway structure.

AltEn LLC response crew on-site. Pump started at approximately 0951.

Photo Direction: Looking west.

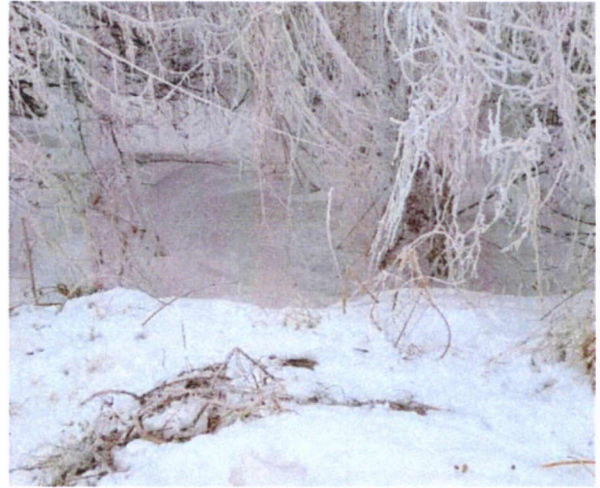
**STOP 5 – UNL Eastern Extension – North
of County Roads 9 & J (continued)**

Yellowish brown discolored ice observed on
the east side of the waterway structure.

Photo Direction: Looking east.

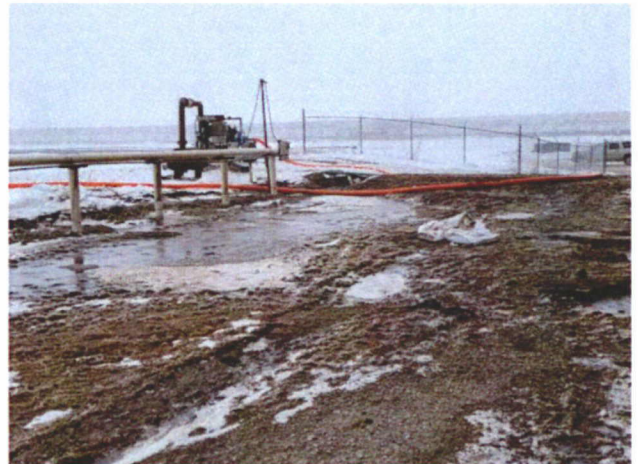
STOP 6 – AltEn LLC Facility Digesters

No active discharge observed from Digester
1. Frozen impacted material observed on the
east side of Digester 1.

Observed a pump transferring liquids from the
south lagoon to the north lagoon to allow
liquid from Stop 5 to be pumped to the south
lagoon.

Photo Direction: Looking south.

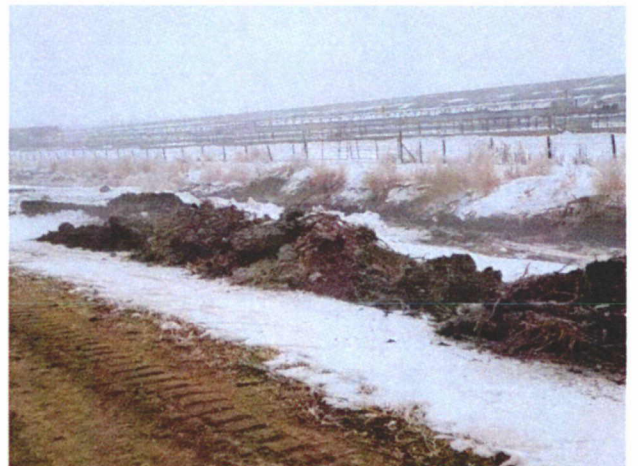
STOP 6 – AltEn LLC Facility Drainageway

Excavation activities to remove impacted
material from drainageway east of the facility
lagoons.

Photo Direction: Looking southeast
