**DATE:** 2/18/21

**INVESTIGATOR:** Greg Michl

**STOP 1 – HIGHWAY 66 WEST of  
ASHLAND GUN CLUB**

## ALTEN SITUATIONAL AWARENESS (FEB 2021)

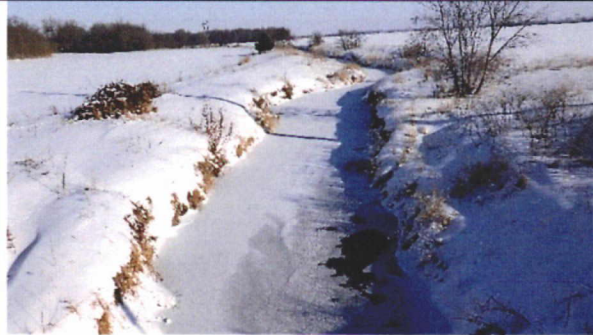
Clear Creek at this location was 99% ice/snow covered. There was a couple of open water areas, but site is currently not impacted from the AltEn LLC thin stillage discharge. Photo is looking north (upstream).

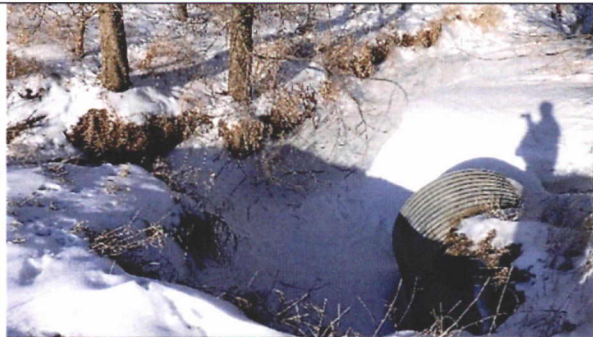
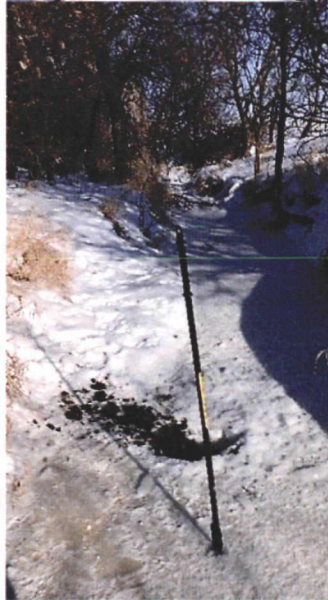
**STOP 2 – North of the Intersection of  
COUNTY ROADS 6 & F**

I found no evidence of the ALTEn LLC thin stillage discharge reaching this location. I chopped a hole in the ice (~10 inches thick) to the channel's substrate. It was completely frozen, with no water below the ice. Photos were taken looking west/northwest (upstream).

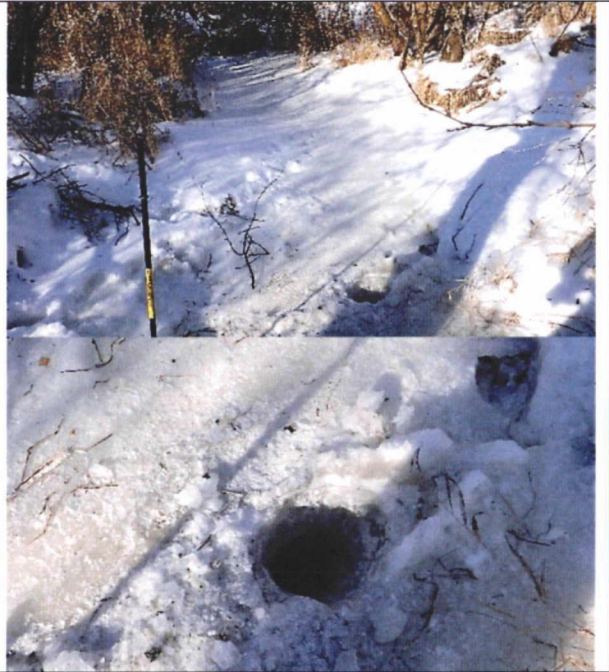
**STOP 3 – Road 7/Highway 66**

I found no evidence of the AltEn LLC thin stillage discharge reaching this location. I chopped a hole in the ice (~12 inches thick) to the channel's substrate. It was completely frozen, with no water below the ice. Photos were taken looking west/northwest (upstream).

The berm/dam located here made up of a tarp and sand bags appears to have constructed on top of the channel's ice surface in front the culvert. It would seem prudent to chip the ice away and lower the entire structure.

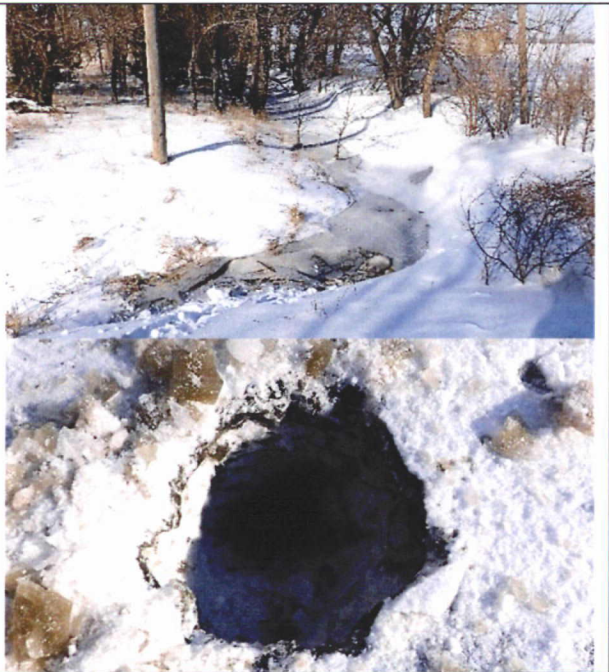
**STOP 4 – County Road 8, North of Road H**

The AltEn LLC thin stillage discharge water remains as a frozen layer on top of the original ice layer that existed prior to the thin stillage release. The frozen waste water ice is much darker in appearance than the snow and original ice in the channel. The darker, frozen top layer was easily broken by walking on it. I did chop a hole through the channel's original ice layer (~12 inches thick) and found water underneath at this location. I do not believe the water to be the thin stillage waste, as there was no pressure from below that filled the hole I had opened. However, I did not have a meter with me to confirm to be true.

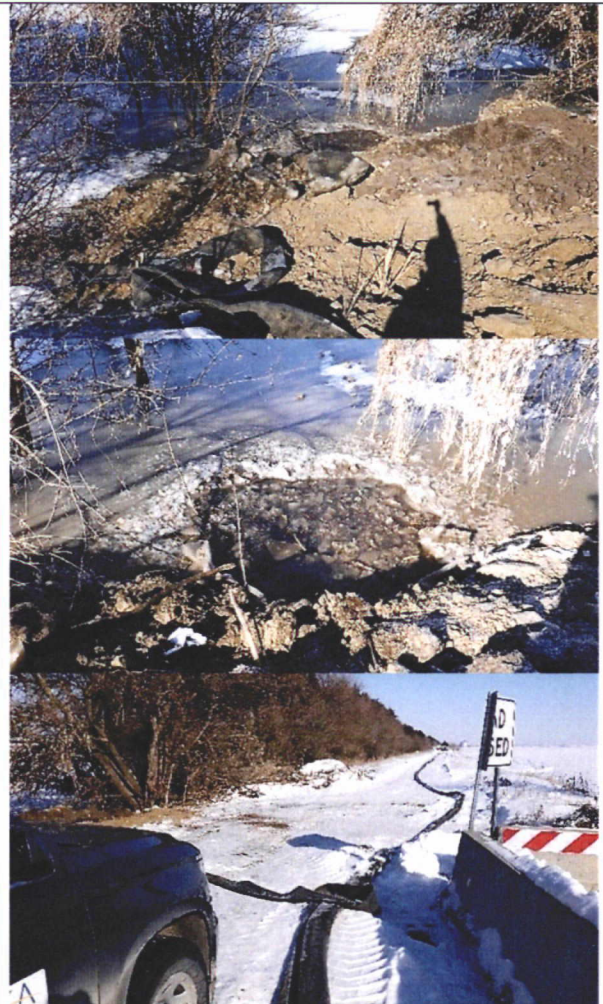
**STOP 5 – UN-L Eastern Extension – North of County Roads 9 & J**

The AltEn LLC thin stillage discharge water remains as a large pooled area behind the make-shift dam constructed on the upstream (west) side at this location. Ken Peterson (AltEn Plant Manager) showed up while I was at this location. He told me they had placed additional earthen material here to stop the seepage through the culverts. He also said they planned to start pumping the liquid from this location back into a lagoon yet today. A hose was stretched out in this area, but no pump was in place when I was there.

Ken Peterson (AltEn Plant Manager) did tell me they were in the process of constructing an additional berm/dam on the affected channel approximately ½ mile south of the "Stop #5".

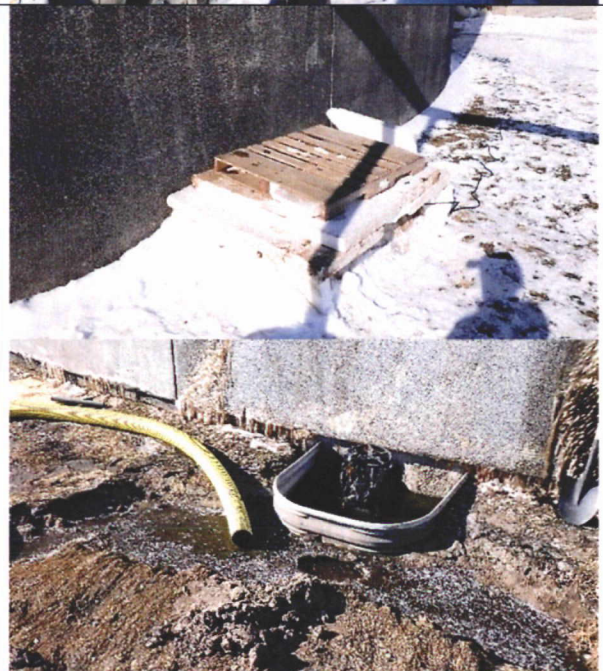
**STOP 6 – ALTEN LLC FACILITY DIGESTERS**

Ken Peterson (AltEn Plant Manager) led me to the digesters and gave me a quick tour. I did not observe any discharges from either the north or south stillage tank. The top photo is the covered pipe/valve housing on the north tank and the bottom photo is of the one that failed on the south tank.
