Date: February 4, 2021

RE: Site Visit
AltEn, LLC
1344 County Road 10
Mead, NE 68041

NDEE ID: 84069

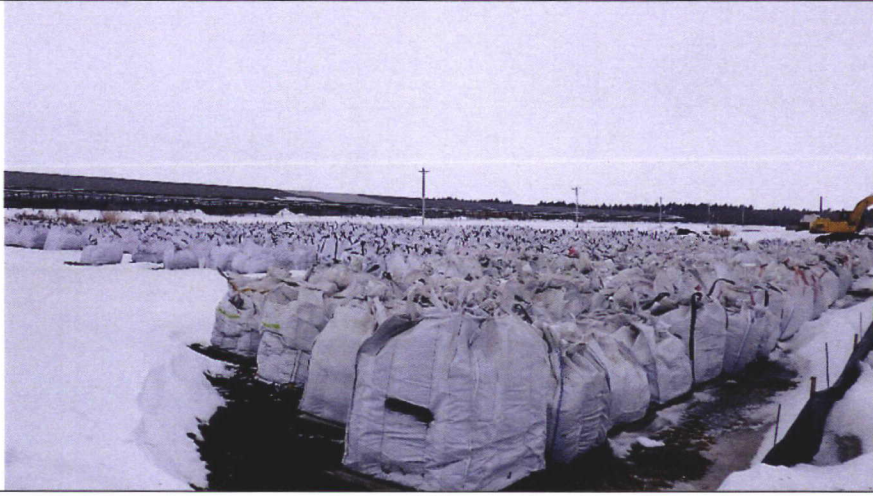
Photograph 1
Date: February 1, 2021
Photographer: Jason Holsten
Camera: Ricoh WG-50
IIS# 84069
Subject: AltEn, LLC Site Visit

1. Super sacks (sack) containing Biochar were located west and east of the Biochar unit (Photograph 1). Mr. Peterson said there were 672 sacks on site. He said the Biochar unit had been down for a month due to having to replace some augers within the unit that had worn down. They hoped to be back operating the unit by Wednesday, February 3. I asked Mr. Peterson if AltEn had found an end use for the biochar. He said there is a company in Iowa that will be taking pretty much all of the sacks however, he did not say what they will do with it. I observed two additional sacks in a different area of the facility and Mr. Peterson said these contained biochar that was drier. He also said a company in Indiana was going to take these sacks for use in trials. He thought they may be taking them to make a different type of biochar. I later observed two sacks in the back of a pick-up truck leaving the facility and Mr. Peterson said these were those two sacks.

Looking southwest, photograph showing super sacks of Biochar located west of the Biochar unit.

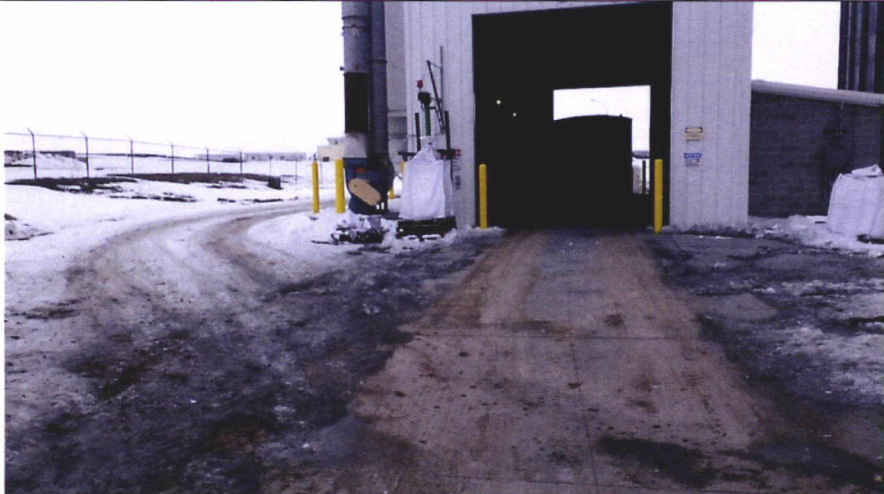
Photograph 2
Date: February 1, 2021
Photographer: Jason Holsten
Camera: Ricoh WG-50
IIS# 84069
Subject: AltEn, LLC Site Visit

2. A sack was next to what I would call the loadout area for the treated seed corn (Photograph 2). This is the area where seed corn is delivered for eventual use in the

ethanol process. The sack was attached to a hose and Mr. Peterson explained that the sack was used for dust collection from the baghouse. He further explained that the dust is put into the Biochar unit where it gets burned up. I observed three other sacks nearby which Mr. Peterson said contained dust (Photograph 3).

Looking north, photograph showing a super sack being used to collect dust from the bag house.

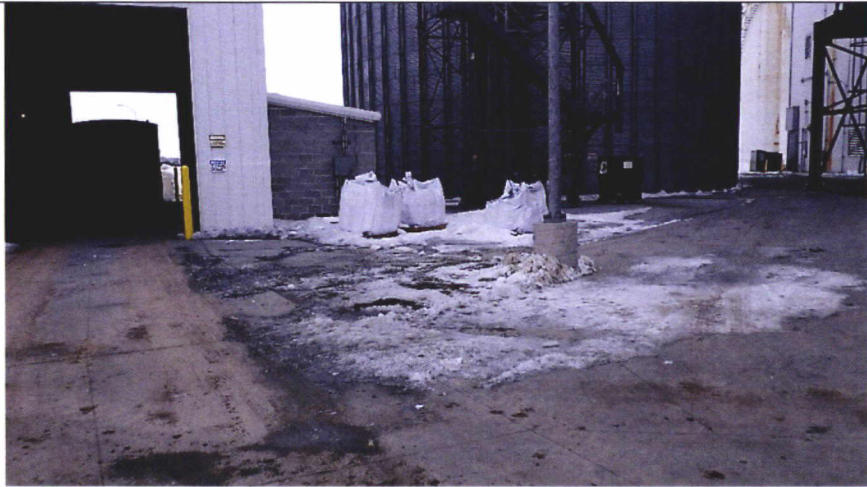
Photograph 3
Date: February 1, 2021
Photographer: Jason Holsten
Camera: Ricoh WG-50
IIS# 84069
Subject: AltEn, LLC Site Visit

Photograph showing three super sacks of accumulated dust from the bag house.

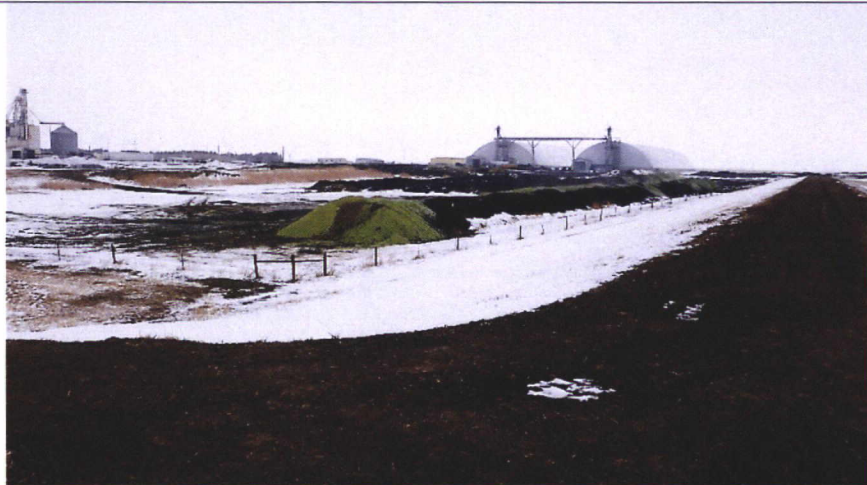
Photograph 4
Date: February 1, 2021
Photographer: Jason Holsten
Camera: Ricoh WG-50
IIS# 84069
Subject: AltEn, LLC Site Visit

4. DG was being stockpiled in areas located east and north of the hoop buildings (Photographs 4-7 and 9-13). DG was also being stockpiled on the east portion of the property, a.k.a. northeast corner of the property (Photographs 14-17).

Looking southwest from the southeast corner berm of the west lagoon. Photograph showing distiller's grain (DG) being stockpiled in the area.

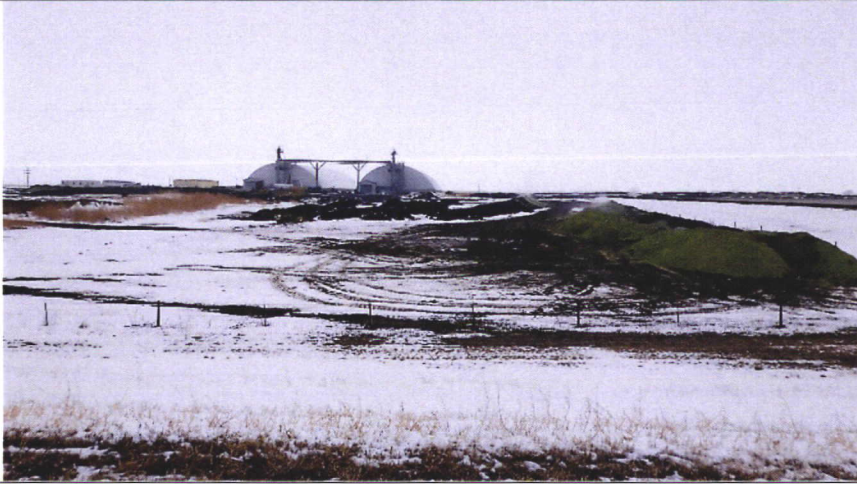
Photograph 5
Date: February 1, 2021
Photographer: Jason Holsten
Camera: Ricoh WG-50
IIS# 84069
Subject: AltEn, LLC Site Visit

Looking west from the west berm of the south lagoon, photograph showing the DG mentioned in photograph 4.

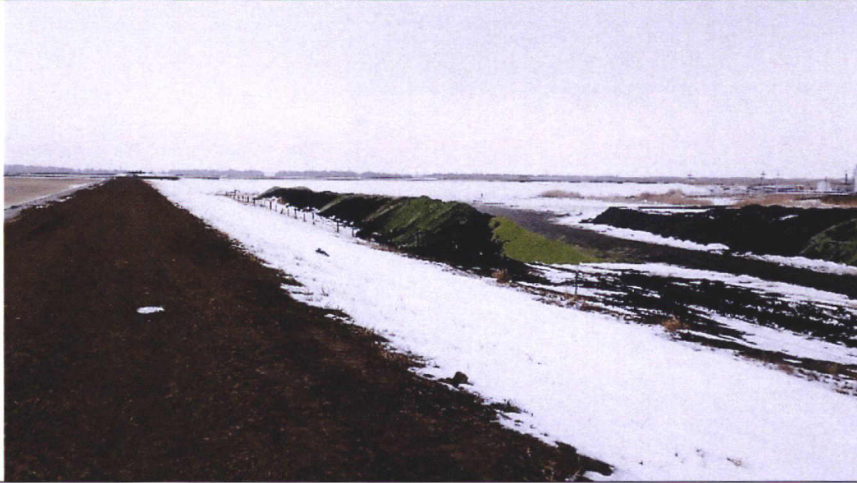
Photograph 6
Date: February 1, 2021
Photographer: Jason Holsten
Camera: Ricoh WG-50
IIS# 84069
Subject: AltEn, LLC Site Visit

Looking east along the south berm of the west lagoon, photograph showing a different view of the DG mentioned in photographs 4 & 5.

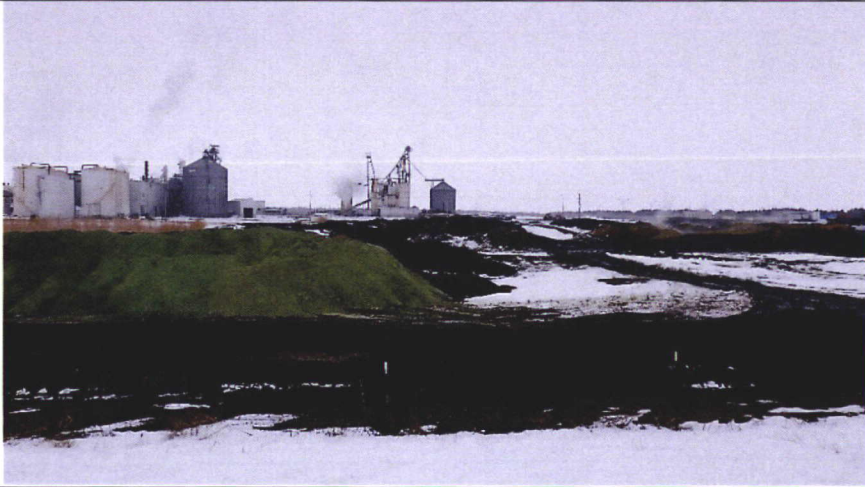
Photograph 7
Date: February 1, 2021
Photographer: Jason Holsten
Camera: Ricoh WG-50
IIS# 84069
Subject: AltEn, LLC Site Visit

Looking south, photograph showing DG being stockpiled east of the hoop buildings. This is some of the same DG as shown in photographs 4-6.

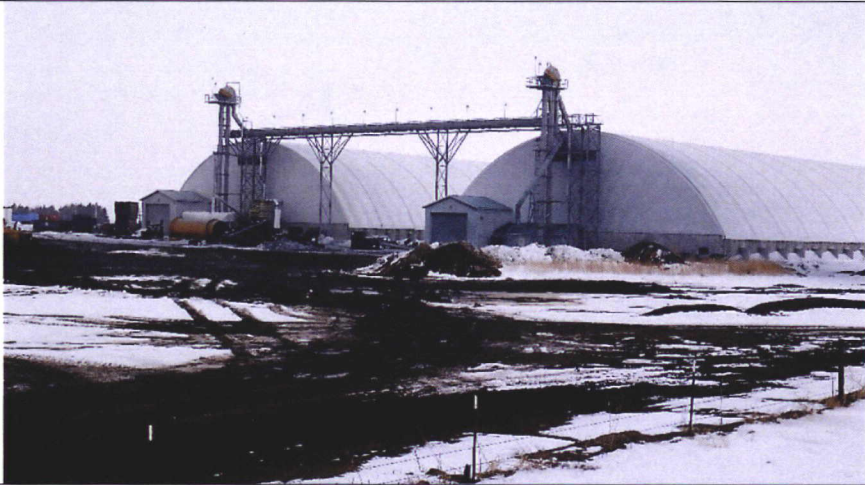
Photograph 8
Date: February 1, 2021
Photographer: Jason Holsten
Camera: Ricoh WG-50
IIS# 84069
Subject: AltEn, LLC Site Visit

5. Discoloration of the white hoop buildings appeared to be more pronounced compared to previous site visits, especially the north building (Photograph 8). In addition, some snow on the ground located north of the hoop buildings was also discolored. This discoloration is presumably caused by the dye coatings on the treated seed.

Looking southwest, photograph showing the east side of the hoop buildings. The north building (right) was covered in a bluish dust, presumably from the seed coating of treated seeds.

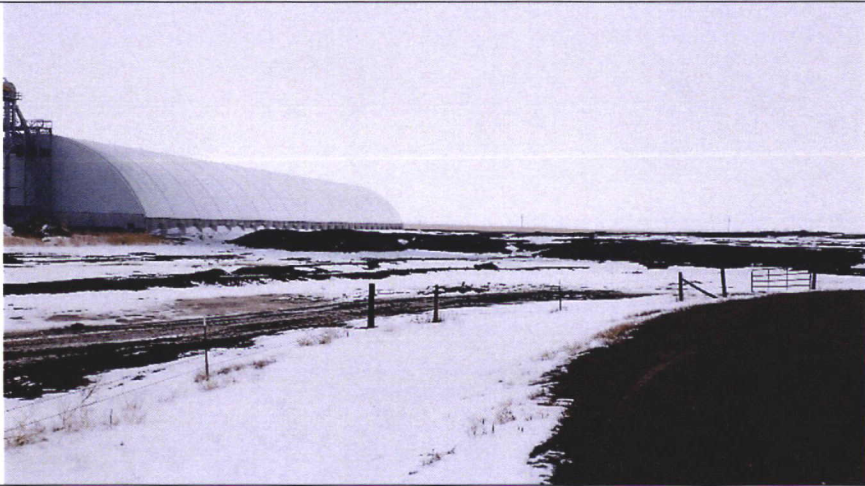
Photograph 9
Date: February 1, 2021
Photographer: Jason Holsten
Camera: Ricoh WG-50
IIS# 84069
Subject: AltEn, LLC Site Visit

Looking west southwest, photograph showing DG being stockpiled north of the hoop buildings.

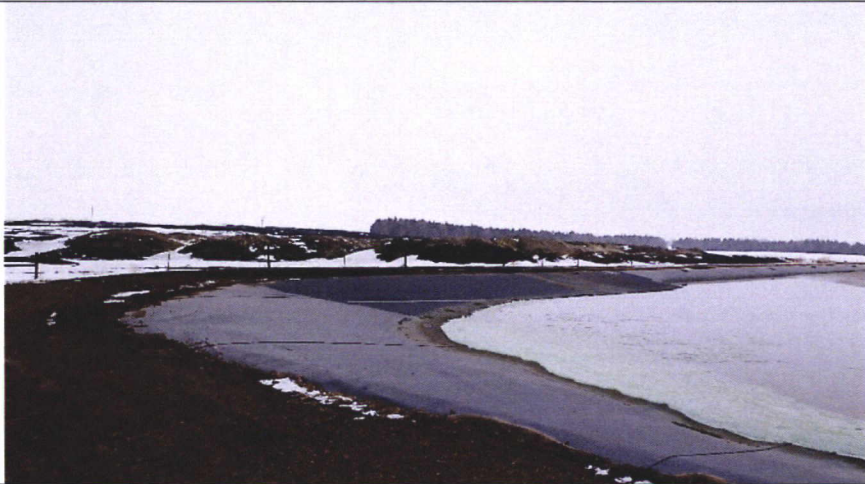
Photograph 10
Date: February 1, 2021
Photographer: Jason Holsten
Camera: Ricoh WG-50
IIS# 84069
Subject: AltEn, LLC Site Visit

Looking west northwest across the southwest corner of the west lagoon, photograph showing DG being stockpiled north of the hoop buildings and west of the west lagoon.

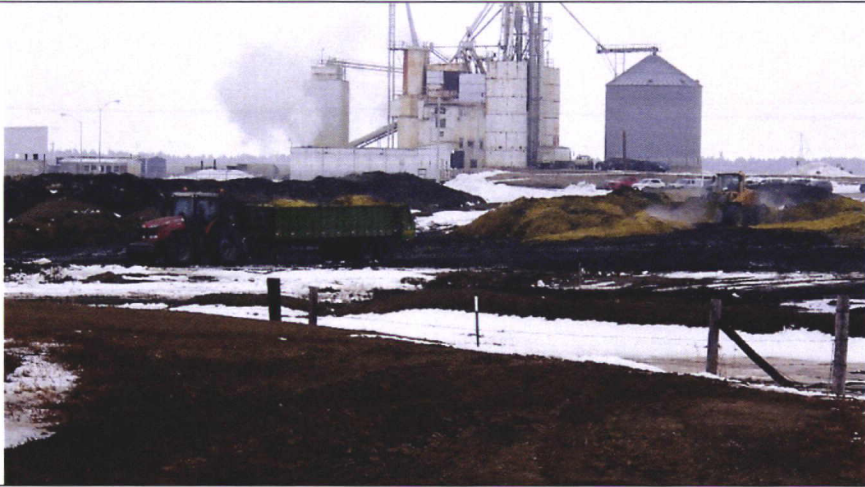
Photograph 11
Date: February 1, 2021
Photographer: Jason Holsten
Camera: Ricoh WG-50
IIS# 84069
Subject: AltEn, LLC Site Visit

6. Equipment was dumping DG in an area east of the hoop buildings (Photographs 11 & 12). I later learned from Mr. Egr that this DG was from an area located west of the compost pads.

Looking south, photograph showing equipment being used to transport DG to an area located east of the hoop buildings. The DG being transported here was from an area located west of the compost pads according to Dean Egr.

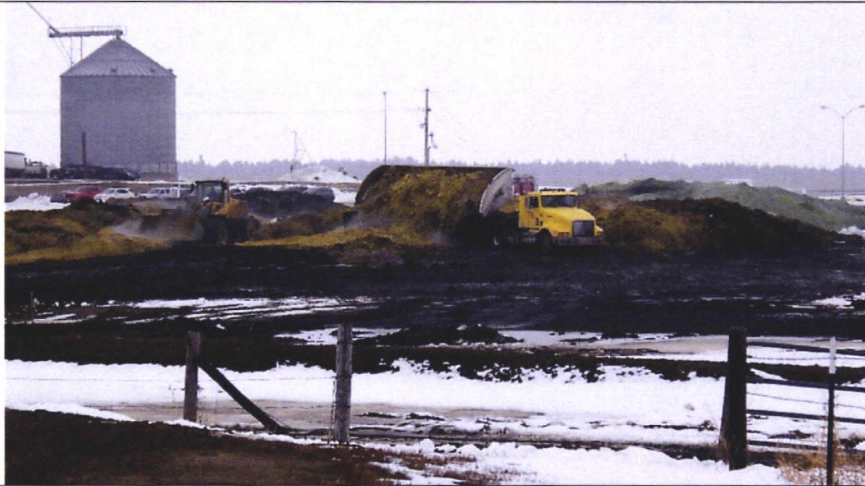
Photograph 12
Date: February 1, 2021
Photographer: Jason Holsten
Camera: Ricoh WG-50
IIS# 84069
Subject: AltEn, LLC Site Visit

Photograph showing a side dump trailer of DG being dumped in the area mentioned in photograph 11.

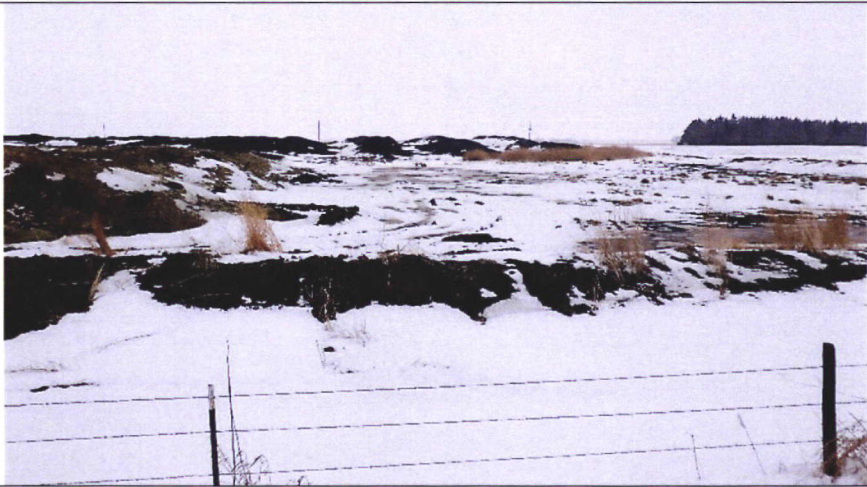
Photograph 13
Date: February 1, 2021
Photographer: Jason Holsten
Camera: Ricoh WG-50
IIS# 84069
Subject: AltEn, LLC Site Visit

Looking west, photograph showing the northern edge of DG being stockpiled north of the hoop buildings. In the foreground was a soil berm.

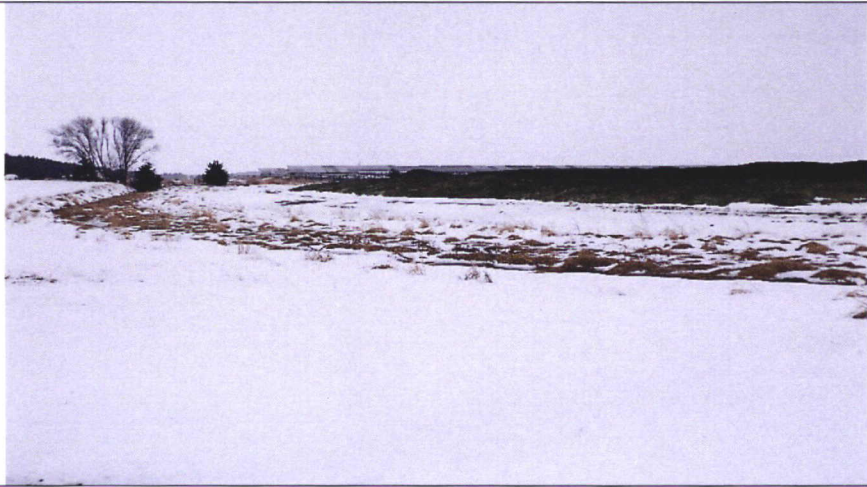
Photograph 14
Date: February 1, 2021
Photographer: Jason Holsten
Camera: Ricoh WG-50
IIS# 84069
Subject: AltEn, LLC Site Visit

Looking south, photograph showing the eastern edge of DG being stockpiled on the east end of AltEn property, a.k.a. northeast corner.

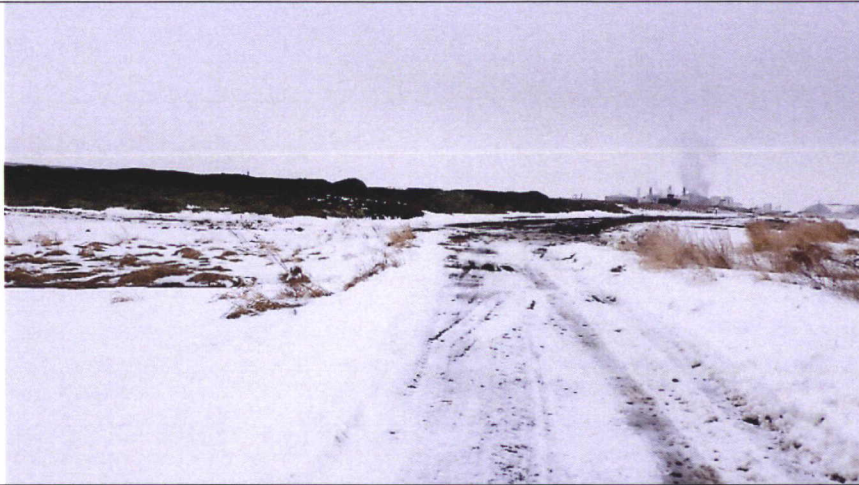
Photograph 15
Date: February 1, 2021
Photographer: Jason Holsten
Camera: Ricoh WG-50
IIS# 84069
Subject: AltEn, LLC Site Visit

Looking west, photograph showing DG stockpiled on the northeast corner of AltEn property.

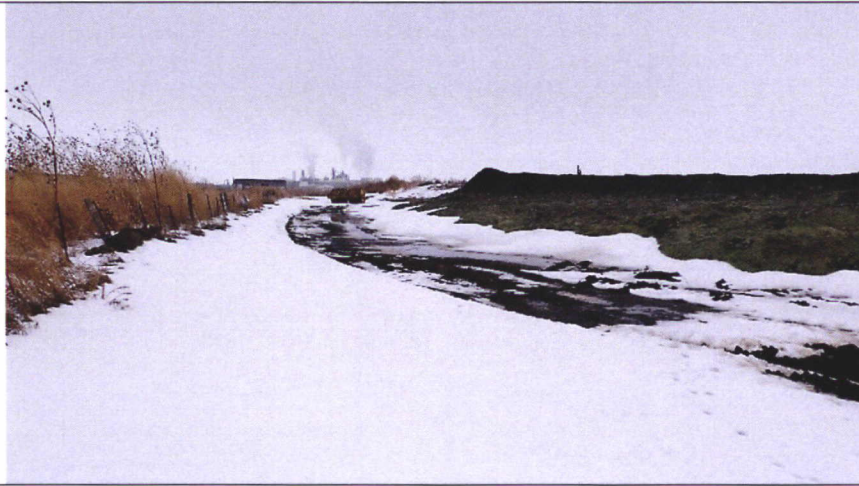
Photograph 16
Date: February 1, 2021
Photographer: Jason Holsten
Camera: Ricoh WG-50
IIS# 84069
Subject: AltEn, LLC Site Visit

Looking west, photograph showing the southern edge of the DG stockpiled and mentioned in photographs 14 & 15.

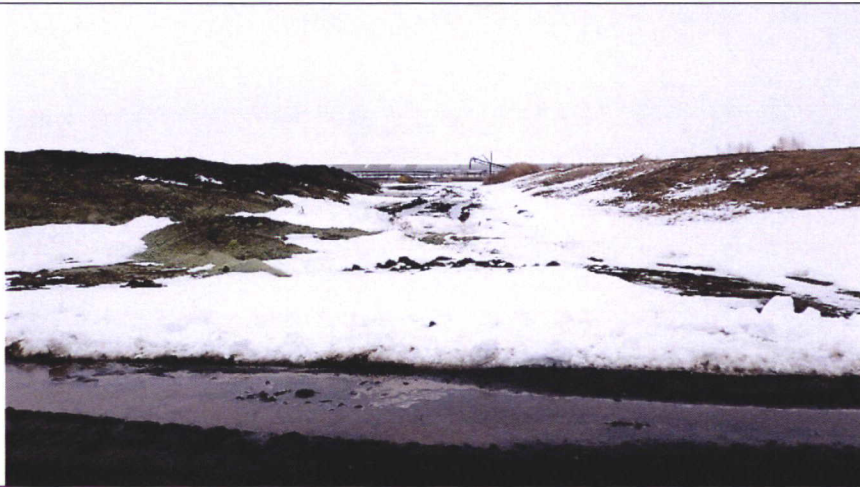
Photograph 17
Date: February 1, 2021
Photographer: Jason Holsten
Camera: Ricoh WG-50
IIS# 84069
Subject: AltEn, LLC Site Visit

Looking south, photograph showing the western edge of the DG stockpiled and mentioned in photographs 14-16.

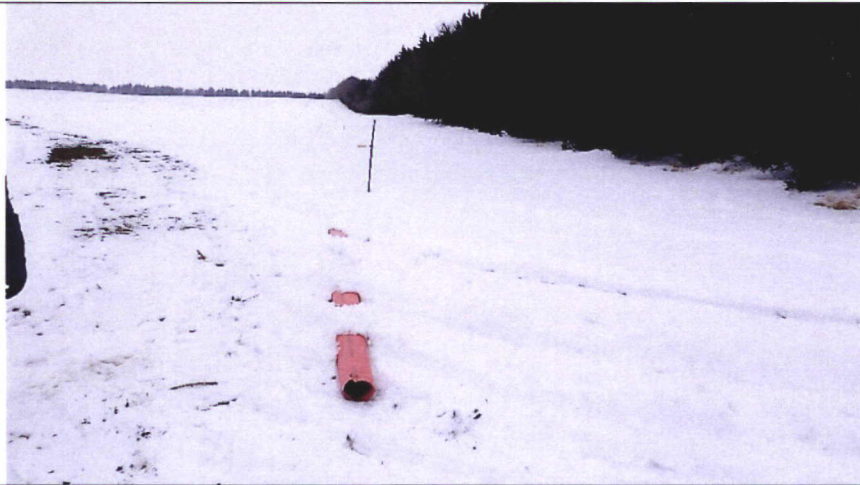
Photograph 18
Date: February 1, 2021
Photographer: Jason Holsten
Camera: Ricoh WG-50
IIS# 84069
Subject: AltEn, LLC Site Visit

7. An orange pipe was lying on the ground northeast of the DG being stockpiled at the northeast corner of the property (Photograph 18). Mr. Egr said this pipe belonged to and was for use by Mead Cattle.

Photograph showing an orange poly tube/pipe. This tube/pipe was located northeast of the DG mentioned in photographs 14-17. Mr. Egr said this tube/pipe was belonged to and was for use by Mead Cattle.

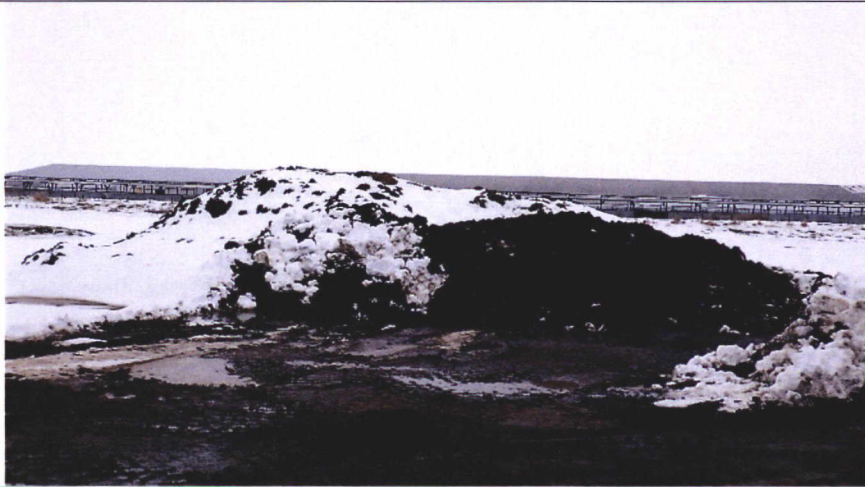
Photograph 20
Date: February 1, 2021
Photographer: Jason Holsten
Camera: Ricoh WG-50
IIS# 84069
Subject: AltEn, LLC Site Visit

Looking south, photograph showing a closer view of the manure pile mentioned in photograph 19.

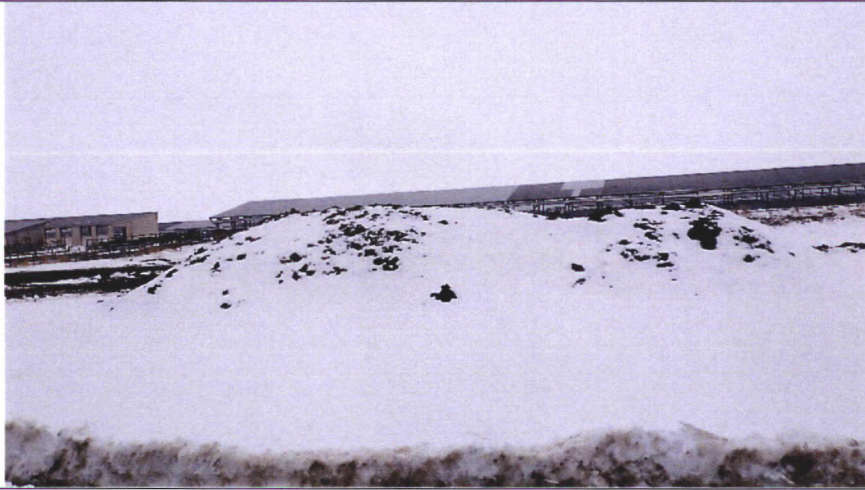
Photograph 21
Date: February 1, 2021
Photographer: Jason Holsten
Camera: Ricoh WG-50
IIS# 84069
Subject: AltEn, LLC Site Visit

Looking south, photograph showing another pile of manure located east of the pile shown in photograph 20.

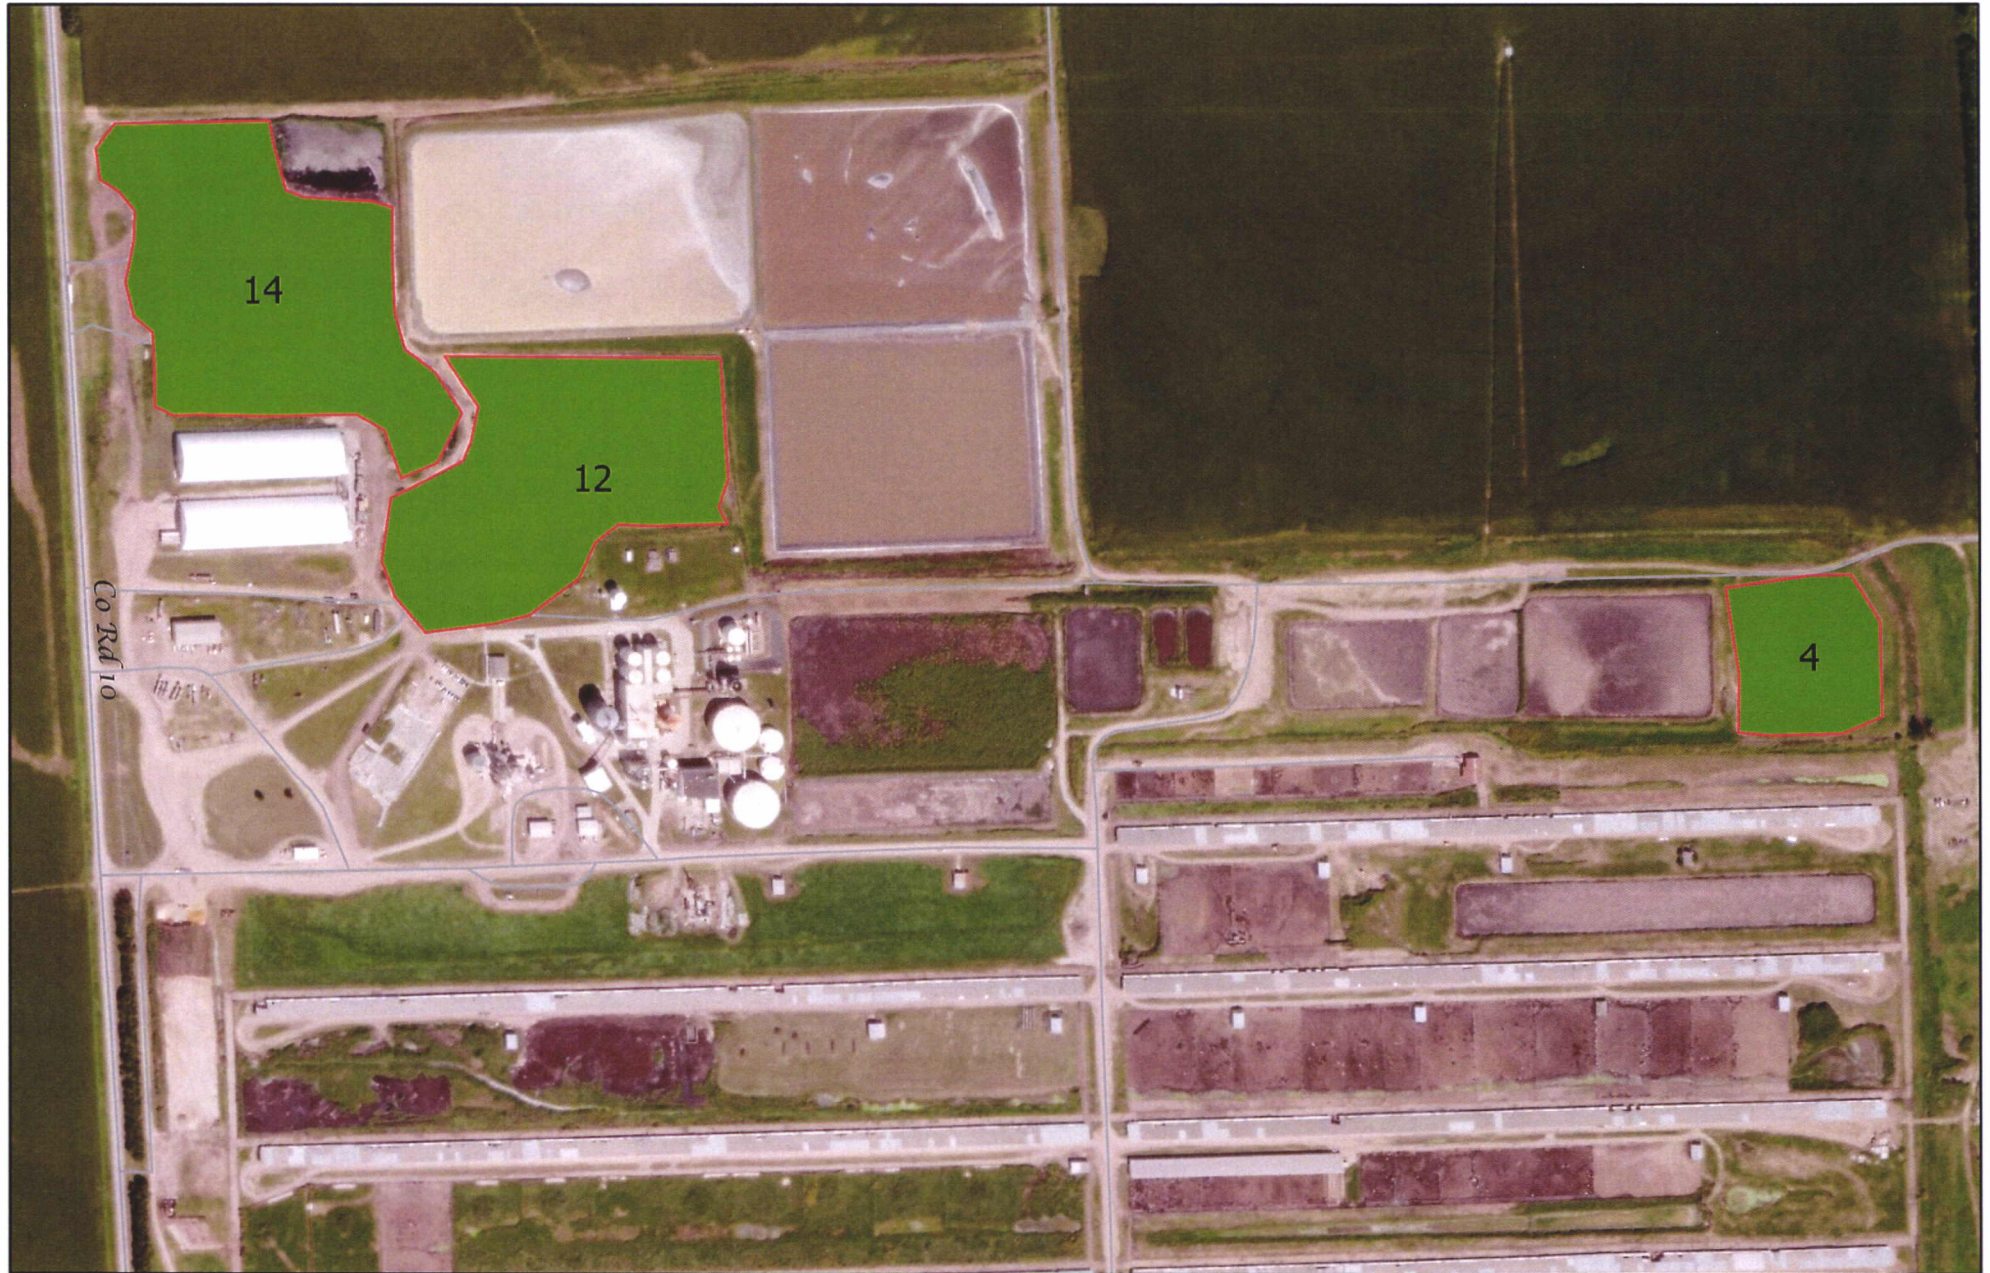
ATTACHMENT II
Aerial Map Showing DG Stockpile Locations

3. After Mr. Pomajzl completed his stormwater inspection around the ethanol plant, Mr. Peterson returned to his office while Mr. Pomajzl, Ms. Stoll, and I proceeded to the wastewater lagoons and DG stockpile locations. Mr. Pomajzl and I recorded GPS coordinates at various points around the DG stockpile locations for eventual use in mapping where DG was being stockpiled. These GPS coordinates were given to Jason Windhorst, NDEE, who created a map showing the stockpile locations (Attachment II). Note, the map does not include a small area located west of the compost pads where DG was also stockpiled.

Approximate Wetcake Area in Acres
