DATE: 2-26-21

INVESTIGATOR: Rachel Neisius

STOP 1 – HIGHWAY 66 WEST of
ASHLAND GUN CLUB
1130 Hours

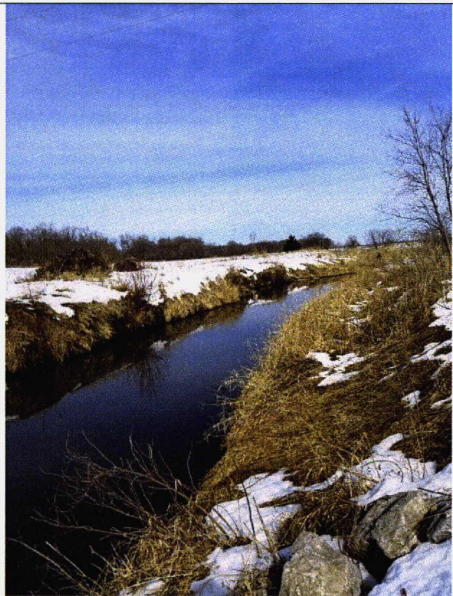
Looking North. Open water, cannot see the bottom- too turbid. Water was flowing slowly. No odor noted.

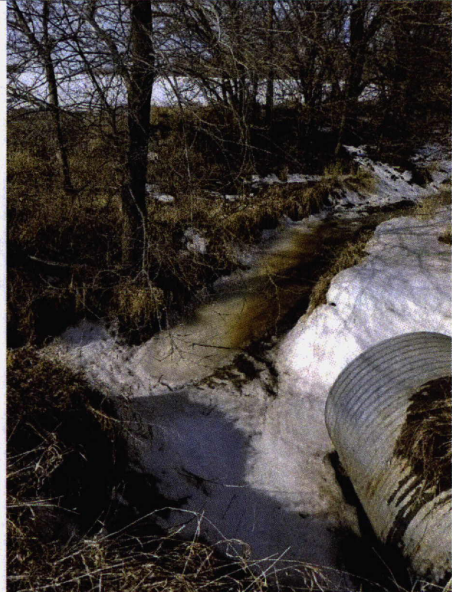
**STOP 2 – North of the Intersection of
COUNTY ROADS 6 & F**

Looking west at creek and culvert. Creek is partially ice-covered. Water looks murky brown. No odor.

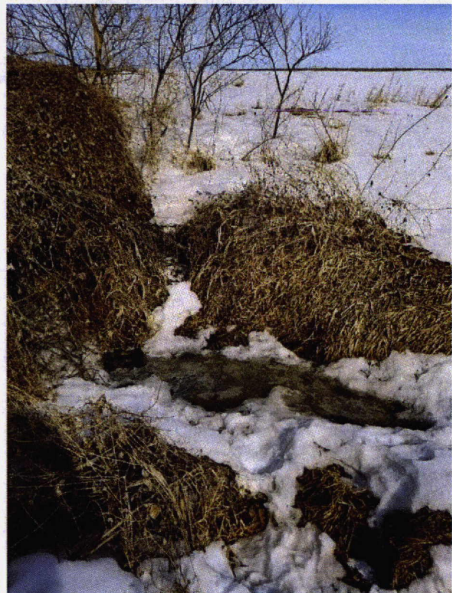
West side of culvert – south side of creek, looking north. Mostly ice covered. Small puddle of water. No odor.

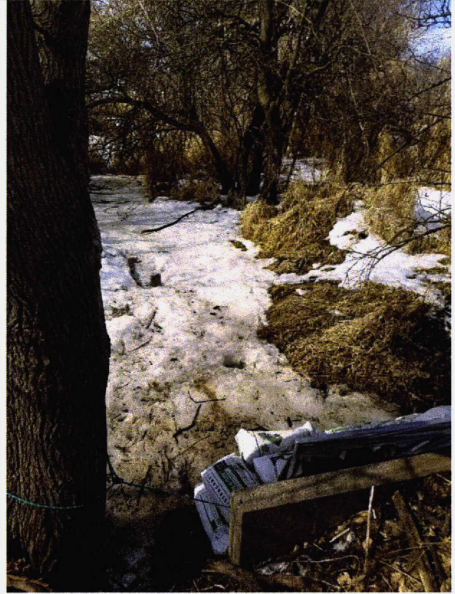
STOP 3 – Road 7/Highway 66

Photo taken on east side of culvert looking west. No obvious water flow. Ice melt near around the culvert is brown in color. The culvert is blocked with sandbags and a tarp.

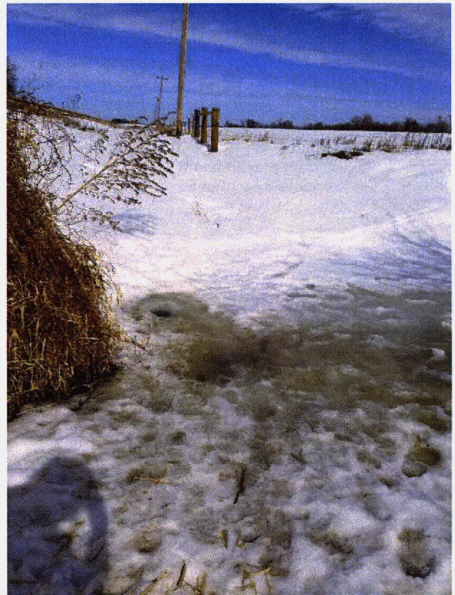
Photo is next to the the culvert on the east side of the road, looking north. No obvious water flow. Ice is starting to melt. Hole drilled in the ice is visible in the picture.

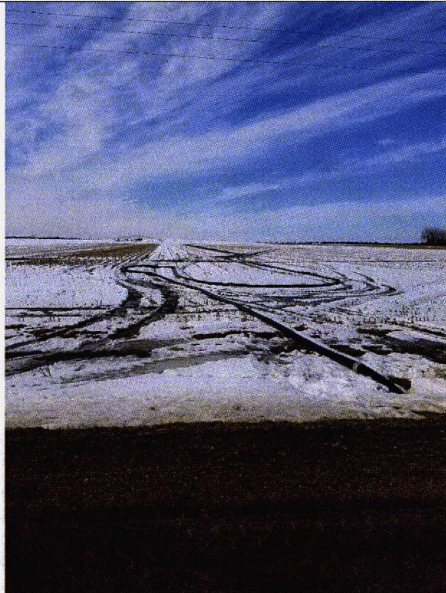
STOP 4 – County Road 8, North of Road H
1220 Hours

Photo is looking west from road 8, just south of the creek. A hose had been laid out through the culvert under Road 8. No liquid seemed to be pumping through at the time of this observation.

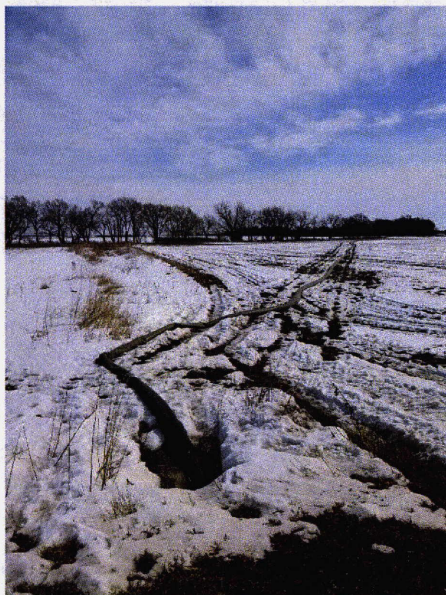
Photo was taken looking east at the culvert and hose on the west side of Road 8. The hose is visible running east.

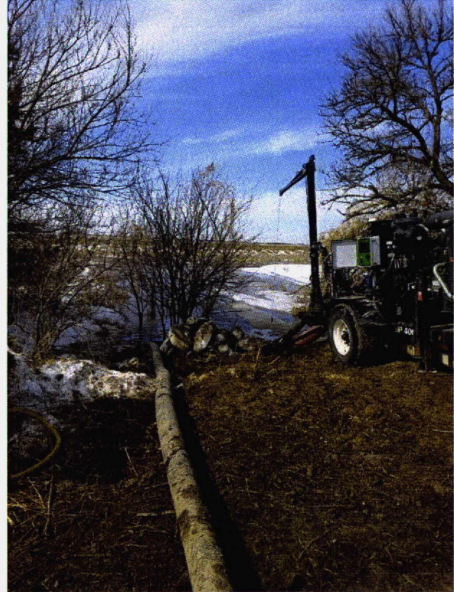
**STOP 5 – UN-L Eastern Extension – North
of County Roads 9 & J**
1227 Hours

Photo taken looking at the west side of Road 9 near the culvert. A PTO-driven pump and hose was actively pumping water from this location during my observation. Slightly turbid water was flowing into this ponded area from the west under the ice. Mr. Ken Peterson was at the site.

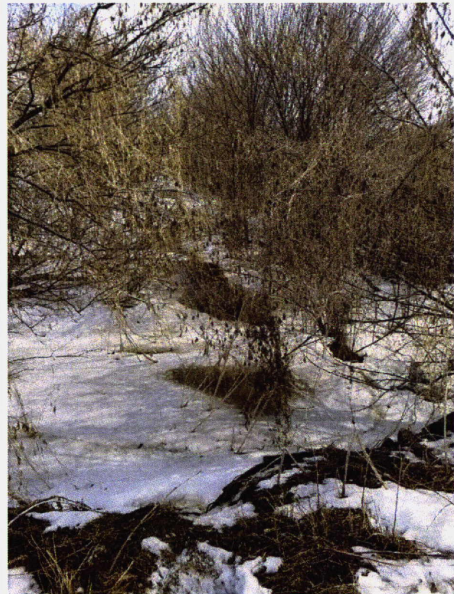
Photo shows the creek on the east side of Road 9. There was no visible water and the creek was snow covered. A Clean Harbors truck pulled up to the site as I was leaving.
