Daily Observation Form – PM REPORT  
AltEn LLC – Mead, NE Release  
Facility ID: 84069; State Spill Report Number: 021221-NH-845  
Date: February 24, 2021  
Weather: Clear and sunny, 41 °F

**Terracon**

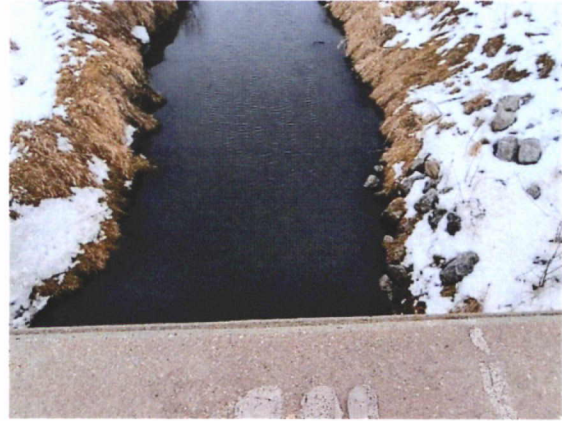
**STOP 1 – Hwy 66 West of Ashland Gun Club**  
**41.0886323, -96.380274**  
Time: 1316

Water is flowing at this location.

No suspect/obvious odor noted. No obvious signs of contamination (visual and/or olfactory) observed in water or on banks

No active work was observed at the time of the site visit.

Photo Direction: Looking north.

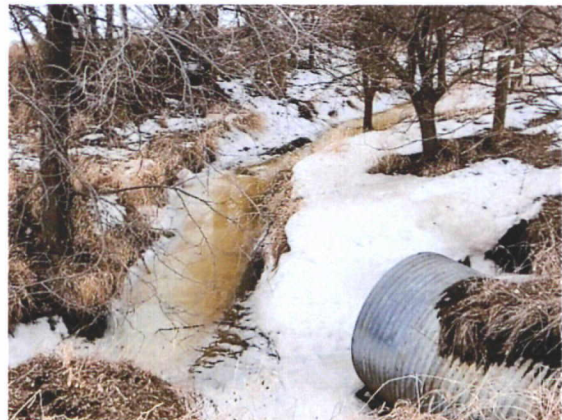
**STOP 2 – North of the intersection of County Roads 6 & F**  
**41.1334626, -96.4064519**  
Time: 1336

No visible water flow on the west side at this location. Ice, snow cover, and surface melt observed at this location

No suspect/obvious odor noted. Yellowish discoloration observed at surface.

No active work was observed at the time of the site visit.

Photo Direction: Looking northwest.

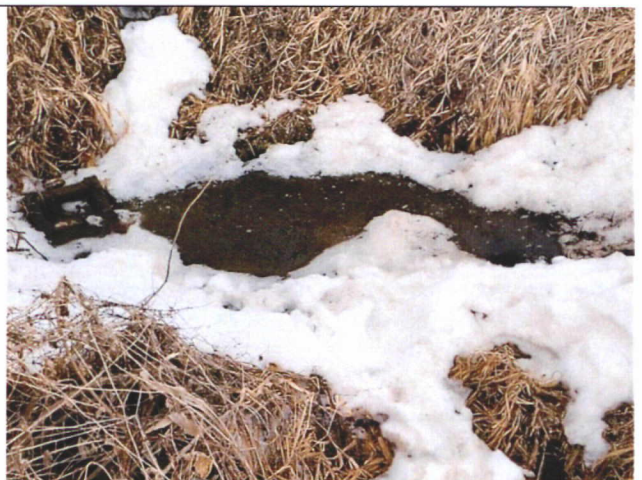
**STOP 2 – North of the intersection of County Roads 6 & F**  
**41.1334626, -96.4064519**  
Time: 1336

No visible water flow on the east side at this location. Ice, snow cover, and surface melt observed at this location

No obvious signs of contamination (visual and/or olfactory) observed.

No active work was observed at the time of the site visit.

Photo Direction: Looking north.

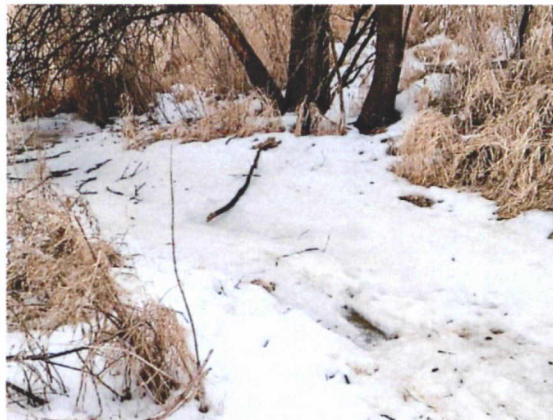
**STOP 3 – Road 7/Hwy 66**  
**41.1388323, -96.4257571**  
Time: 1256

Obvious signs of contamination (visual and/or olfactory) observed in water and on sides of penetration in ice.

No active work was observed on the west side at the time of the site visit.

Photo Direction: Looking northwest.

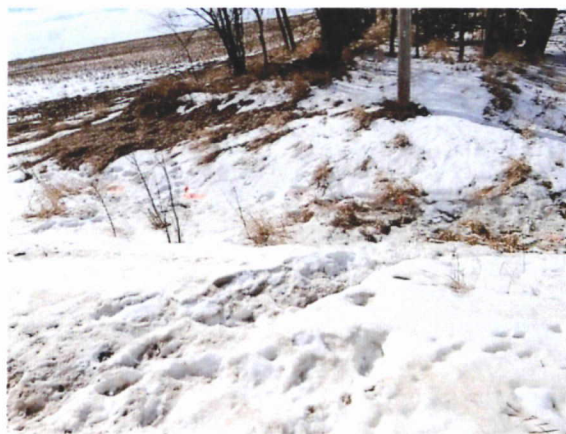
**STOP 4 – County Road 8, North of Road H**  
**GPS: 41.1677657, -96.4447025**  
Time: 1350

No visible water flow on the west side of this location. Ice and snow covered.

Obvious signs of contamination (visual and/or olfactory) observed in water and banks.

No active work was observed at the time of the site visit. Orange paint markings observed.

Photo Direction: Looking west.

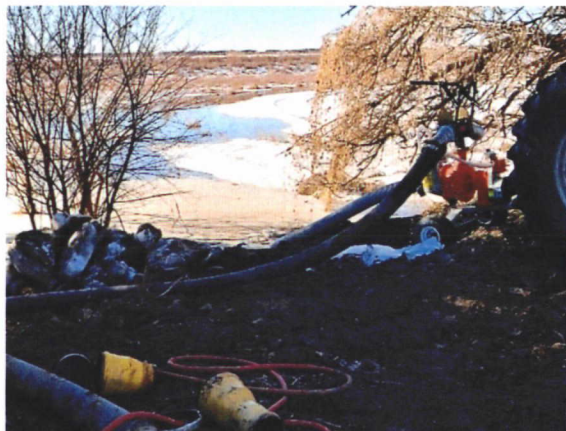
**STOP 5 – UNL Eastern Extension – North of County Roads 9 & J**  
**GPS: 41.1862613, -96.4638642**  
Time: 1540

Obvious signs of contamination (visual and/or olfactory) observed in water and banks.

Active work was observed at the time of the site visit. Hose connection at the pump was leaking liquid at the time of the site visit.

Photo Direction: Looking west.

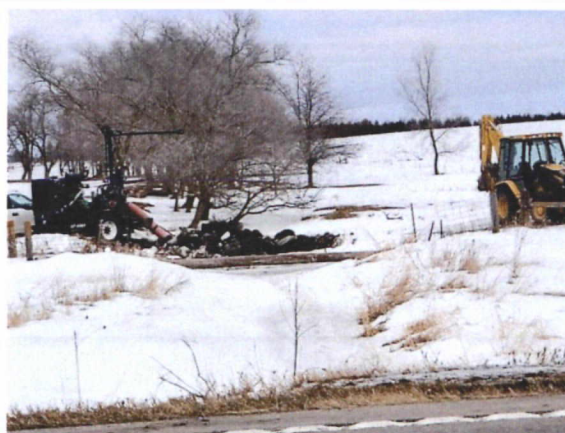
**Between Stop 3 and Stop 4 – Hwy 66, East of Road 8**

Soil berm placed within drainageway north of Hwy 66.

Pumping of liquid active during this visit.

Photo Direction: Looking northeast.

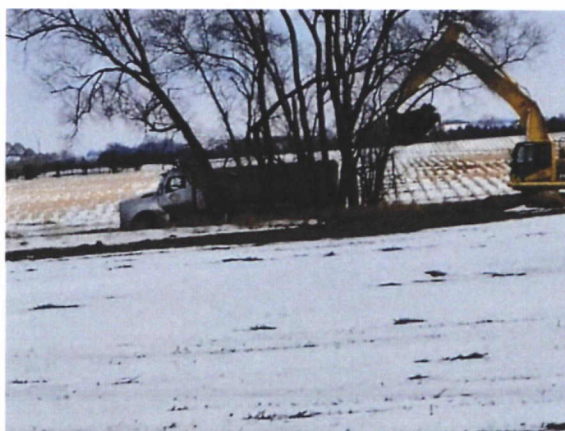
**Between Stop 4 and Stop 5 – UNL Eastern Extension – Southeast of County Roads 9 & J**

Heimes Corporation crew removing impacted material from drainageway. Removed material is being loaded into dump truck for disposal in AltEn's lagoon.

Photo Direction: Looking east.
