From: Hagemeister, Mike <Mike.Hagemeister@terracon.com>
Sent: Wednesday, February 24, 2021 11:30 AM
To: Buell, Thomas
Cc: Pracheil, Brad; Mann, Nancy; Koehler, James J; Starostka, Jesse C
Subject: 2-23-21 AM and PM Reports for Terracon Observation Work Associated with AltEn Release
Attachments: 20210223_104205.jpg; 20210223_103734.jpg; 05217146R07 2021-02-23 PM.pdf; 05217146R06 2021-02-23 AM.pdf

Daily Observation Form – AM REPORT
AltEn LLC – Mead, NE Release
Facility ID: 84069; State Spill Report Number: 021221-NH-845
Date: February 23, 2021
Weather: Clear and sunny, 32°F

Daily Observation Form – PM REPORT
AltEn LLC – Mead, NE Release
Facility ID: 84069; State Spill Report Number: 021221-NH-845
Date: February 23, 2021
Weather: Clear and sunny, 48 °F

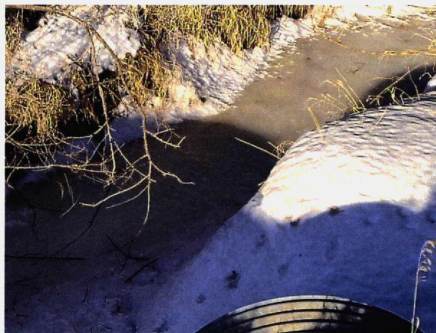
STOP 2 – North of the intersection of County Roads 6 & F

No visible water flow at this location. Ice and snow covered.

No obvious signs of contamination (visual and/or olfactory) observed in water or on banks.

No active work was observed at the time of the site visit.

Photo Direction: Looking West.

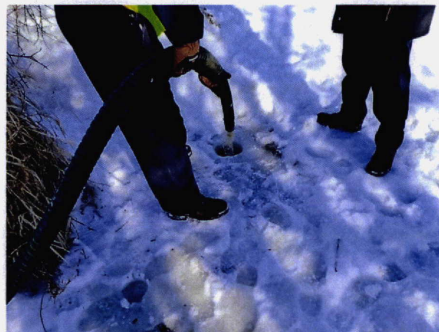
STOP 3 – Road 7/Hwy 66

Obvious signs of contamination (visual and/or olfactory) observed on the east side of Stop 3 in water and on sides of penetration.

Photo Direction: Looking north.

Terracon onsite with Clean Harbors crew. Active recovery of impacted material through penetration on east side of Stop 3.

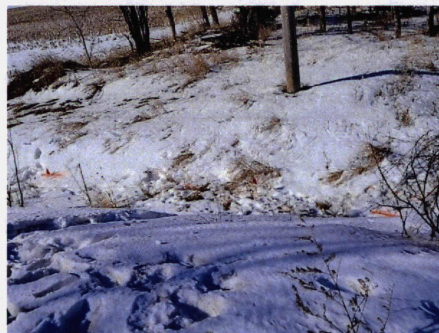
STOP 4 – County Road 8, North of Road H

No visible water flow on the west side of this location. Ice and snow covered.

No obvious signs of contamination (visual and/or olfactory) observed in water or on banks.

No active work was observed at the time of the site visit. Orange paint markings observed.

Photo Direction: Looking west.

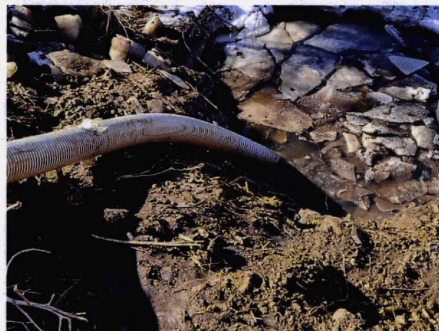
STOP 5 – UNL Eastern Extension – North of County Roads 9 & J

Obvious signs of contamination (visual and/or olfactory) observed on the west side of Stop 5 in water and on sides of penetration in ice.

Equipment on-site during this visit. Equipment was not operating at the time of the site visit.

Photo Direction: Looking southwest.

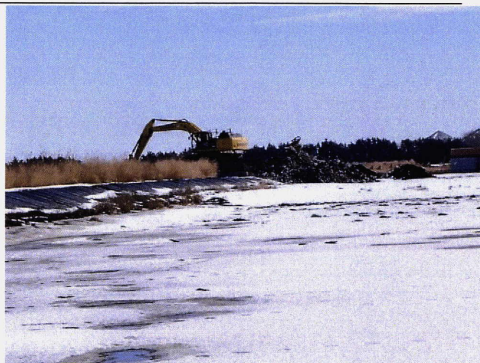
STOP 6 – AltEn LLC Facility Digesters

Impacted material stockpiled prior to
placement in AltEn's lagoon.

Photo Direction: Looking north.

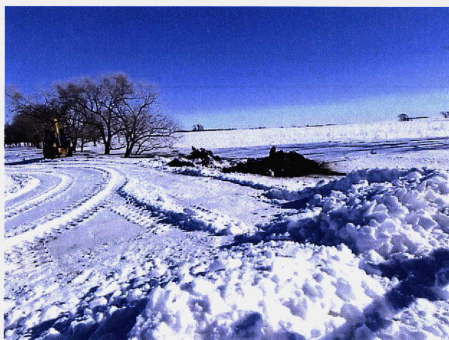
**Between Stop 3 and Stop 4 – Hwy 66, East
of Road 8**

Soil berm placed within drainageway north of
Hwy 66.

Photo Direction: Looking east.

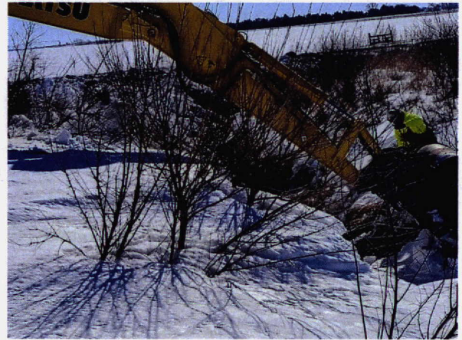
**Between Stop 4 and Stop 5 – UNL Eastern
Extension – Southeast of County Roads 9
& J**

Ice and snow observed at this location.

Photo Direction: Looking southwest.

Heimes Corporation crew removing impacted material from drainageway. Removed material is being hauled for disposal in AltEn's lagoon.

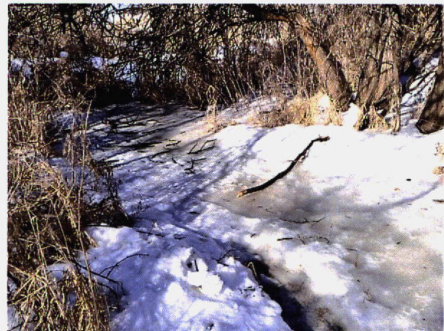
STOP 3 – Road 7/Hwy 66

Obvious signs of contamination (visual and/or olfactory) observed in water and on sides of penetration in ice.

No active work was observed on the west side at the time of the site visit.

Photo Direction: Looking northwest.

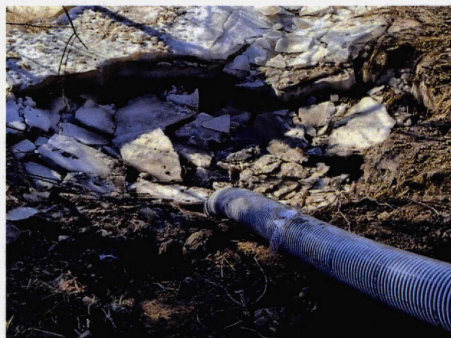
STOP 5 – UNL Eastern Extension – North of County Roads 9 & J
GPS: 41.1862613, -96.4638642
Time: 1540

Obvious signs of contamination (visual and/or olfactory) observed in water or on banks.

Photo Direction: Looking west.

Active work was observed at the time of the site visit. Pump was removing liquid to the practical limit.

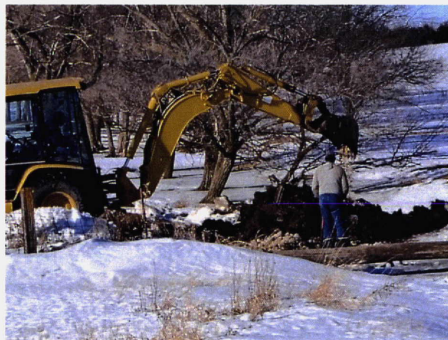
Between Stop 3 and Stop 4 – Hwy 66, East of Road 8

No visible water flow at this location. Ice and snow covered.

Photo Direction: Looking northeast.

Active work was observed at the time of the site visit. Crew onsite using backhoe to remove ice (containing some impacted material) from drainageway in preparation for recovery of impacted material scheduled for February 24, 2021.

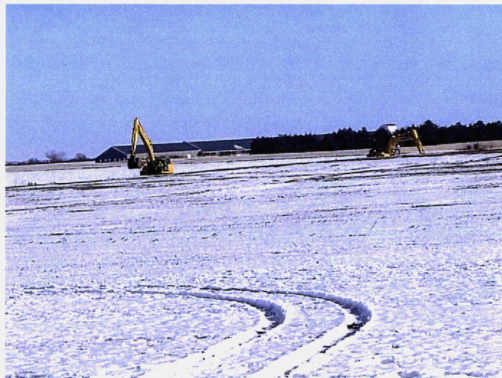
Between Stop 4 and Stop 5 – UNL Eastern Extension – Southeast of County Roads 9 & J

Photo Direction: Looking southeast.

Equipment onsite relocating in preparation for continued removal of impacted material from drainageway scheduled for February 24, 2021.

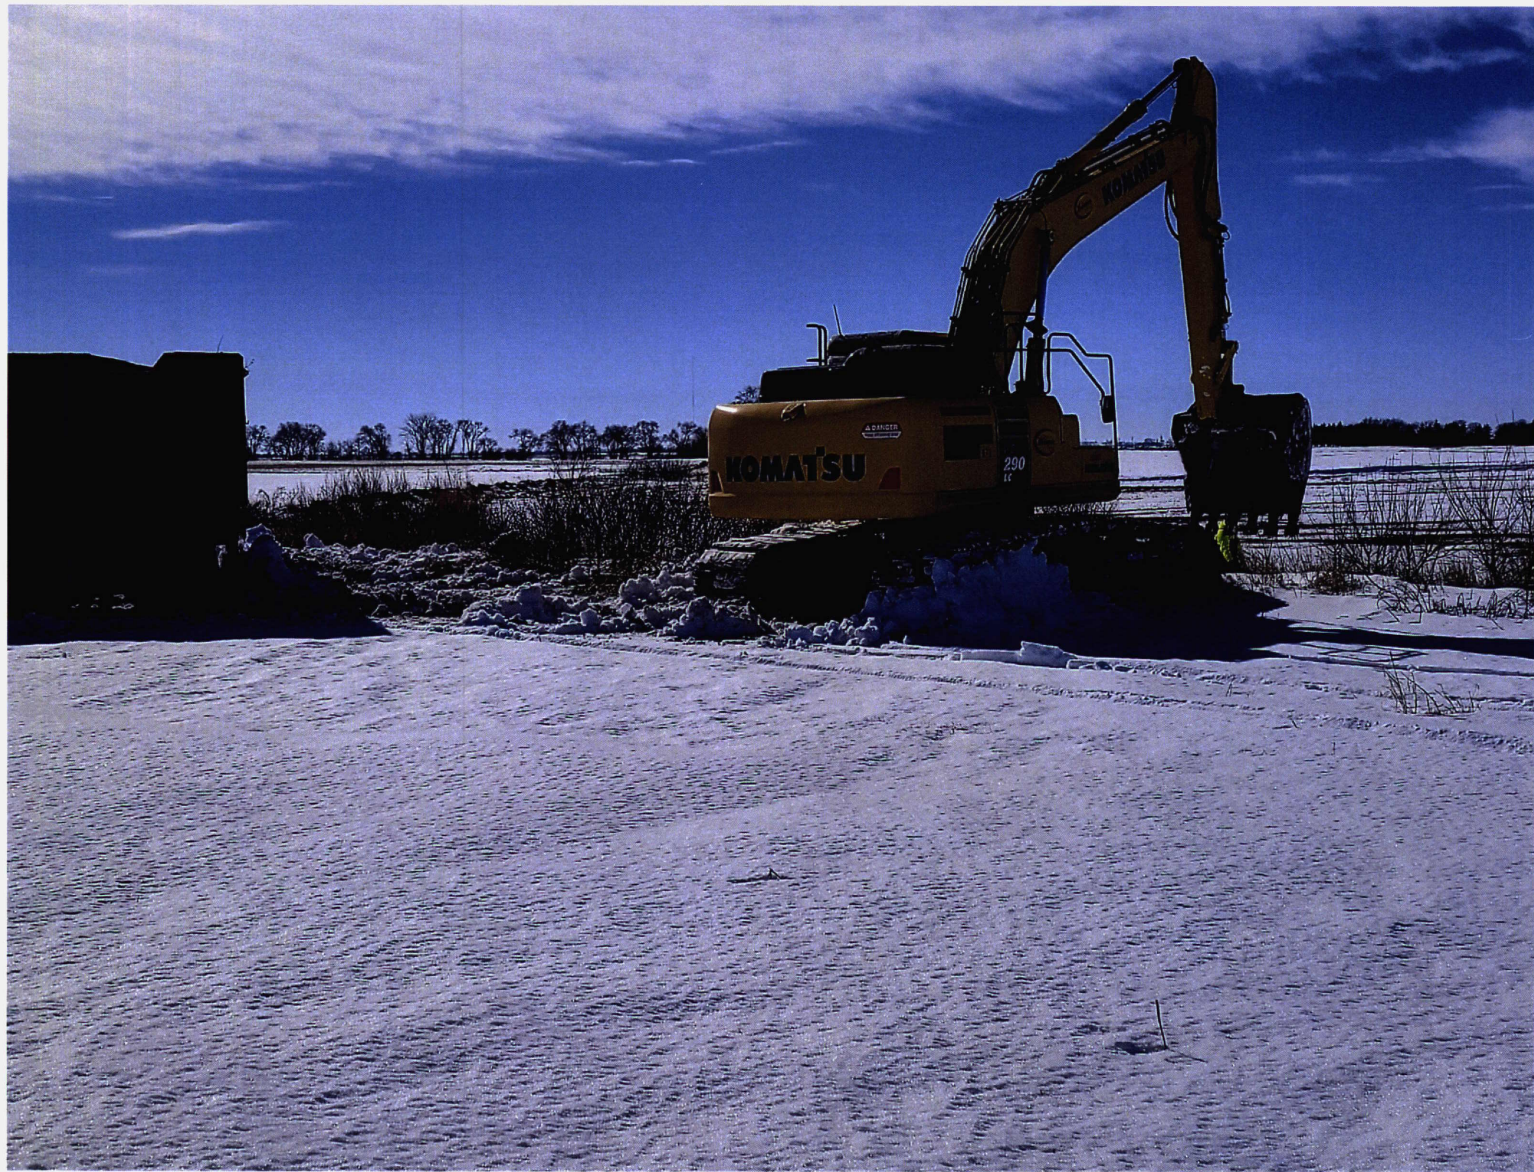
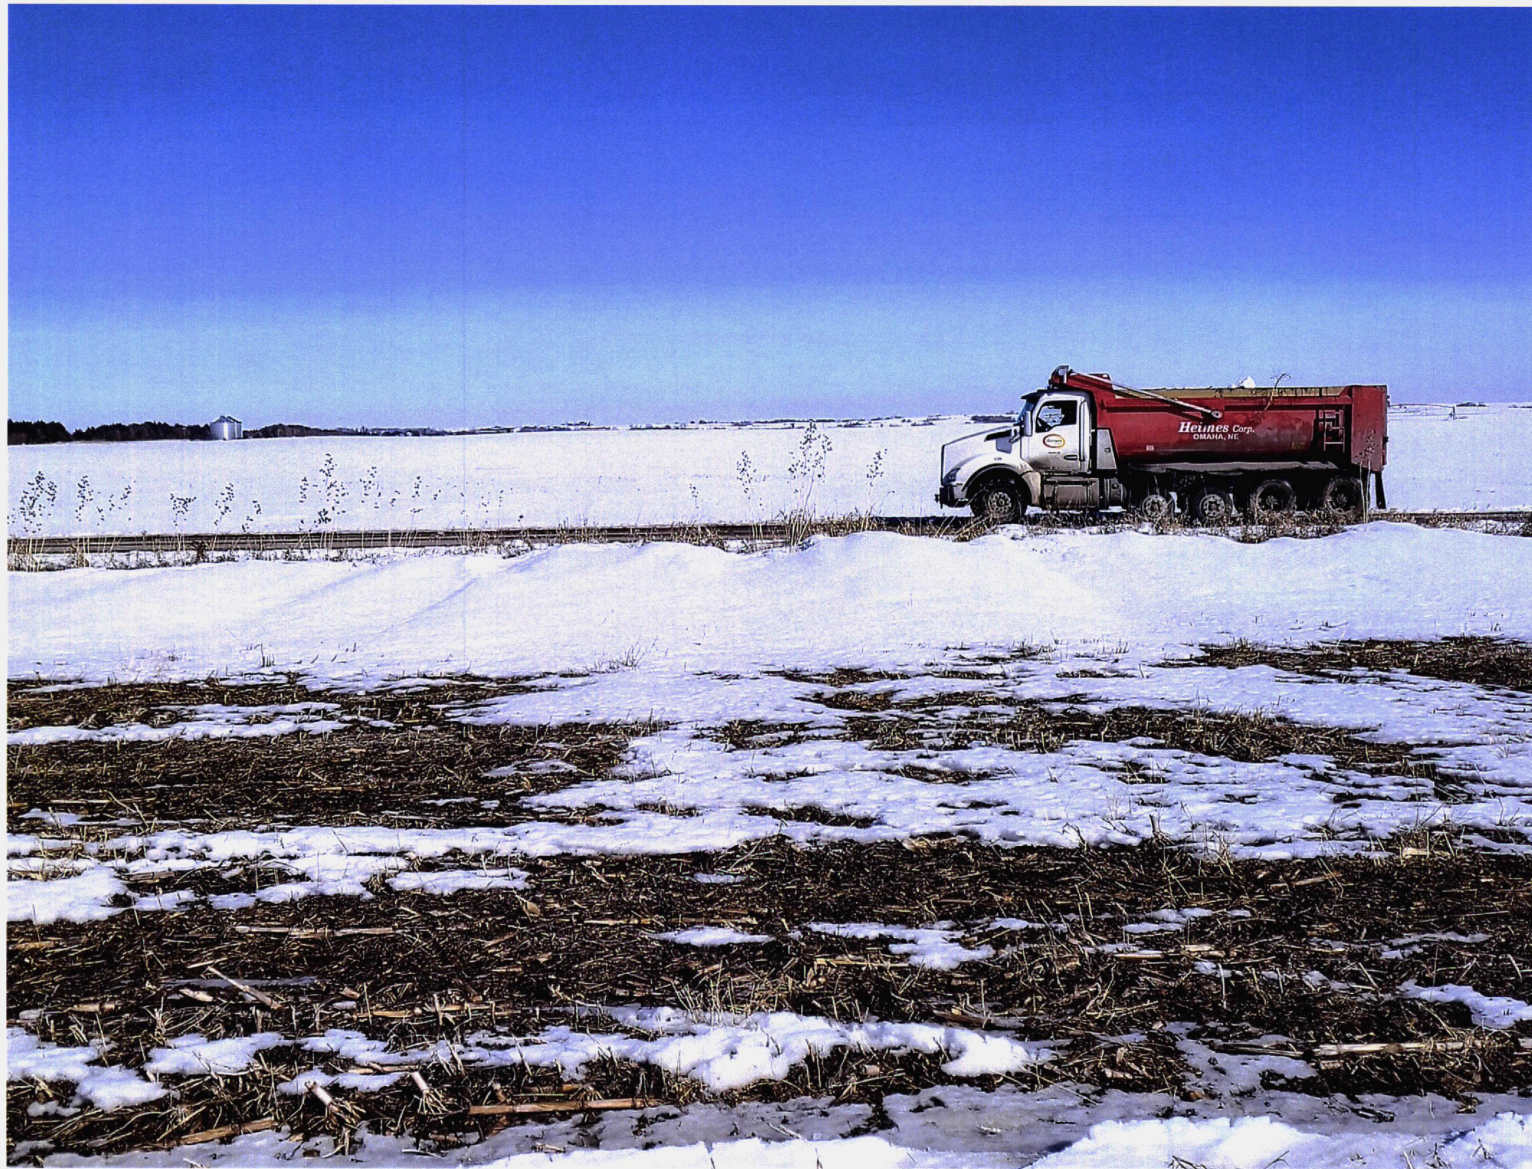
As a note and consistent with Tom's email from this morning, here are a couple photos from Feb 23, 2021 of loading/hauling impacted material collected between Stop 4 and 5. Additional photos as requested will be taken today and including in the 2-24-2021 Observation Report(s) that will be issued tomorrow.
