Daily Observation Form – PM REPORT
 AltEn LLC – Mead, NE Release
 Facility ID: 84069; State Spill Report Number: 021221-NH-845
 Date: February 28, 2021
 Weather: Cloudy and Windy, 34 °F

Terracon

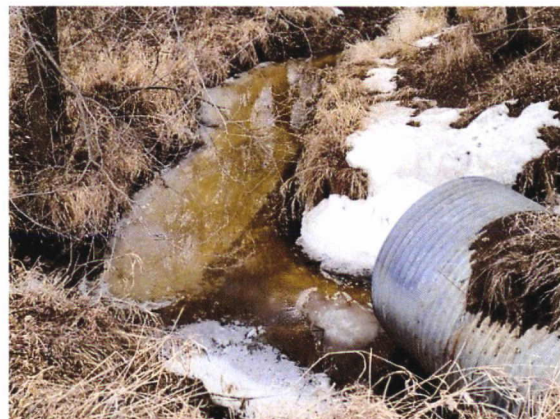
STOP 2 – North of the intersection of County Roads 6 & F
41.1334626, -96.4064519
 Time: 1205

No suspect/obvious odor noted. Obvious signs of contamination (visual) observed on the west side in water.

Flow (audible and/or visual) observed at this location.

No active work was observed at the time of the site visit.

Photo Direction: Looking northwest.

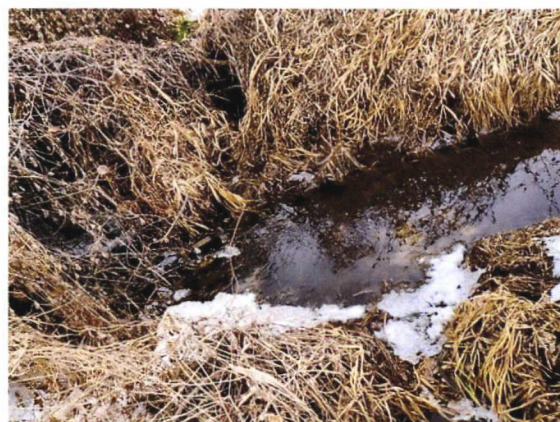
STOP 2 – North of the intersection of County Roads 6 & F
41.1334626, -96.4064519
 Time: 1209

No suspect/obvious odor noted. Obvious signs of contamination (visual) observed on the east side in water.

Flow (audible and/or visual) observed at this location.

No active work was observed at the time of the site visit.

Photo Direction: Looking north.

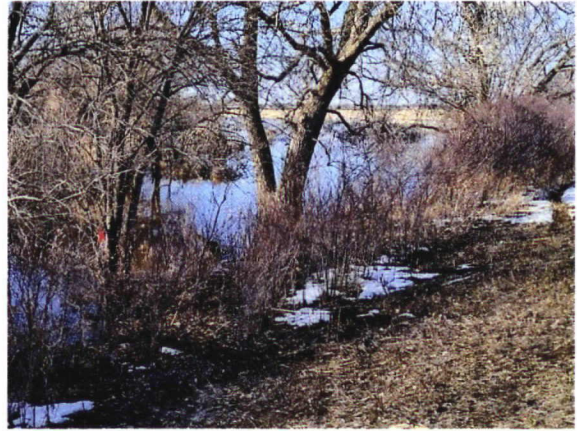
STOP 3 – Road 7/Hwy 66
41.1388323, -96.4257571
Time: 1525

Obvious signs of contamination (visual and/or olfactory) observed on the west side of Stop 3 in water. Water pooling at this location. No flow (audible and/or visual) observed at this location.

No active work was observed on the west side of the Stop 3 location at the time of the site visit.

Photo Direction: Looking northwest.

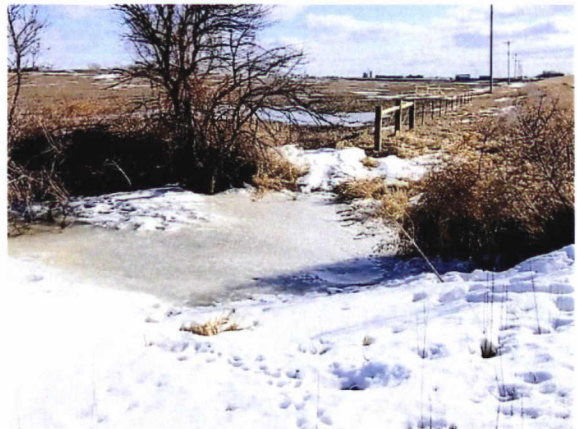
STOP 3 – Road 7/Hwy 66
41.1388323, -96.4257571
Time: 1527

Obvious signs of contamination (visual and/or olfactory) observed on the east side of Stop 3. No flow (audible and/or visual) observed at this location.

No active work was observed on the east side of the Stop 3 location at the time of the site visit.

Photo Direction: Looking southeast.

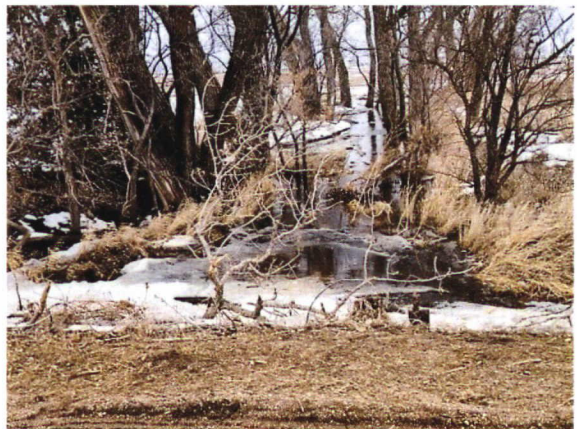
STOP 4 – County Road 8, North of Road H
GPS: 41.1677657, -96.4447025
Time: 1424

Obvious signs of contamination (visual and/or olfactory) observed in water on the east side at this location. Observed flow from adjacent fields coming into the area.

No active work was observed at the time of the site visit.

Photo Direction: Looking east.

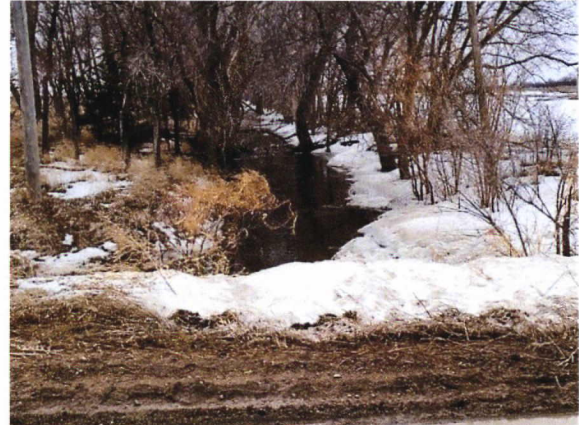
STOP 4 – County Road 8, North of Road H
GPS: 41.1677657, -96.4447025
Time: 1427

Obvious signs of contamination (visual and/or olfactory) observed in water on the west side at this location.

No active work was observed at the time of the site visit.

Photo Direction: Looking west.

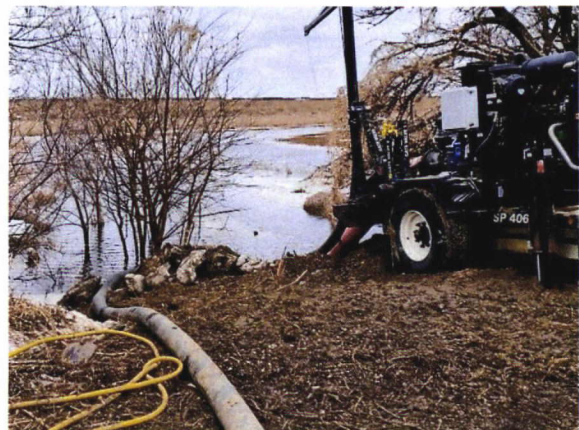
STOP 5 – UNL Eastern Extension – North of County Roads 9 & J
GPS: 41.1862613, -96.4638642
Time: 1445

Obvious signs of contamination (visual and/or olfactory) observed on the west side of Stop 5 in water. Strong odor noted at this location

The liquid has extended beyond the defined drainageway. Pumping of impacted material active.

Photo Direction: Looking northwest.

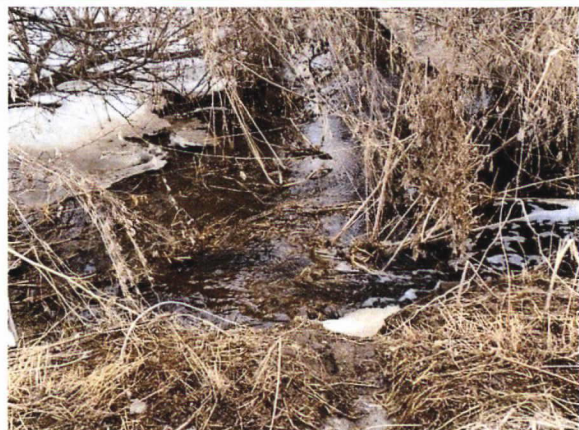
STOP 5 – UNL Eastern Extension – North of County Roads 9 & J
GPS: 41.1862613, -96.4638642
Time: 1447

Obvious signs of contamination (visual and/or olfactory) observed on the east side of Stop 5.

Observed flow from adjacent fields and west side through culvert coming into the area.

Photo Direction: Looking east.

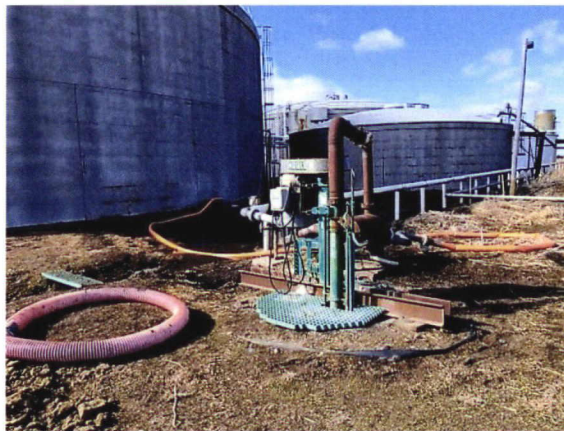
**STOP 6 – AltEn LLC Facility – East Side of
Digester 1**

Obvious signs of contamination (visual and/or olfactory) observed on the east side of Digester 1.

Pump proximal to the south lagoon connected to Digester 1 was inactive at the time of the site visit.

Photo Direction: Looking northwest.

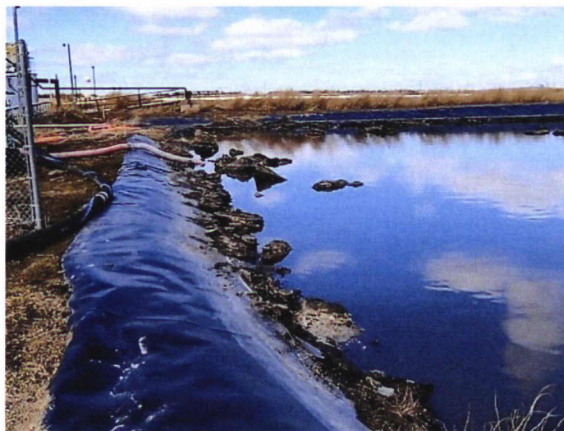
**STOP 6 – AltEn LLC Facility – Impacted
Material Disposal Site: South Lagoon**

Impacted material within AltEn's lagoon.

Photo Direction: Looking north.

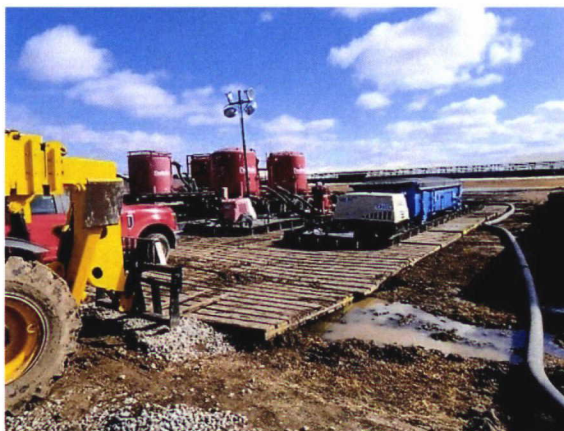
**STOP 6 – AltEn LLC Facility – South of
Emergency Lagoon**

Treatment vessels associated with constructed holding tank located south of the lagoon.

Photo Direction: Looking southeast.

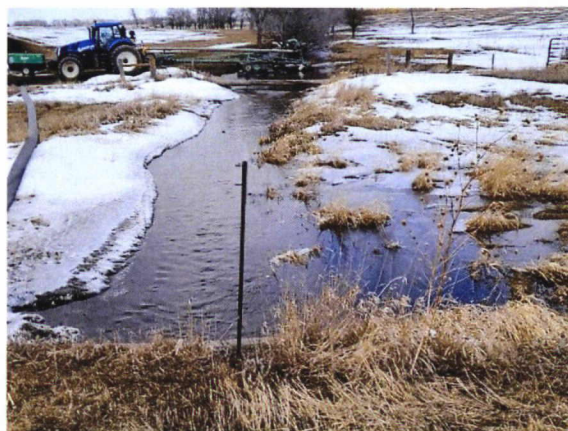
Between Stop 3 and Stop 4 – Hwy 66, East of Road 8

Obvious signs of contamination (visual and/or olfactory) observed on the north side of Hwy 66. Flow observed at this location.

Pumping of impacted material active; however, pump operation was intermittent.

Photo Direction: Looking north.

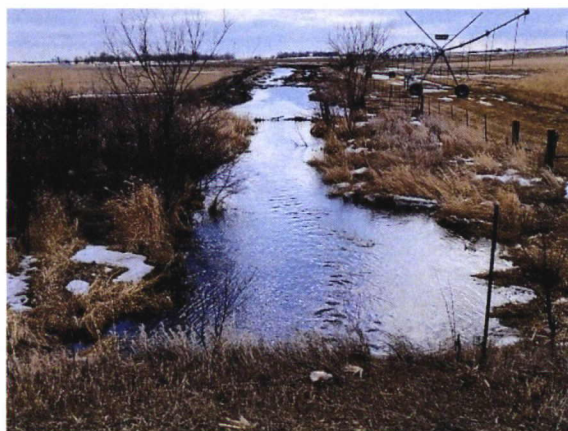
Between Stop 3 and Stop 4 – Hwy 66, East of Road 8

Obvious signs of contamination (visual and/or olfactory) observed on the south side of Hwy 66. Flow observed at this location.

Photo Direction: Looking south.

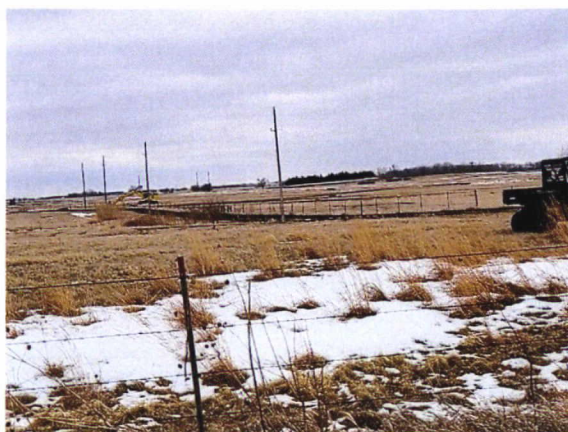
Between Stop 3 and Stop 4 – County Road H Between Roads 7 & 8

Heimes Corporation equipment inactive south of County Road H.

Photo Direction: Looking southwest.

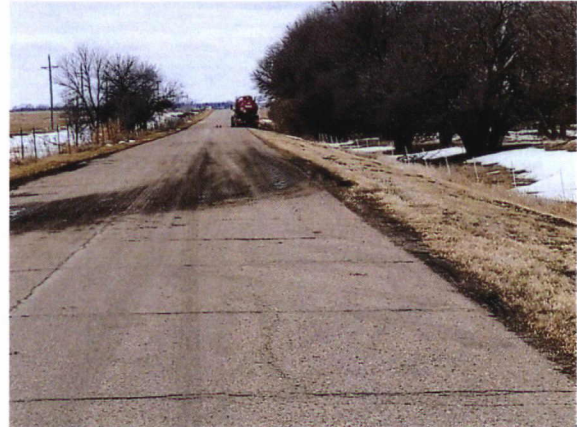
**Between Stop 3 and Stop 4 – County Road
H Between Roads 7 & 8
GPS: 41.161258, -96.437785
Time: 1420**

Vacuum truck staged at this location. Vacuum truck inactive at time of visit.

Photo Direction: Looking west.

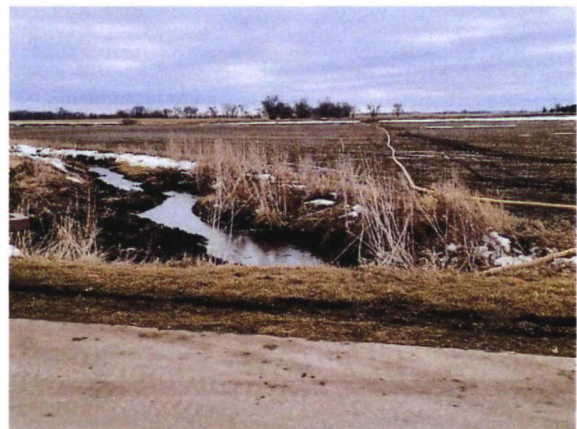
**Between Stop 4 and Stop 5 – UNL Eastern
Extension – Southeast of County Roads 9
& J
GPS: 41.1850660, -96.4616990
Time: 1220**

Vacuum truck staged at this location. Vacuum truck inactive at time of visit.

Observed flow from north side through culvert coming into the area.

Photo Direction: Looking south.

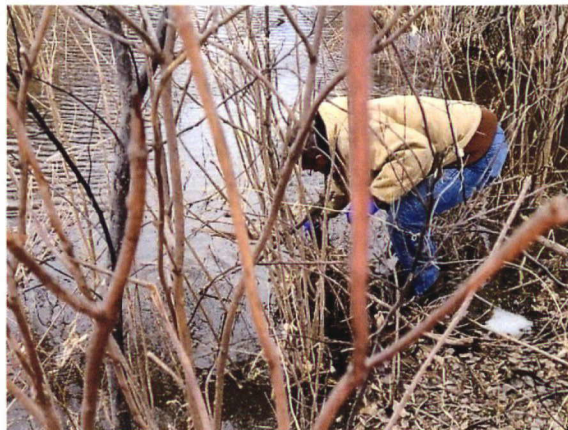
STOP 3 – Road 7/Hwy 66
41.1388323, -96.4257571
Time: 1527

Ken Peterson (AltEn Facility Manager) taking
sample on west side of Stop 3.

Photo Direction: Looking northwest.

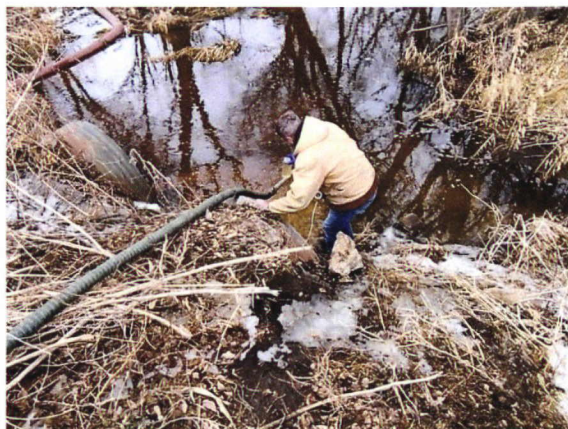
**Between Stop 3 and Stop 4 – County Road
H Between Roads 7 & 8**
GPS: 41.161258, -96.437785
Time: 1417

Ken Peterson (AltEn Facility Manager) taking
sample on north side of County Road H.

Photo Direction: Looking north.

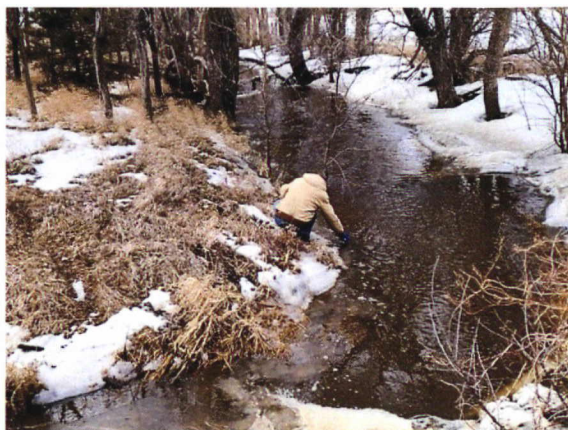
STOP 4 – County Road 8, North of Road H
GPS: 41.1677657, -96.4447025
Time: 1424

Ken Peterson (AltEn Facility Manager) taking
sample on west side of Stop 4.

Photo Direction: Looking west.

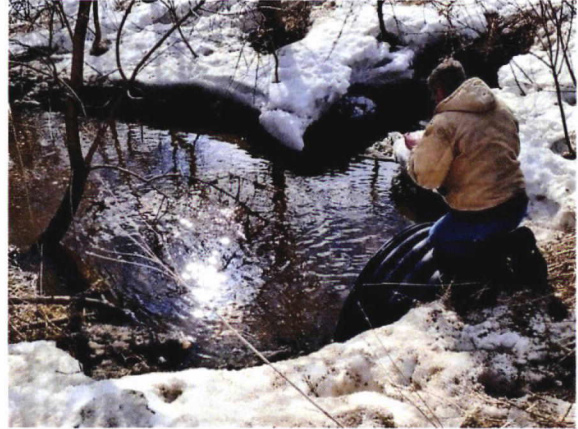
**Between Stop 4 and Stop 5 – County Road I
Between Roads 8 & 9**
GPS: 41.1756749, -96.4541687
Time: 1431

Ken Peterson (AltEn Facility Manager) taking sample on south side of County Road I.

Photo Direction: Looking southwest.

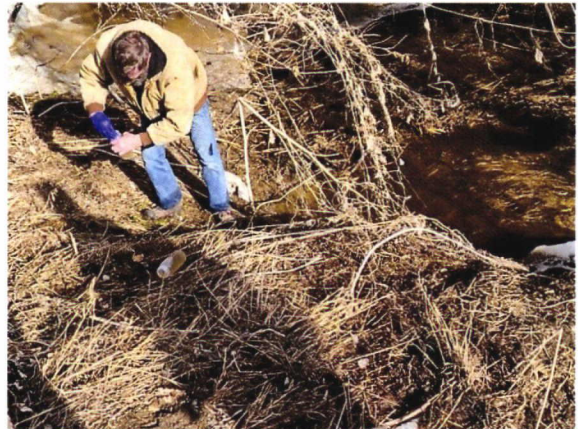
**STOP 5 – UNL Eastern Extension – North
of County Roads 9 & J**
GPS: 41.1862613, -96.4638642
Time: 1445

Ken Peterson (AltEn Facility Manager) taking sample on east side of Stop 5.

Photo Direction: Looking east.

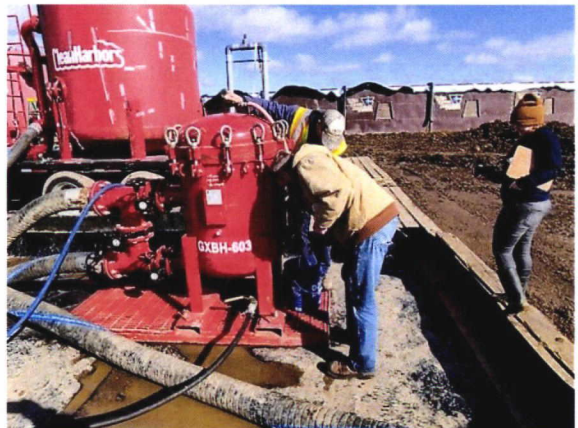
**STOP 6 – AltEn LLC Facility – South of
Emergency Lagoon**
GPS: 41.194701, -96.47611
Time: 1455

Ken Peterson (AltEn Facility Manager) taking sample of influent material entering treatment vessels located south of Stop 6.

Photo Direction: Looking east.

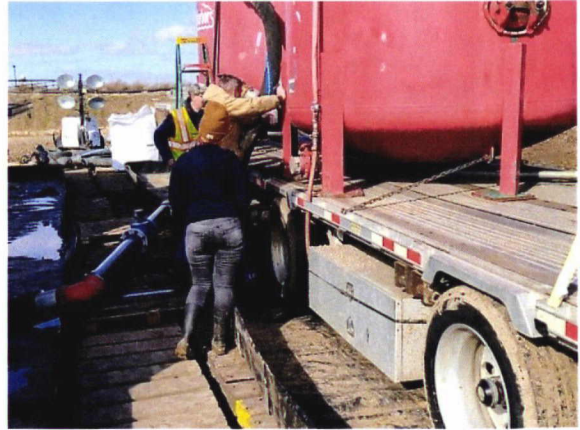
**STOP 6 – AltEn LLC Facility – South of
Emergency Lagoon**
GPS: 41.19470, -96.47611
Time: 1458

Ken Peterson (AltEn Facility Manager) taking
sample of effluent material exiting treatment
vessels located south of Stop 6.

Photo Direction: Looking northeast.
