Daily Observation Form – PM REPORT  
AltEn LLC – Mead, NE Release  
Facility ID: 84069; State Spill Report Number: 021221-NH-845  
Date: February 25, 2021  
Weather: Clear and sunny, 43 °F

**Terracon**

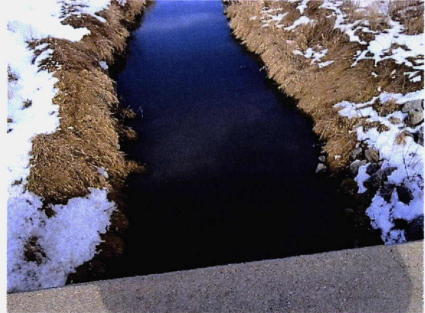
**STOP 1 – Hwy 66 West of Ashland Gun Club**

Water is flowing at this location.

No suspect/obvious odor noted. No obvious signs of contamination (visual and/or olfactory) observed in water or on banks

No active work was observed at the time of the site visit.

Photo Direction: Looking north.

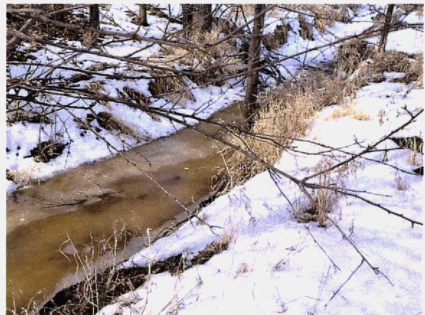
**STOP 2 – North of the intersection of County Roads 6 & F**

No visible water flow on the west side at this location. Ice, snow cover, and surface melt observed at this location

No suspect/obvious odor noted. Yellowish discoloration observed at surface.

No active work was observed at the time of the site visit.

Photo Direction: Looking northwest.

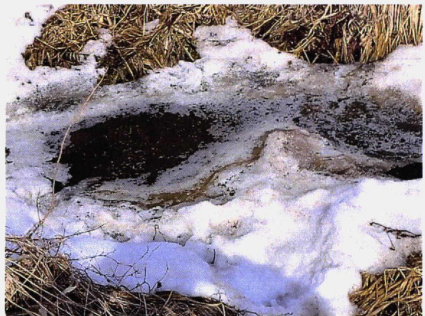
**STOP 2 – North of the intersection of County Roads 6 & F**

Audible water flow (no visible water flow) on the east side at this location. Ice, snow cover, and surface melt observed at this location

No obvious signs of contamination (visual and/or olfactory) observed.

No active work was observed at the time of the site visit.

Photo Direction: Looking north.

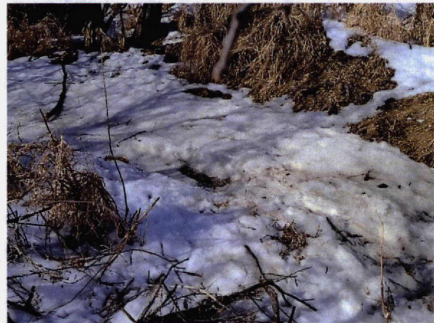
**STOP 3 – Road 7/Hwy 66**  
**41.1388323, -96.4257571**  
Time: 1332

Obvious signs of contamination (visual and/or olfactory) observed on the west side of Stop 3 in water and on sides of penetration.

No active work was observed on the west side at the Stop 3 at the time of the site visit.

Photo Direction: Looking northwest.

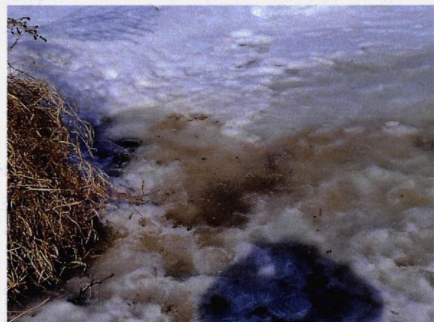
**STOP 3 – Road 7/Hwy 66: East Side**  
**41.1388323, -96.4257571**  
Time: 1332

Obvious signs of contamination (visual and/or olfactory) observed on the east side of Stop 3 in water and on sides of penetration.

No active work was observed on the east side at the Stop 3 at the time of the site visit.

Photo Direction: Looking north.

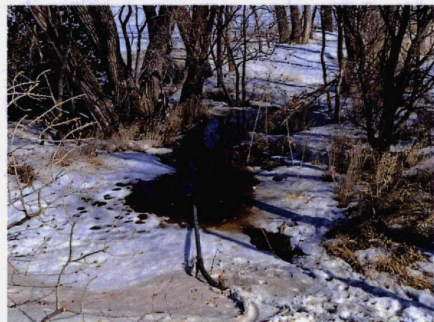
**STOP 4 – County Road 8, North of Road H**  
**GPS: 41.1677657, -96.4447025**  
Time: 1418

Obvious signs of contamination (visual and/or olfactory) observed in water on the east side at this location.

No active work was observed at the time of the site visit.

Photo Direction: Looking east.

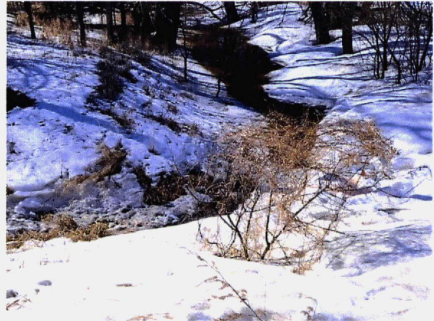
**STOP 4 – County Road 8, North of Road H**

Obvious signs of contamination (visual and/or olfactory) observed in water on the west side at this location.

No active work was observed at the time of the site visit.

Photo Direction: Looking west.

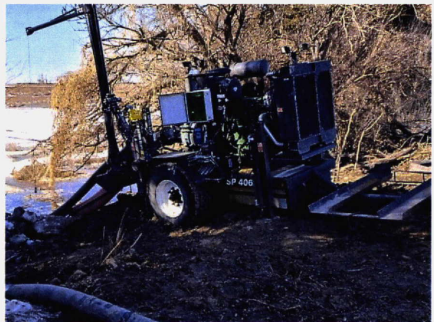
**STOP 5 – UNL Eastern Extension – North of County Roads 9 & J**

Obvious signs of contamination (visual and/or olfactory) observed on the west side of Stop 5.

Pumping of impacted material active during this visit.

Photo Direction: Looking northwest.

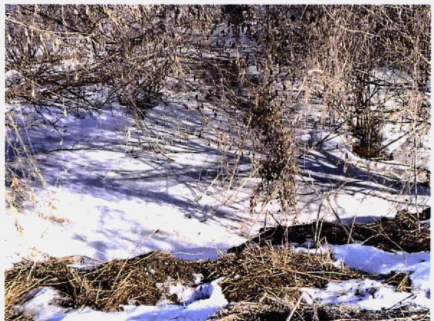
**STOP 5 – UNL Eastern Extension – North of County Roads 9 & J**

Obvious signs of contamination (visual and/or olfactory) observed on the east side of Stop 5 in water.

Photo Direction: Looking east.

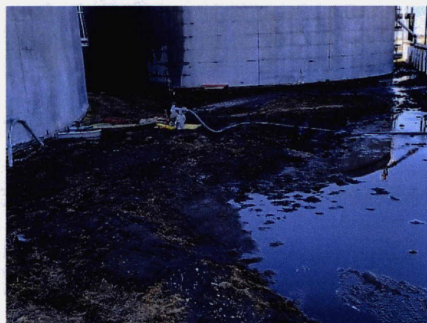
**STOP 6 – AltEn LLC Facility – East Side of  
Digester 1**  
GPS: 41.195558, -96.473923  
Time: 1528

Obvious signs of contamination (visual and/or olfactory) observed on the east side of Digester 1.

Pump active between Digester 1 (influent) and lagoon (effluent) at the time of the site visit.

Photo Direction: Looking north.

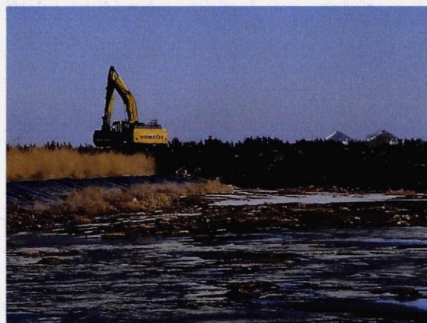
**STOP 6 – AltEn LLC Facility – Drainage  
Ditch Dumping Site: South Lagoon**  
GPS: 41.195558, -96.473923  
Time: 1530

Impacted material stockpiled at northeast corner of AltEn's lagoon.

Photo Direction: Looking east.

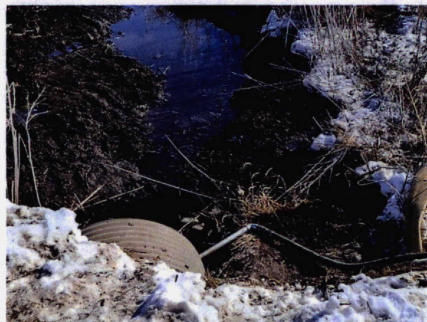
**Between Stop 4 and Stop 5 – UNL Eastern  
Extension – Southeast of County Roads 9  
& J**  
GPS: 41.1850660, -96.4616990  
Time: 1448

Clean Harbors crew recovering impacted material from drainageway with a vacuum truck. Material is being transported to AltEn's lagoon system for disposal.

Photo Direction: Looking south.

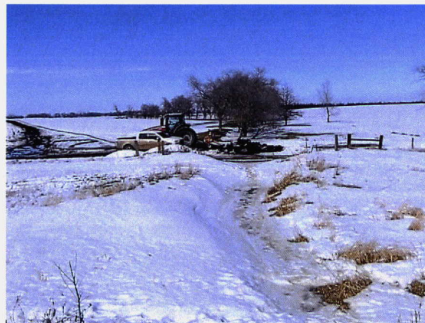
**Between Stop 3 and Stop 4 – Hwy 66, East of Road 8**

Soil berm placed within drainageway on the north side of Hwy 66.

Pumping of impacted material active during this visit.

Photo Direction: Looking north.

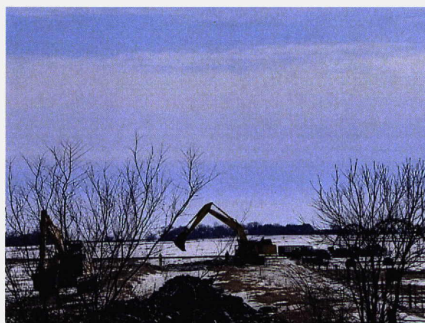
**Between Stop 3 and Stop 4 – Hwy 66, East of Road 8**

Heimes Corporation crew removing impacted material from drainageway south of Hwy 66 (generally northwest of Stop 3). Removed material is being loaded into dump trucks for disposal in AltEn's lagoon system.

Photo Direction: Looking south.

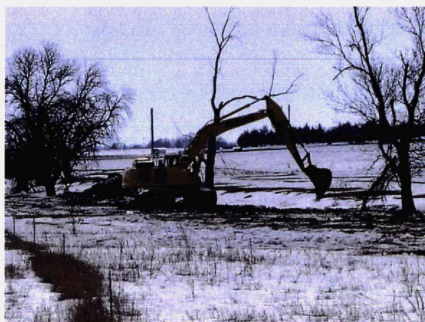
**Between Stop 3 and Stop 4 –County Road H Between Roads 7 & 8**

Heimes Corporation crew removing impacted material from drainageway on the south side of Road H. Removed material is being loaded into dump trucks for disposal in AltEn's lagoon.

Photo Direction: Looking south.
