PCS 84069

Daily Observation Form – AM REPORT
AltEn LLC – Mead, NE Release
Facility ID: 84069; State Spill Report Number: 021221-NH-845
Date: February 27, 2021
Weather: Clear and sunny, 30 °F

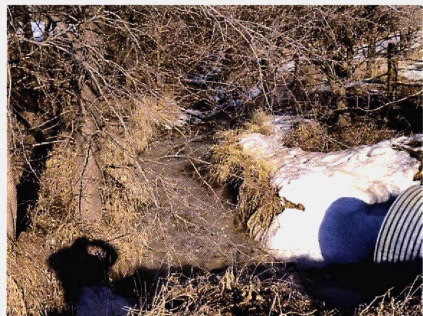
STOP 2 – North of the intersection of County Roads 6 & F
41.1334626, -96.4064519
Time: 0910

Yellowish discoloration observed on the west side of Stop 2.

No active work was observed at the time of the site visit.

Photo Direction: Looking northwest.

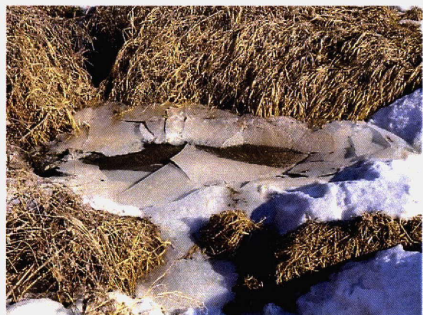
STOP 2 – North of the intersection of County Roads 6 & F
41.1334626, -96.4064519
Time: 0910

Ice observed on the east side of Stop 2. Ice appeared to be discolored.

No active work was observed at the time of the site visit.

Photo Direction: Looking north.

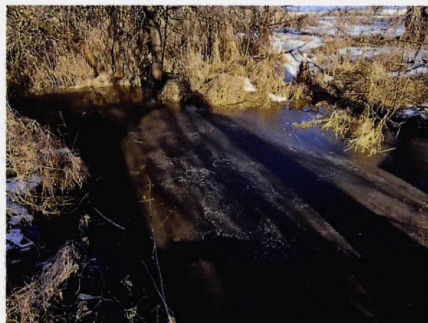
STOP 3 – Road 7/Hwy 66
41.1388323, -96.4257571
Time: 0838

Obvious signs of contamination (visual and/or olfactory) observed on the west side of Stop 3 in water. Pooled water observed at this location. No visual flow observed at this location; however, audible flow note.

No active work was observed on the west side of the Stop 3 location at the time of the site visit.

Photo Direction: Looking northwest.

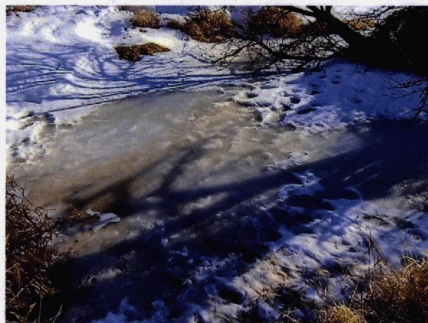
STOP 3 – Road 7/Hwy 66: East Side
41.1388323, -96.4257571
Time: 0840

Obvious signs of contamination (visual and/or olfactory) observed on the east side of Stop 3. No visual flow observed at this location; however, audible flow note.

No active work was observed on the east side of the Stop 3 location at the time of the site visit.

Photo Direction: Looking north.

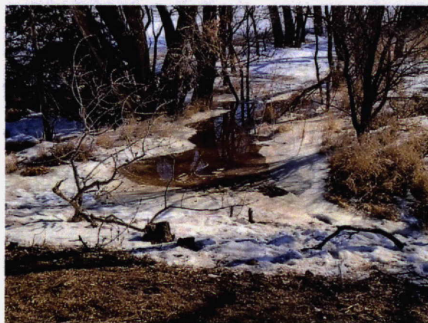
STOP 4 – County Road 8, North of Road H
GPS: 41.1677657, -96.4447025
Time: 0942

Obvious signs of contamination (visual and/or olfactory) observed in water on the east side at this location.

No active work was observed at the time of the site visit.

Photo Direction: Looking east.

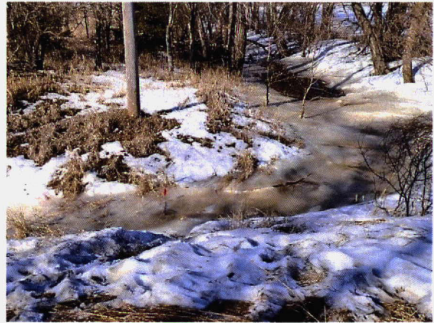
STOP 4 – County Road 8, North of Road H
GPS: 41.1677657, -96.4447025
Time: 0942

Obvious signs of contamination (visual and/or olfactory) observed in water on the west side at this location.

No active work was observed at the time of the site visit.

Photo Direction: Looking west.

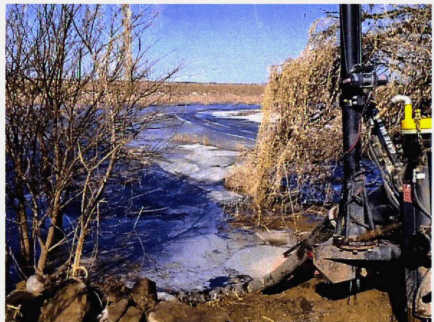
STOP 5 – UNL Eastern Extension – North of County Roads 9 & J
GPS: 41.1862613, -96.4638642
Time: 1004

Obvious signs of contamination (visual and/or olfactory) observed on the west side of Stop 5 in water and on sides of penetration in ice.

Pumping of impacted material inactive during this visit.

The liquid has extended beyond the defined drainageway as soil is placed in front of the culvert at this location.

Photo Direction: Looking northwest.

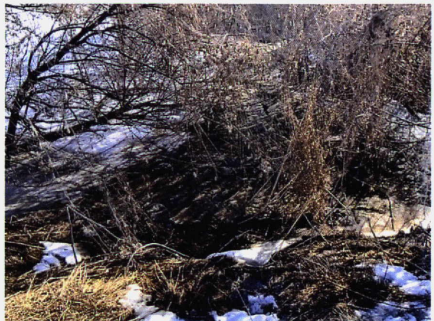
STOP 5 – UNL Eastern Extension – North of County Roads 9 & J
GPS: 41.1862613, -96.4638642
Time: 1004

Obvious signs of contamination (visual and/or olfactory) observed on the east side of Stop 5.

Photo Direction: Looking east.

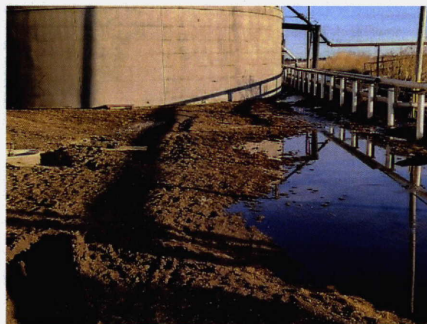
**STOP 6 – AltEn LLC Facility – East Side of
Digester 1**
GPS: 41.195558, -96.473923
Time: 0800

Obvious signs of contamination (visual and/or olfactory) observed on the east side of Digester 1.

No active work was observed at the time of the site visit.

Photo Direction: Looking north.

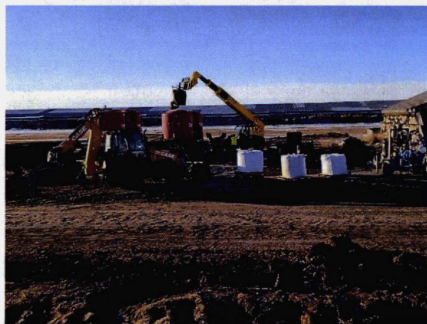
**STOP 6 – AltEn LLC Facility – South of
Emergency Lagoon**
GPS: 41.19470, -96.47611
Time: 0807

Well Water Solutions and Heimes Corporation crews preparing treatment vessels.

It is Terracon's understanding the liquid from the south lagoon will be pumped through the treatment vessels into a holding tank and tested to determine disposal options.

Photo Direction: Looking south.

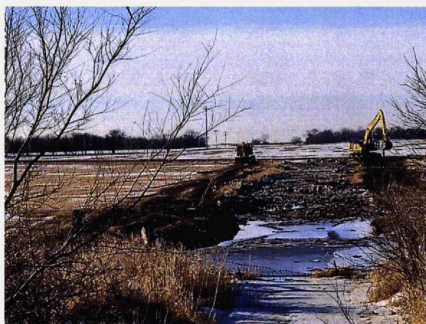
Between Stop 3 and Stop 4 – Hwy 66, East of Road 8

Heimes Corporation equipment inactive south of Hwy 66 (generally northwest of Stop 3).

Photo Direction: Looking south.

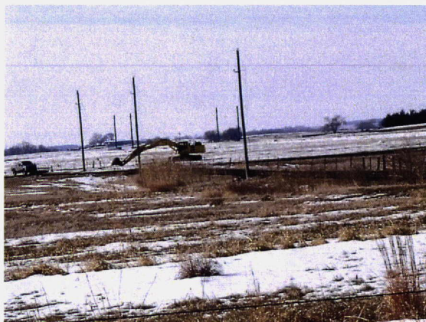
Between Stop 3 and Stop 4 – County Road H Between Roads 7 & 8

Heimes Corporation equipment inactive south of County Road H.

Photo Direction: Looking south.

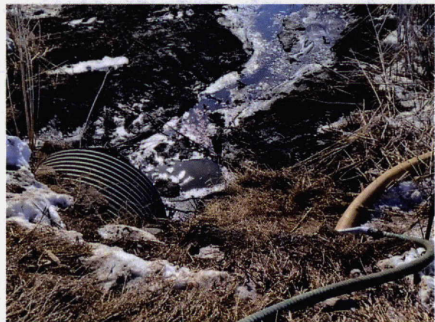
**Between Stop 4 and Stop 5 – UNL Eastern
Extension – Southeast of County Roads 9
& J
GPS: 41.1850660, -96.4616990
Time: 1010**

Clean Harbors crew/vacuum truck staged at this location.

Vacuum truck inactive at time of visit as it is Terracon's understanding the south lagoon needs to be pumped down prior to receiving additional impacted material.

Photo Direction: Looking south.
