Daily Observation Form – AM REPORT  
AltEn LLC – Mead, NE Release  
Facility ID: 84069; State Spill Report Number: 021221-NH-845  
Date: February 25, 2021  
Weather: Clear and sunny, 32°F

**Terracon**

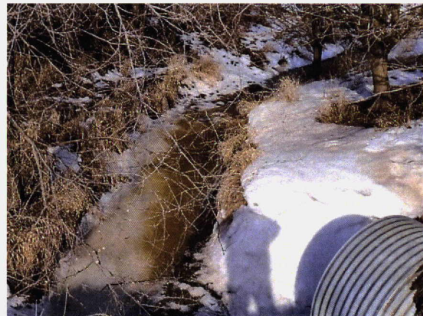
**STOP 2 – North of the intersection of County Roads 6 & F**

Yellowish discoloration observed on the west side of Stop 2.

No active work was observed on the west side at the time of the site visit.

Photo Direction: Looking northwest.

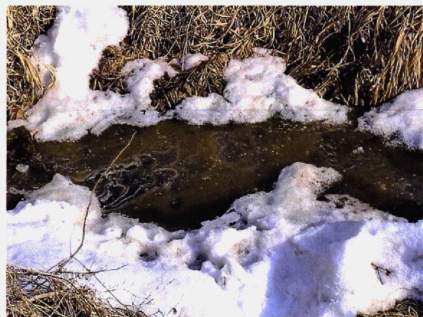
**STOP 2 – North of the intersection of County Roads 6 & F**

Ice observed on the east side of Stop 2. Ice appeared to be discolored.

No active work was observed on the west side at the time of the site visit.

Photo Direction: Looking west.

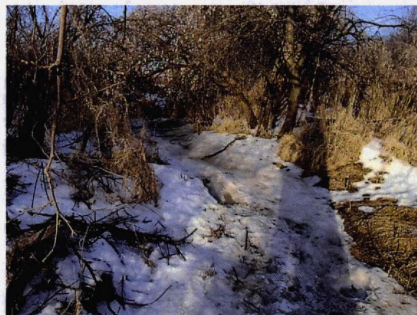
**STOP 3 – Road 7/Hwy 66**  
**GPS: 41.1388323, -96.4257571**  
Time: 0849

Obvious signs of contamination (visual and/or olfactory) observed on the west side of Stop 3 in water and on sides of penetration.

No active work was observed on the west side of the Stop 3 location at the time of the site visit.

Photo Direction: Looking northwest.

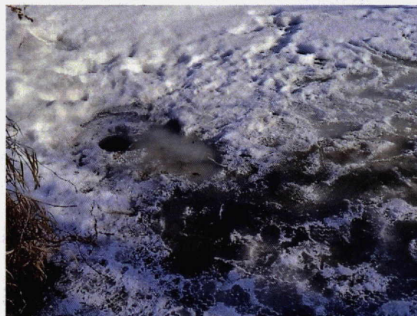
**STOP 3 – Road 7/Hwy 66**  
**GPS: 41.1388323, -96.4257571**  
Time: 0849

Obvious signs of contamination (visual and/or olfactory) observed on the east side of Stop 3 in water and on sides of penetration.

No active work was observed on the east side of the Stop 3 location at the time of the site visit.

Photo Direction: Looking north.

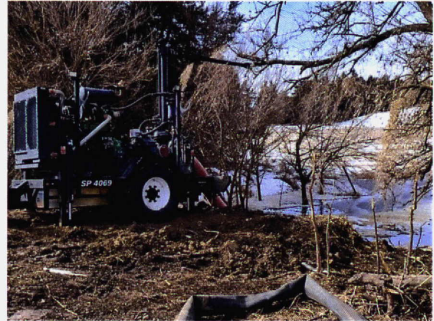
**STOP 5 – UNL Eastern Extension – North  
of County Roads 9 & J**  
GPS: 41.1862613, -96.4638642  
Time: 1110

Obvious signs of contamination (visual and/or olfactory) observed on the west side of Stop 5 in water and on sides of drainageway.

A trailer mounter pump and power unit were onsite. Pumping of impacted material active during this visit.

Photo Direction: Looking southwest.

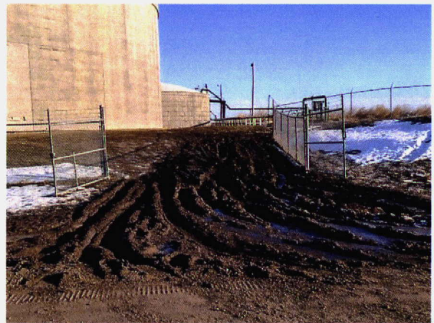
**STOP 6 – AltEn LLC Facility – East Side of  
Digester 1**  
GPS: 41.195558, -96.473923  
Time: 0809

Obvious signs of contamination (olfactory) observed on the east side of Digester 1.

No active work was observed at the time of the site visit.

Photo Direction: Looking north.

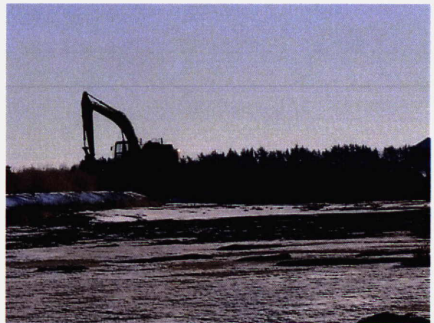
**STOP 6 – AltEn LLC Facility – Drainage  
Ditch Dumping Site: South Lagoon**  
GPS: 41.195558, -96.473923  
Time: 0811

Impacted material stockpiled at northeast corner of AltEn's lagoon.

Photo Direction: Looking east.

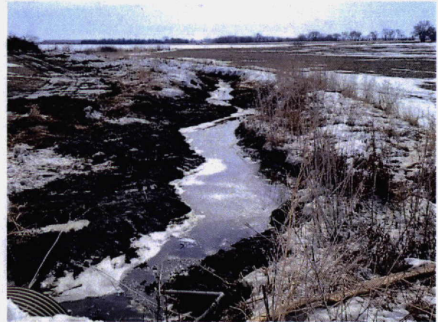
**Between Stop 4 and Stop 5 – UNL Eastern Extension – Southeast of County Roads 9 & J**

Clean Harbors crew recovering impacted material from drainageway with a vacuum truck. Recovered material is being transported to AltEn for disposal in the lagoon system.

Photo Direction: Looking south.

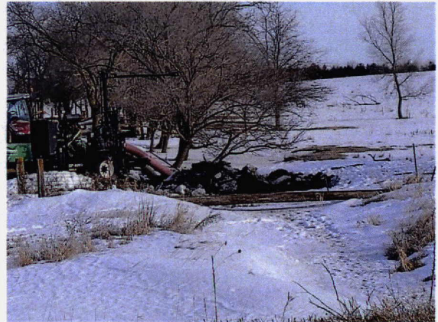
**Between Stop 3 and Stop 4 – Hwy 66, East of Road 8**

Soil berm placed within drainageway north of Hwy 66.

Pumping/recovery of impacted material inactive during this visit.

Photo Direction: Looking north.

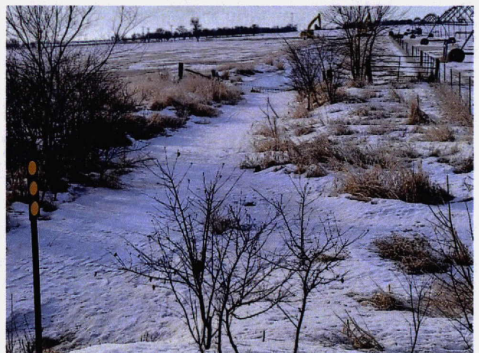
**Between Stop 3 and Stop 4 – Hwy 66, East of Road 8**

Heimes Corporation crew removing impacted material from drainageway on the south side of Hwy 66 (generally northwest of Stop 3). Removed material is being loaded into dump trucks for disposal in AltEn's lagoon system.

Photo Direction: Looking south.

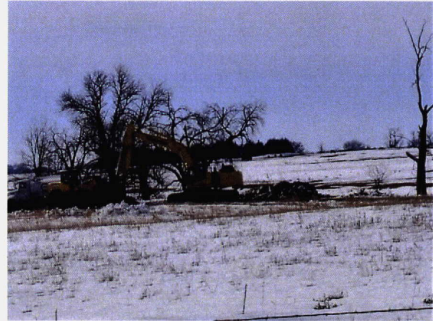
**Between Stop 3 and Stop 4 –County Road  
H Between Roads 7 & 8**  
GPS: 41.161258, -96.437785  
Time: 1015

Heimes Corporation crew removing impacted material from drainageway on the south side of Road H. Removed material is being loaded into dump trucks for disposal in AltEn's lagoon.

Photo Direction: Looking south.

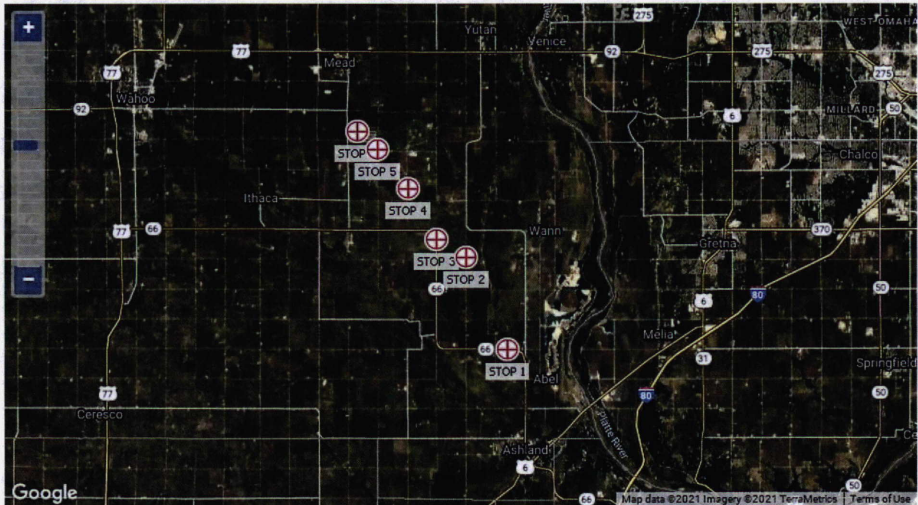
**ALTEN SITUATIONAL AWARENESS (FEB 2021)**

- DAILY TRIPS (One Person) - This could be twice per day as things warm up.
- 6 Stops
- Visual Observations recorded
- Immediate Notification/Action if changes are observed.
  - Sampling
  - Initiate a Response Contractor
- Record observations on a custom/standard form.
