PCS 84069

Daily Observation Form – AM REPORT
AltEn LLC – Mead, NE Release
Facility ID: 84069; State Spill Report Number: 021221-NH-845
Date: February 26, 2021
Weather: Clear and sunny, 30 °F

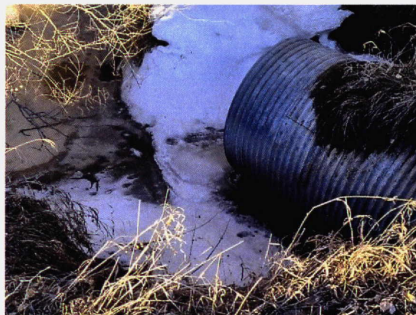
STOP 2 – North of the intersection of County Roads 6 & F
41.1334626, -96.4064519
Time: 0820

Yellowish discoloration observed on the west side of Stop 2.

No active work was observed at the time of the site visit.

Photo Direction: Looking northwest.

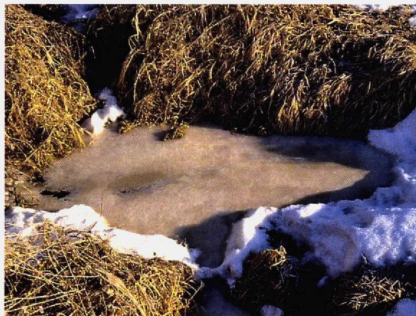
STOP 2 – North of the intersection of County Roads 6 & F
41.1334626, -96.4064519
Time: 0820

Ice observed on the east side of Stop 2. Ice appeared to be discolored.

No active work was observed at the time of the site visit.

Photo Direction: Looking north.

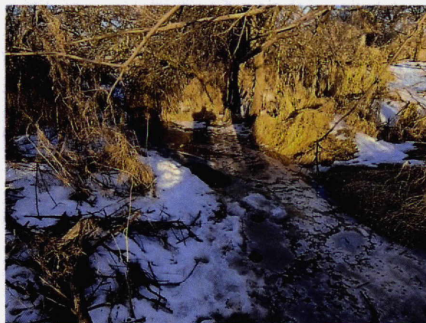
STOP 3 – Road 7/Hwy 66
41.1388323, -96.4257571
Time: 0806

Obvious signs of contamination (visual and/or olfactory) observed on the west side of Stop 3 in water and on sides of penetration.

No active work was observed on the west side of the Stop 3 location at the time of the site visit.

Photo Direction: Looking northwest.

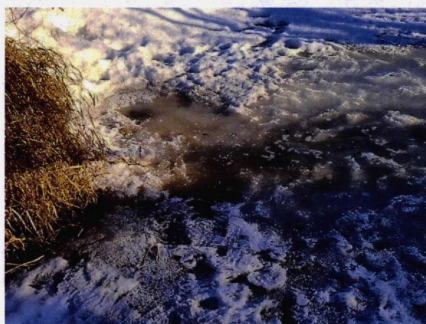
STOP 3 – Road 7/Hwy 66: East Side
41.1388323, -96.4257571
Time: 0806

Obvious signs of contamination (visual and/or olfactory) observed on the east side of Stop 3.

No active work was observed on the east side of the Stop 3 location at the time of the site visit.

Photo Direction: Looking north.

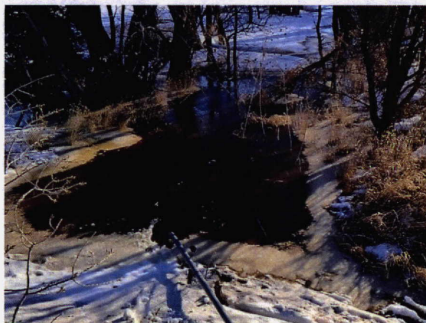
STOP 4 – County Road 8, North of Road H
GPS: 41.1677657, -96.4447025
Time: 0841

Obvious signs of contamination (visual and/or olfactory) observed in water on the east side at this location.

No active work was observed at the time of the site visit.

Photo Direction: Looking east.

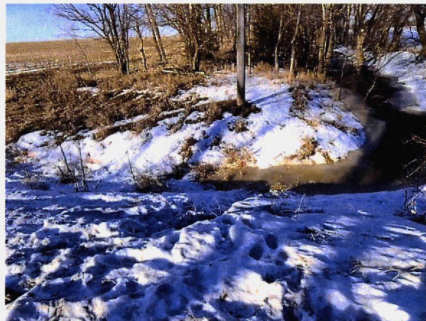
STOP 4 – County Road 8, North of Road H
GPS: 41.1677657, -96.4447025
Time: 0841

Obvious signs of contamination (visual and/or olfactory) observed in water on the west side at this location.

No active work was observed at the time of the site visit.

Photo Direction: Looking west.

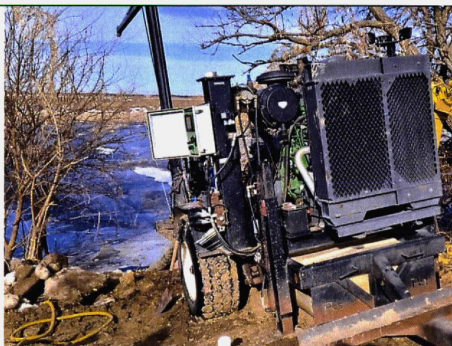
STOP 5 – UNL Eastern Extension – North of County Roads 9 & J
GPS: 41.1862613, -96.4638642
Time: 0928

Obvious signs of contamination (visual and/or olfactory) observed on the west side of Stop 5 in water and on sides of penetration in ice.

Pumping of impacted material active during this visit.

The liquid has extended beyond the defined drainageway as soil is placed in front of the culvert at this location.

Photo Direction: Looking northwest.

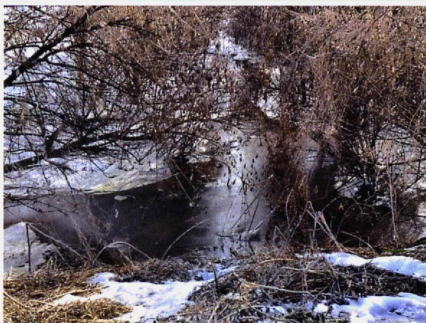
STOP 5 – UNL Eastern Extension – North of County Roads 9 & J
GPS: 41.1862613, -96.4638642
Time: 0928

Obvious signs of contamination (visual and/or olfactory) observed on the east side of Stop 5.

Photo Direction: Looking east.

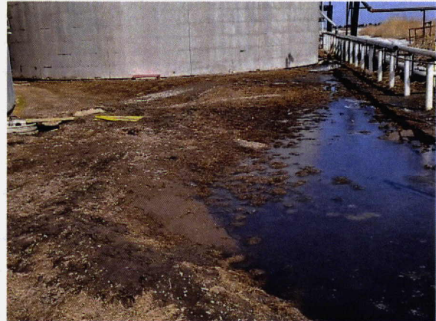
**STOP 6 – AltEn LLC Facility – East Side of
Digester 1**
GPS: 41.195558, -96.473923
Time: 1046

Obvious signs of contamination (visual and/or
olfactory) observed on the east side of
Digester 1.

No active work was observed at the time of
the site visit.

Photo Direction: Looking north.

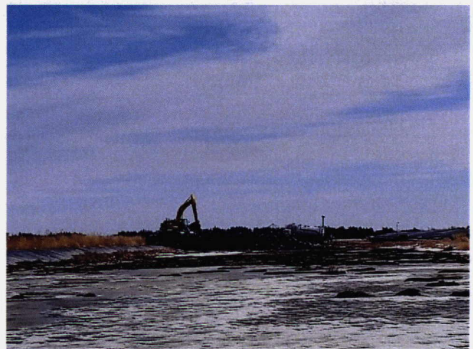
**STOP 6 – AltEn LLC Facility – Impacted
Material Disposal Site: South Lagoon**
GPS: 41.195558, -96.473923
Time: 1050

Impacted material stockpiled at northeast
corner of AltEn's lagoon.

Photo Direction: Looking east.

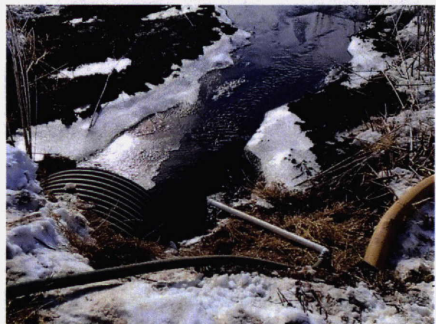
**Between Stop 4 and Stop 5 – UNL Eastern
Extension – Southeast of County Roads 9
& J**
GPS: 41.1850660, -96.4616990
Time: 0937

Clean Harbors crew recovering impacted
material from drainageway with a vacuum
truck. Material is being transported to AltEn's
lagoon system for disposal.

Photo Direction: Looking south.

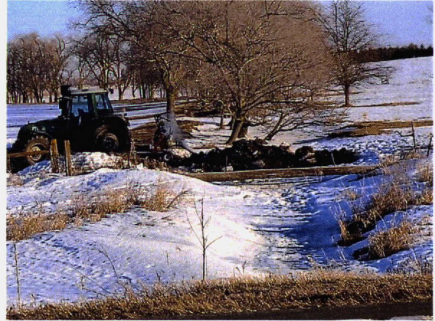
Between Stop 3 and Stop 4 – Hwy 66, East of Road 8
GPS: 41.1464807, -96.4324881
Time: 0800

Soil berm placed within drainageway on the north side of Hwy 66.

Pumping of impacted material active during this visit.

Photo Direction: Looking north.

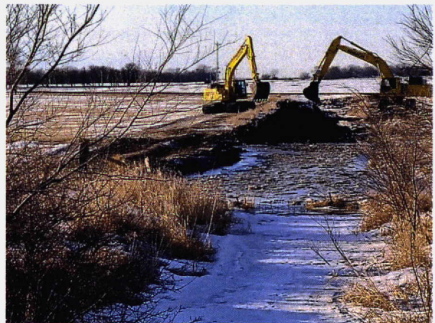
Between Stop 3 and Stop 4 – Hwy 66, East of Road 8
GPS: 41.1464807, -96.4324881
Time: 0800

Heimes Corporation crew removing impacted material from drainageway south of Hwy 66 (generally northwest of Stop 3). Removed material is being loaded into dump trucks for disposal in AltEn's lagoon system.

Photo Direction: Looking south.

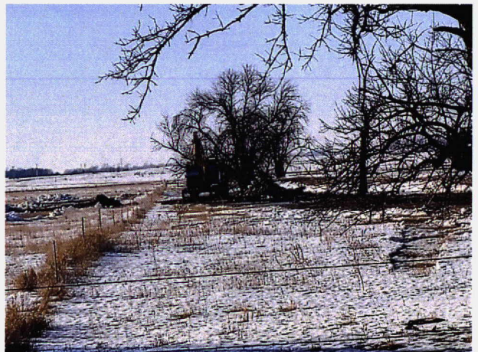
Between Stop 3 and Stop 4 –County Road H Between Roads 7 & 8
GPS: 41.161258, -96.437785
Time: 0836

Heimes Corporation crew removing impacted material from drainageway on the south side of Road H. Removed material is being loaded into dump trucks for disposal in AltEn's lagoon.

Photo Direction: Looking south.
