PCS 84069

Daily Observation Form – AM REPORT  
AltEn LLC – Mead, NE Release  
Facility ID: 84069; State Spill Report Number: 021221-NH-845  
Date: February 24, 2021  
Weather: Clear and sunny, 37°F

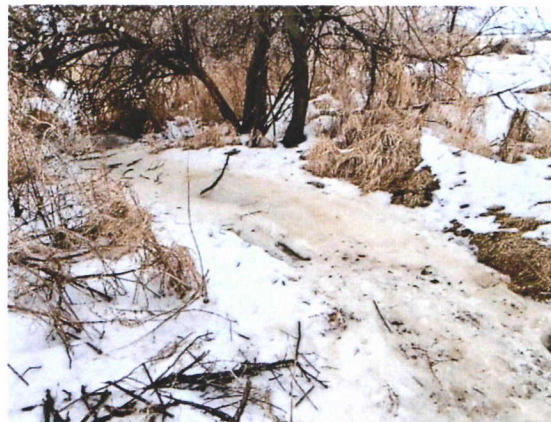
Photo Direction: Looking northwest.

Obvious signs of contamination (visual and/or olfactory) observed on the west side of Stop 3 in water and on sides of penetration in ice.

No active work was observed on the west side at the time of the site visit.

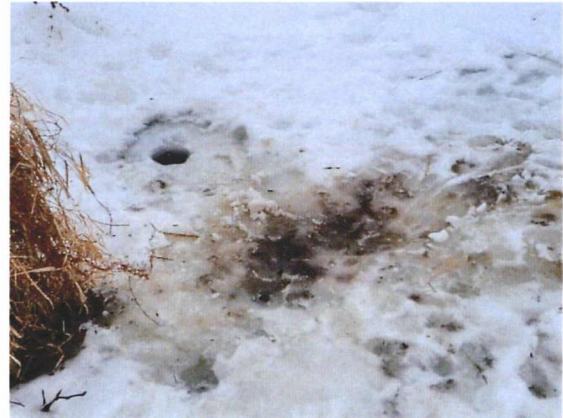
Photo Direction: Looking north.

Obvious signs of contamination (visual and/or olfactory) observed on the east side of Stop 3 in water and on sides of penetration.

No active work was observed on the east side at the time of the site visit.

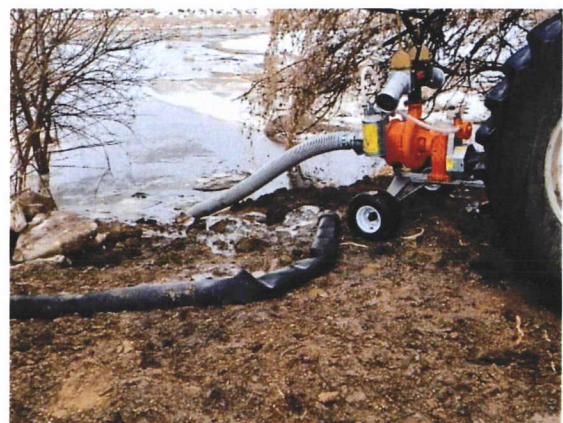
Photo Direction: Looking west.

Obvious signs of contamination (visual and/or olfactory) observed on the west side of Stop 5.

Hose connection at pump (effluent) was disconnected and draining impacted material back into the west side of Stop 5.

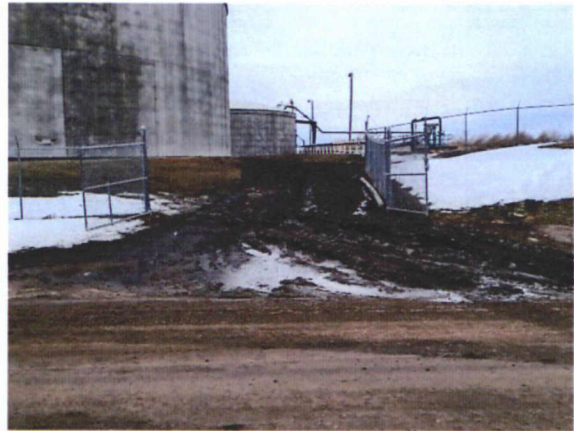
Photo Direction: Looking north.

Obvious signs of contamination (olfactory) observed on the east side of Digester 1.

No active work was observed at the time of the site visit.

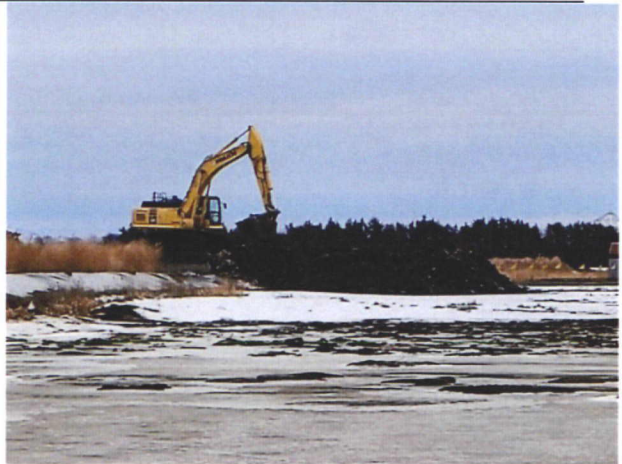
Photo Direction: Looking northeast.

Impacted material stockpiled at northeast corner of AltEn's lagoon.

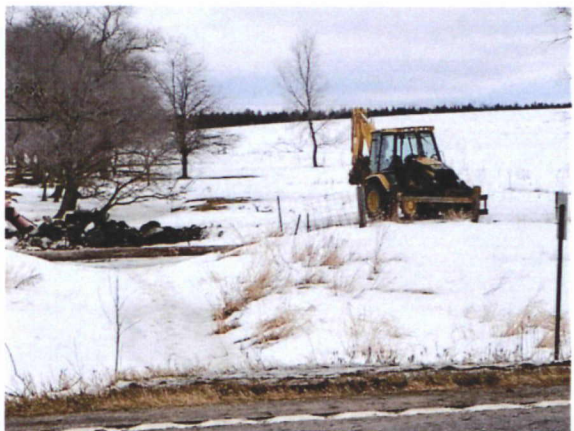
Photo Direction: Looking north.

Soil berm placed within drainageway north of Hwy 66.

Pumping of impacted material inactive during this visit.

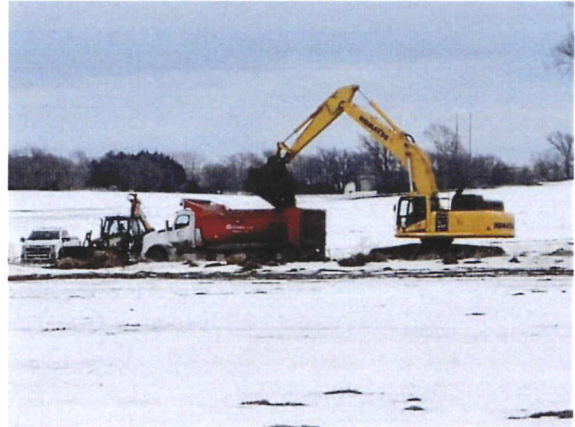
Photo Direction: Looking east.

Heimes Corporation crew removing impacted material from drainageway. Removed material is being loaded into dump truck for disposal in AltEn's lagoon.
