Daily Observation Form – PM REPORT
AltEn LLC – Mead, NE Release
Facility ID: 84069; State Spill Report Number: 021221-NH-845
Date: February 27, 2021
Weather: Cloudy, 48 °F

PCS 84069

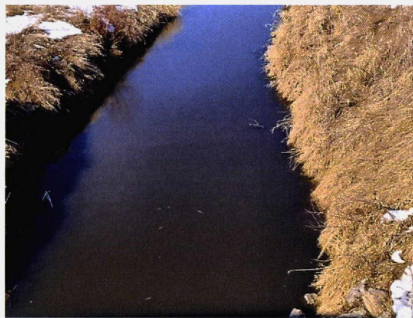
STOP 1 – Hwy 66 West of Ashland Gun Club
41.0886323, -96.380274
Time: 1445

Water is flowing at this location.

No suspect/obvious odor noted. No obvious signs of contamination (visual and/or olfactory) observed in water or on banks

No active work was observed at the time of the site visit.

Photo Direction: Looking north.

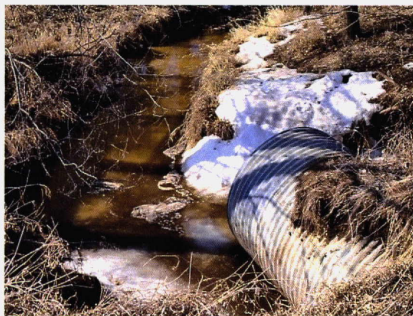
STOP 2 – North of the intersection of County Roads 6 & F
41.1334626, -96.4064519
Time: 1457

Obvious signs of contamination (visual and/or olfactory) observed on the west side in water.

No active work was observed at the time of the site visit.

Photo Direction: Looking northwest.

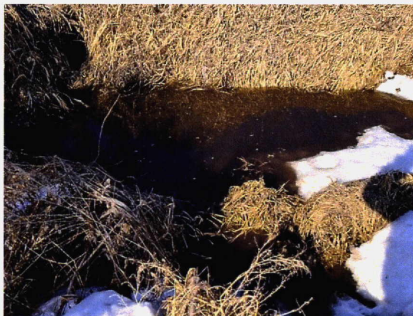
STOP 2 – North of the intersection of County Roads 6 & F
41.1334626, -96.4064519
Time: 1459

Obvious signs of contamination (visual and/or olfactory) observed on the east side in water.

No active work was observed at the time of the site visit.

Photo Direction: Looking north.

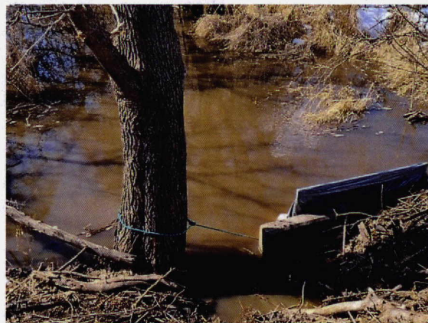
STOP 3 – Road 7/Hwy 66

Obvious signs of contamination (visual and/or olfactory) observed on the west side of Stop 3 in water. Water pooling at this location. No flow (audible and/or visual) observed at this location.

No active work was observed on the west side of the Stop 3 location at the time of the site visit.

Photo Direction: Looking northwest.

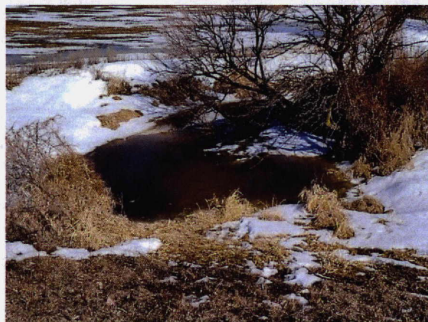
STOP 3 – Road 7/Hwy 66: East Side

Obvious signs of contamination (visual and/or olfactory) observed on the east side of Stop 3. No flow (audible and/or visual) observed at this location

No active work was observed on the east side of the Stop 3 location at the time of the site visit.

Photo Direction: Looking north.

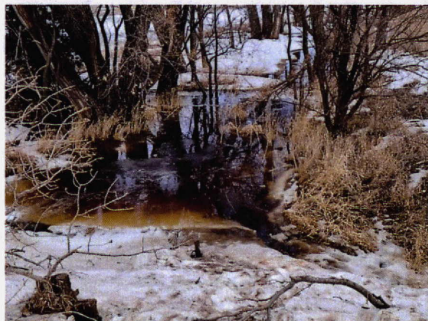
STOP 4 – County Road 8, North of Road H

Obvious signs of contamination (visual and/or olfactory) observed in water on the east side at this location. Observed flow from adjacent fields coming into the area.

No active work was observed at the time of the site visit.

Photo Direction: Looking east.

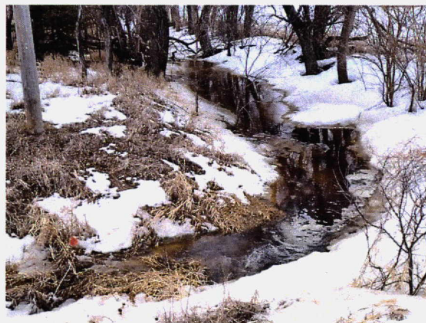
STOP 4 – County Road 8, North of Road H
GPS: 41.1677657, -96.4447025
Time: 1518

Obvious signs of contamination (visual and/or olfactory) observed in water on the west side at this location.

No active work was observed at the time of the site visit.

Photo Direction: Looking west.

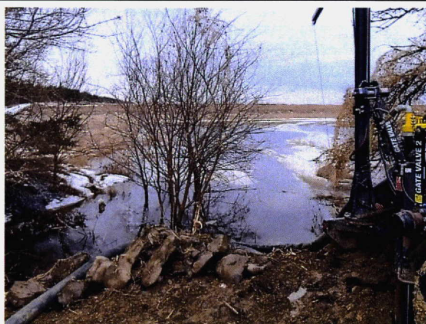
STOP 5 – UNL Eastern Extension – North of County Roads 9 & J
GPS: 41.1862613, -96.4638642
Time: 1541

Obvious signs of contamination (visual and/or olfactory) observed on the west side of Stop 5 in water.

Pumping of impacted material inactive during this visit.

The liquid has extended beyond the defined drainageway as soil is placed in front of the culvert at this location.

Photo Direction: Looking northwest.

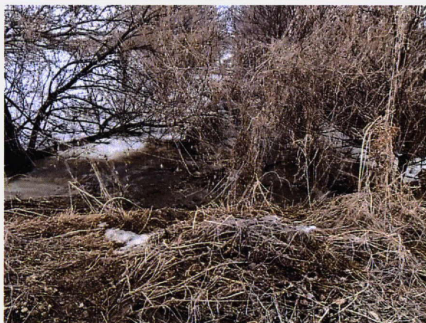
STOP 5 – UNL Eastern Extension – North of County Roads 9 & J
GPS: 41.1862613, -96.4638642
Time: 1543

Obvious signs of contamination (visual and/or olfactory) observed on the east side of Stop 5.

Photo Direction: Looking east.

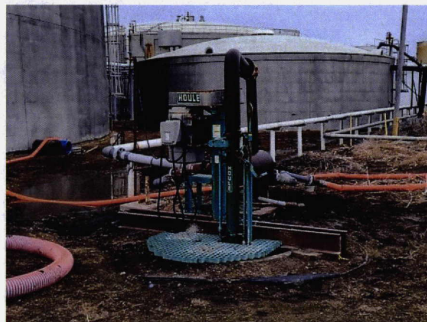
**STOP 6 – AltEn LLC Facility – East Side of
Digester 1**
GPS: 41.195558, -96.473923
Time: 1610

Obvious signs of contamination (visual and/or
olfactory) observed on the east side of
Digester 1.

Pump proximal to the south lagoon was
operating with associated hose connected to
Digester 1.

Photo Direction: Looking northwest.

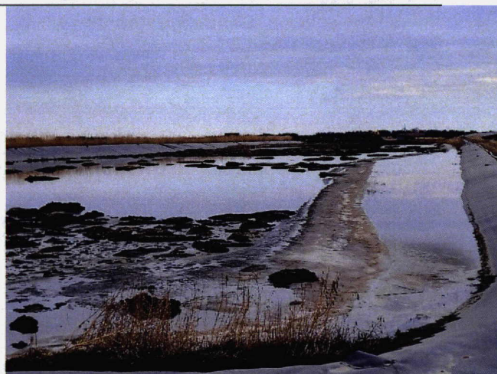
**STOP 6 – AltEn LLC Facility – Impacted
Material Disposal Site: South Lagoon**
GPS: 41.195558, -96.473923
Time: 1614

Impacted material stockpiled proximal to and
within AltEn's lagoon.

Photo Direction: Looking east.

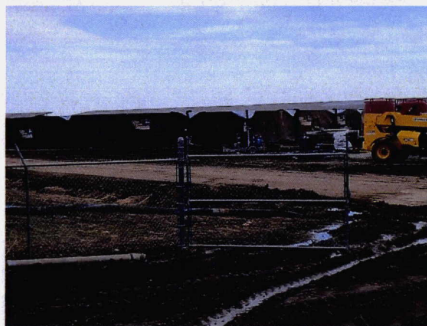
**STOP 6 – AltEn LLC Facility – South of
Emergency Lagoon**
GPS: 41.19470, -96.47611
Time: 1620

Constructed holding tank associated with
treatment vessels located south of the
lagoon.

Photo Direction: Looking southeast.

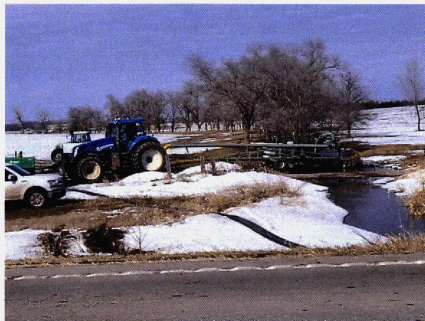
Between Stop 3 and Stop 4 – Hwy 66, East of Road 8

Soil berm placed within drainageway on the north side of Hwy 66. Flow observed at this location.

Pumping of impacted material inactive during this visit.

Photo Direction: Looking north.

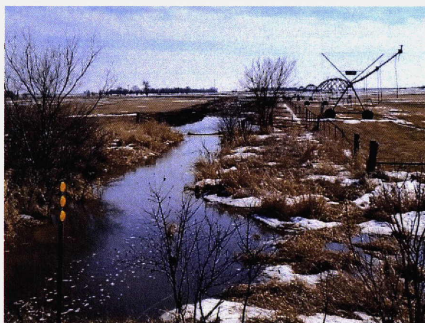
Between Stop 3 and Stop 4 – Hwy 66, East of Road 8

Obvious signs of contamination (visual and/or olfactory) observed on the south side of Hwy 66. Flow observed at this location.

Photo Direction: Looking south.

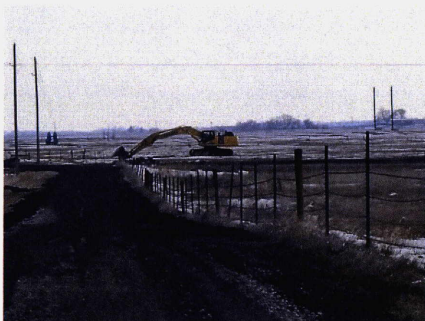
Between Stop 3 and Stop 4 – County Road H Between Roads 7 & 8

Heimes Corporation equipment inactive south of County Road H.

Photo Direction: Looking south.

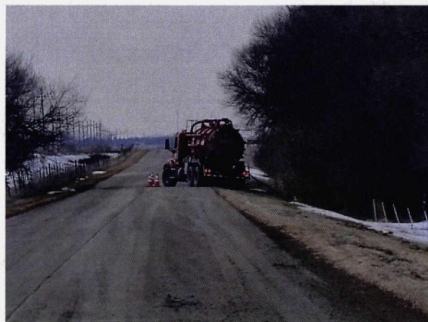
**Between Stop 3 and Stop 4 – County Road
H Between Roads 7 & 8
GPS: 41.161258, -96.437785
Time: 1513**

Vacuum truck staged at this location. Vacuum truck inactive at time of visit.

Photo Direction: Looking west.
