ALTEN LLC – MEAD NEBRASKA SPILL - DAILY OBSERVATIONS FORM
FACILITY ID 84069 STATE SPILL REPORT NUMBER 021221-NH--845

DATE: 2-25-21

INVESTIGATOR: Rachel Neisius

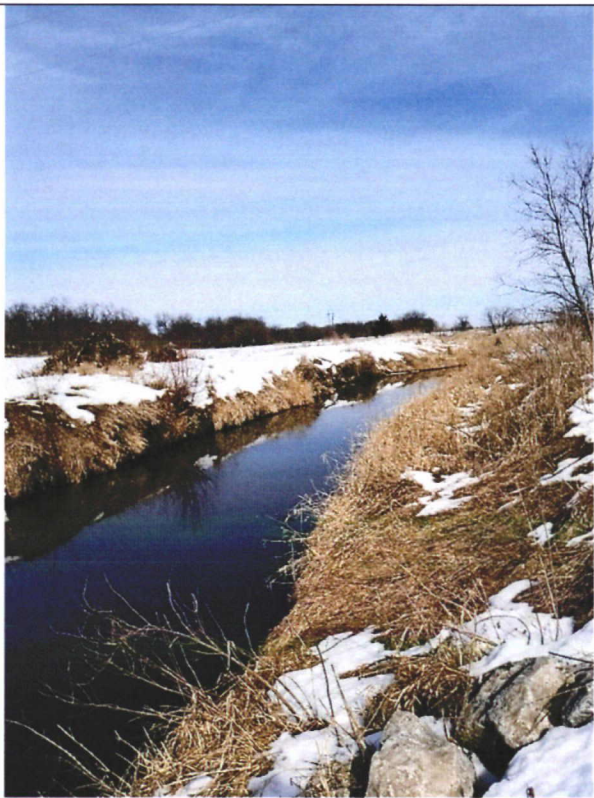
STOP 1 – HIGHWAY 66 WEST of
ASHLAND GUN CLUB

Looking North. Open water, cannot see the bottom- too turbid. Water was flowing slowly. No odor noted.

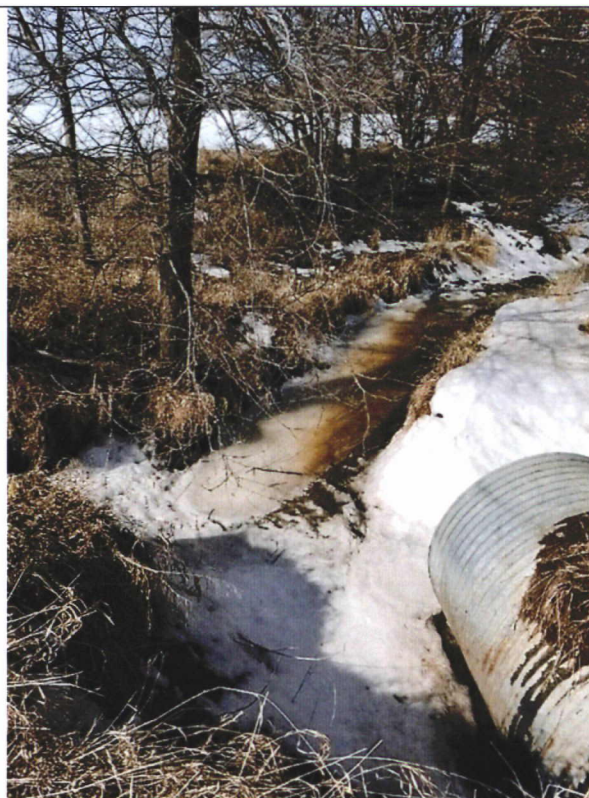
**STOP 2 – North of the Intersection of
COUNTY ROADS 6 & F**

Looking west at creek and culvert. Creek is partially ice-covered. Water looks murky brown. No odor.

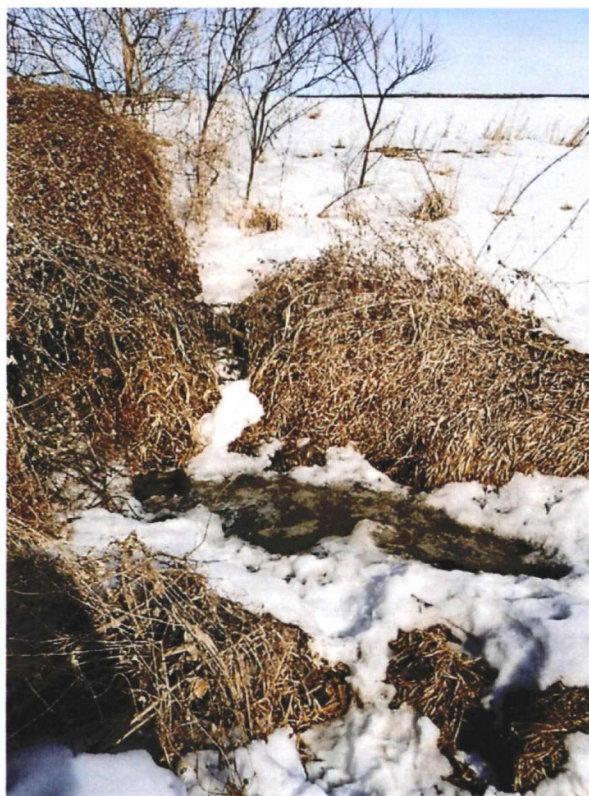
West side of culvert – south side of creek, looking north. Mostly ice covered. Small puddle of water. No odor.

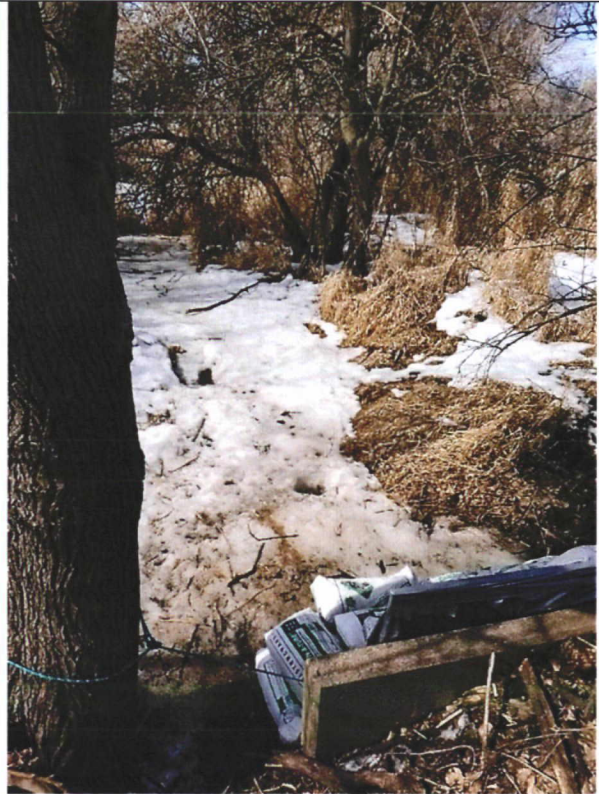
STOP 3 – Road 7/Highway 66
1215 Hours

Photo taken on east side of culvert looking west. No obvious water flow. Ice melt near around the culvert is brown in color. The culvert is blocked with sandbags and a tarp.

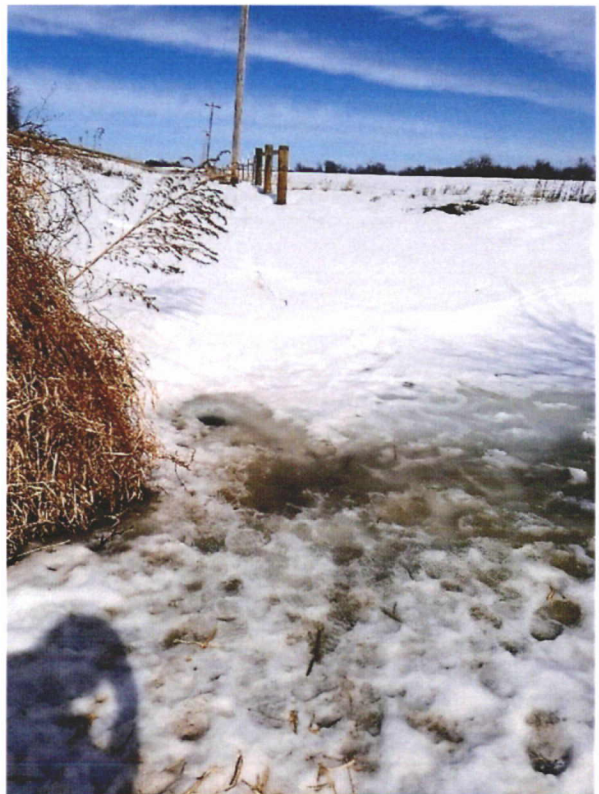
Photo is next to the the culvert on the east side of the road, looking north. No obvious water flow. Ice is starting to melt. Hole drilled in the ice is visible in the picture.

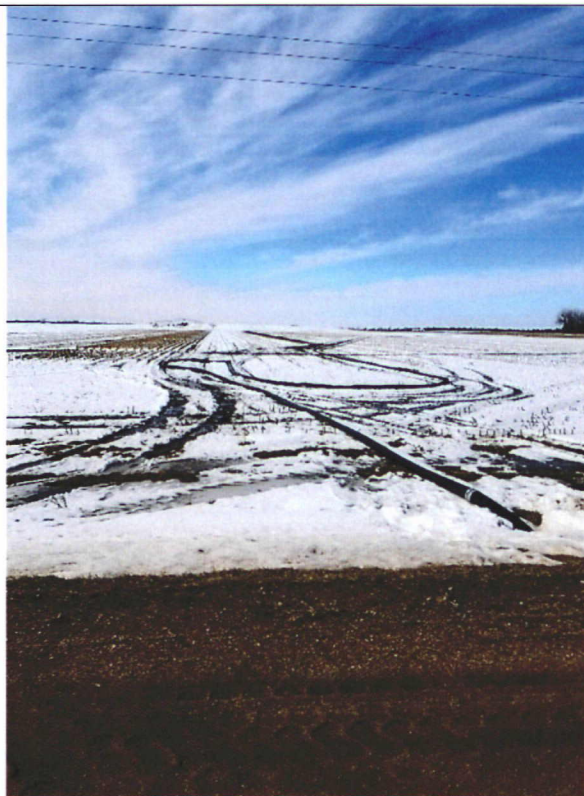
STOP 4 – County Road 8, North of Road H
1220 Hours

Photo is looking west from road 8, just south of the creek. A hose had been laid out through the culvert under Road 8. No liquid seemed to be pumping through at the time of this observation.

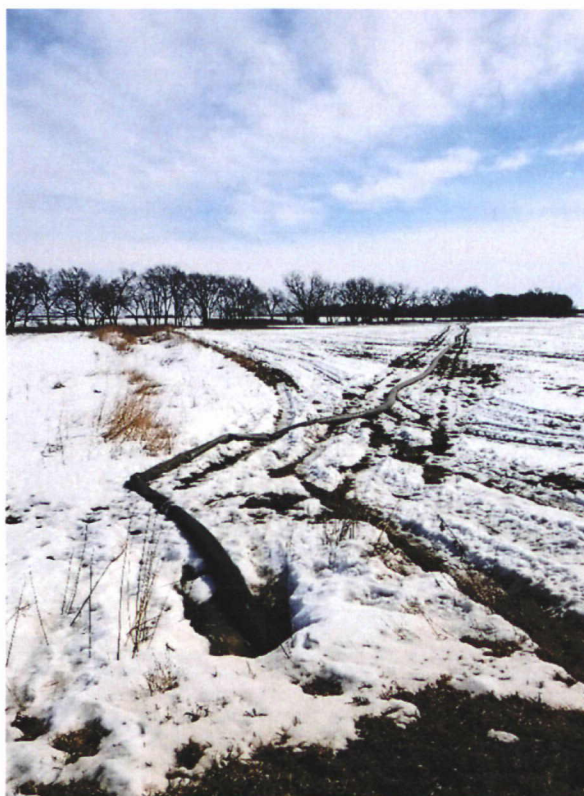
Photo was taken looking east at the culvert and hose on the west side of Road 8. The hose is visible running east.

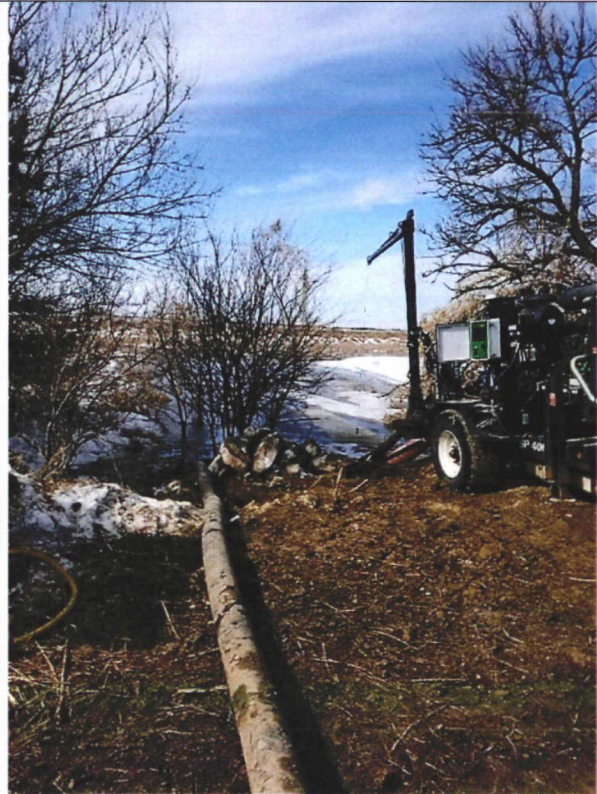
**STOP 5 – UN-L Eastern Extension – North
of County Roads 9 & J**

Photo taken looking at the west side of Road 9 near the culvert. A PTO-driven pump and hose was actively pumping water from this location during my observation. Slightly turbid water was flowing into this ponded area from the west under the ice. Mr. Ken Peterson was at the site.

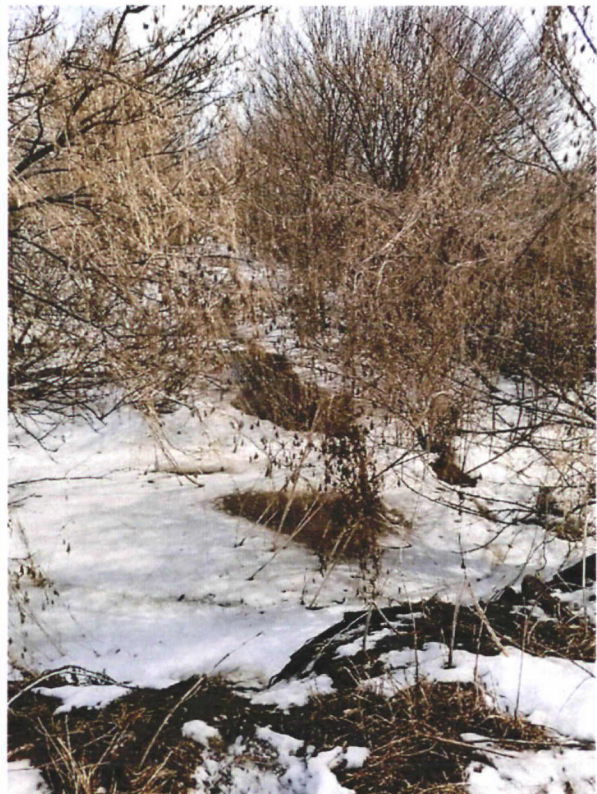
Photo shows the creek on the east side of Road 9. There was no visible water and the creek was snow covered. A Clean Harbors truck pulled up to the site as I was leaving.
