PCS 84069

Daily Observation Form – PM REPORT
AltEn LLC – Mead, NE Release
Facility ID: 84069; State Spill Report Number: 021221-NH-845
Date: February 26, 2021
Weather: Clear and sunny, 45 °F

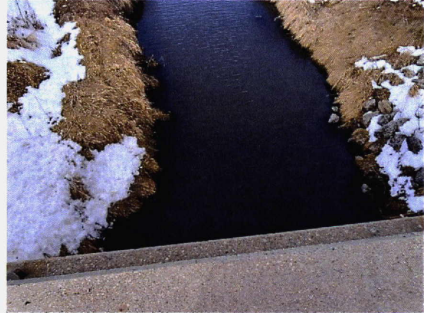
STOP 1 – Hwy 66 West of Ashland Gun Club
41.0886323, -96.380274
Time: 1407

Water is flowing at this location.

No suspect/obvious odor noted. No obvious signs of contamination (visual and/or olfactory) observed in water or on banks

No active work was observed at the time of the site visit.

Photo Direction: Looking north.

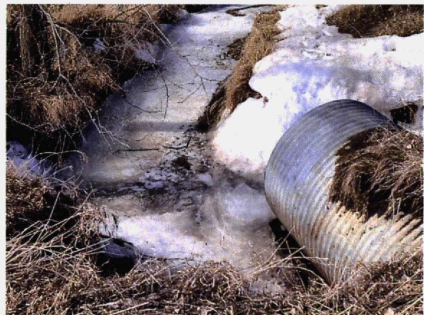
STOP 2 – North of the intersection of County Roads 6 & F
41.1334626, -96.4064519
Time: 1425

No visible water flow on the west side at this location. Ice, snow cover, and surface melt observed at this location

No suspect/obvious odor noted. Yellowish discoloration observed at surface.

No active work was observed at the time of the site visit.

Photo Direction: Looking northwest.

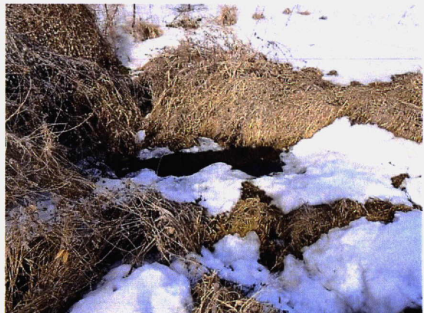
STOP 2 – North of the intersection of County Roads 6 & F
41.1334626, -96.4064519
Time: 1425

Standing water (no visible water flow) on the east side at this location. Ice, snow cover, and surface melt observed at this location

No obvious signs of contamination (visual and/or olfactory) observed.

No active work was observed at the time of the site visit.

Photo Direction: Looking north.

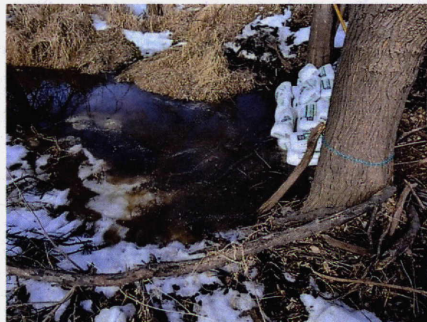
STOP 3 – Road 7/Hwy 66

Obvious signs of contamination (visual and/or olfactory) observed on the west side of Stop 3 in water. Pooled water observed at this location.

No active work was observed on the west side at the Stop 3 at the time of the site visit.

Photo Direction: Looking northwest.

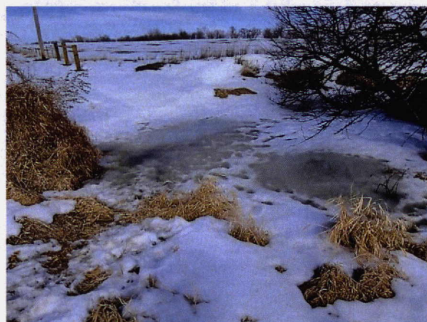
STOP 3 – Road 7/Hwy 66: East Side

Obvious signs of contamination (visual and/or olfactory) observed on the east side of Stop 3 in water and on sides of penetration.

No active work was observed on the east side at the Stop 3 at the time of the site visit.

Photo Direction: Looking north.

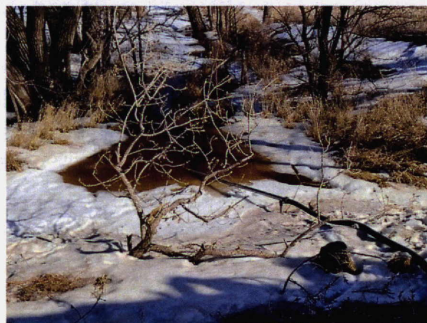
STOP 4 – County Road 8, North of Road H

Obvious signs of contamination (visual and/or olfactory) observed in water on the east side at this location.

Prairie Industrial Group crew recovering impacted material from drainageway with a vacuum truck. Material is being transported to AltEn's lagoon system for disposal.

Photo Direction: Looking east.

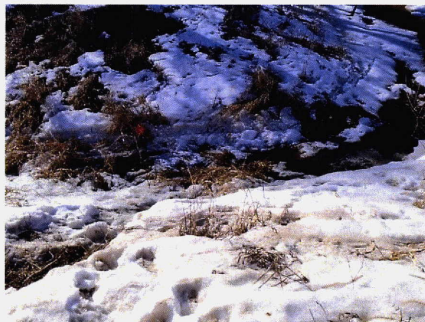
STOP 4 – County Road 8, North of Road H

Obvious signs of contamination (visual and/or olfactory) observed in water on the west side at this location.

Photo Direction: Looking west.

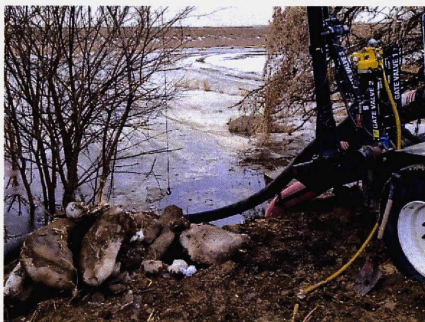
STOP 5 – UNL Eastern Extension – North of County Roads 9 & J

Obvious signs of contamination (visual and/or olfactory) observed on the west side of Stop 5.

Pumping of impacted material active during this visit.

Photo Direction: Looking northwest.

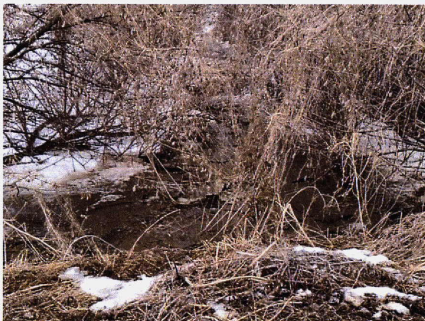
STOP 5 – UNL Eastern Extension – North of County Roads 9 & J

Obvious signs of contamination (visual and/or olfactory) observed on the east side of Stop 5.

Photo Direction: Looking east.

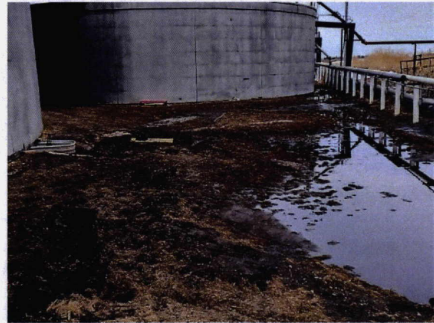
**STOP 6 – AltEn LLC Facility – East Side of
Digester 1**

Obvious signs of contamination (visual and/or olfactory) observed on the east side of Digester 1.

No active work was observed at the Stop 6 at the time of the site visit.

Photo Direction: Looking north.

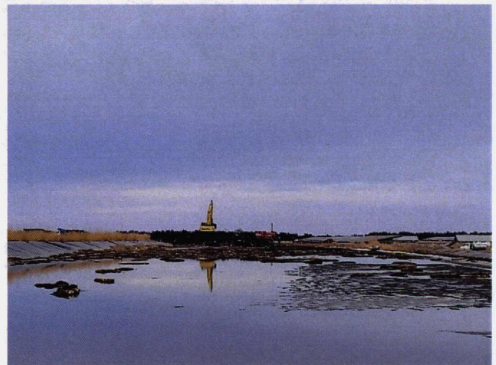
**STOP 6 – AltEn LLC Facility – Impacted
Material Disposal Site: South Lagoon**

Impacted material stockpiled at northeast corner of AltEn's lagoon.

Photo Direction: Looking east.

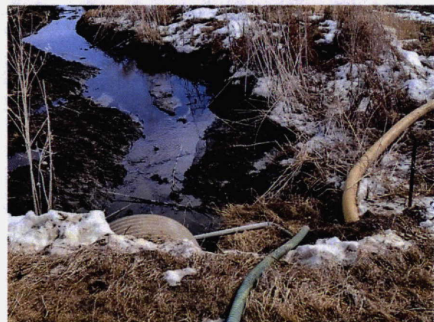
**Between Stop 4 and Stop 5 – UNL Eastern
Extension – Southeast of County Roads 9
& J**

Clean Harbors crew recovering impacted material from drainageway with a vacuum truck. Material is being transported to AltEn's lagoon system for disposal.

Photo Direction: Looking south.

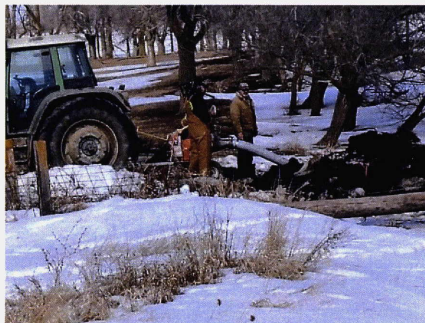
Between Stop 3 and Stop 4 – Hwy 66, East of Road 8

Soil berm placed within drainageway on the north side of Hwy 66.

Pumping of impacted material active during this visit.

Photo Direction: Looking north.

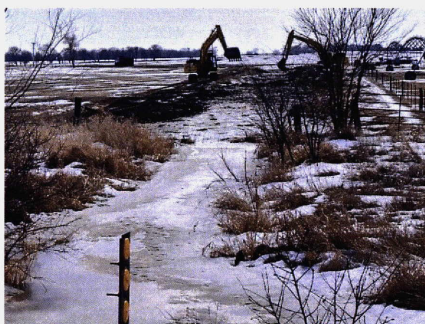
Between Stop 3 and Stop 4 – Hwy 66, East of Road 8

Heimes Corporation crew removing impacted material from drainageway south of Hwy 66 (generally northwest of Stop 3). Removed material is being loaded into dump trucks for disposal in AltEn's lagoon system.

Photo Direction: Looking south.

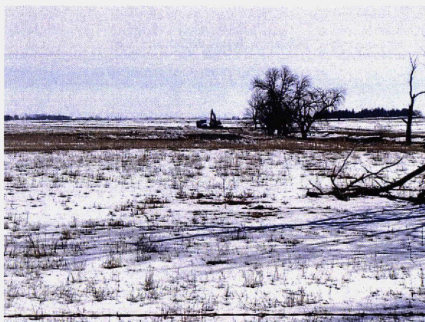
Between Stop 3 and Stop 4 –County Road H Between Roads 7 & 8

Heimes Corporation crew removing impacted material from drainageway on the south side of Road H. Removed material is being loaded into dump trucks for disposal in AltEn's lagoon.

Clean Harbors crew recovering impacted material from drainageway with a vacuum truck. Material is being transported to AltEn's lagoon system for disposal.

Photo Direction: Looking south.
