Daily Observation Form – AM REPORT
 AltEn LLC – Mead, NE Release
 Facility ID: 84069; State Spill Report Number: 021221-NH-845
 Date: February 28, 2021
 Weather: Cloudy and Windy, 36 °F

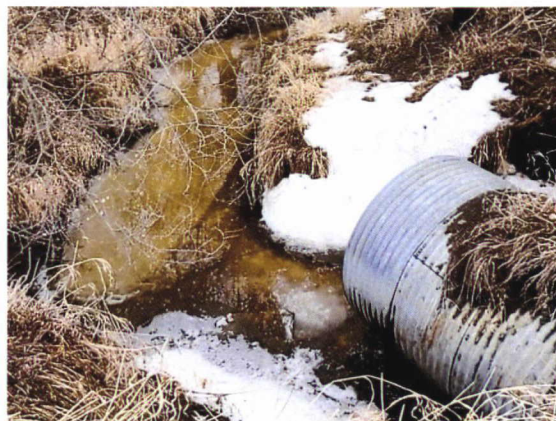
STOP 2 – North of the intersection of County Roads 6 & F
41.1334626, -96.4064519
 Time: 0856

No suspect/obvious odor noted. Obvious signs of contamination (visual) observed on the west side in water.

Flow (audible and/or visual) observed at this location.

No active work was observed at the time of the site visit.

Photo Direction: Looking northwest.

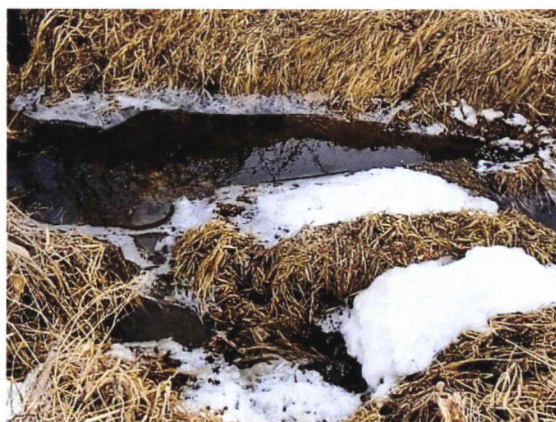
STOP 2 – North of the intersection of County Roads 6 & F
41.1334626, -96.4064519
 Time: 0858

No suspect/obvious odor noted. Obvious signs of contamination (visual) observed on the east side in water.

Flow (audible and/or visual) observed at this location.

No active work was observed at the time of the site visit.

Photo Direction: Looking north.

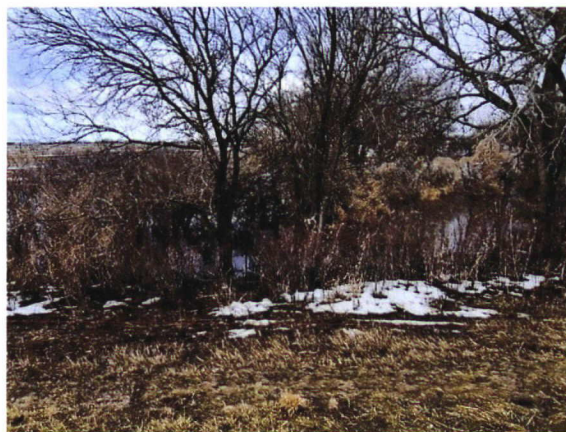
STOP 3 – Road 7/Hwy 66

Obvious signs of contamination (visual and/or olfactory) observed on the west side of Stop 3 in water. Water pooling at this location. The sandbags associated with the culvert plug/balloon are submerged. No flow (audible and/or visual) observed at this location.

No active work was observed on the west side of the Stop 3 location at the time of the site visit.

Photo Direction: Looking west.

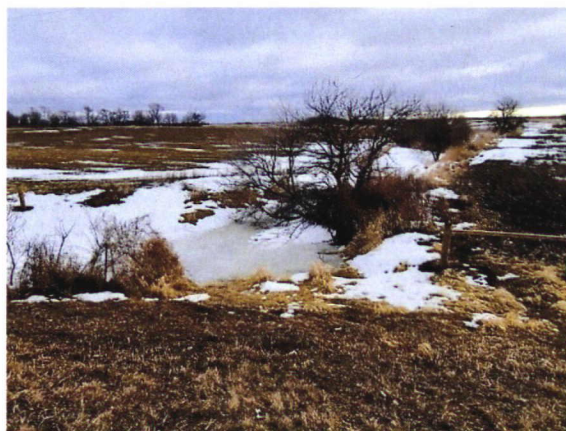
STOP 3 – Road 7/Hwy 66

Obvious signs of contamination (visual and/or olfactory) observed on the east side of Stop 3. Area around the culvert at this location is ice covered. No flow (audible and/or visual) observed at this location.

No active work was observed on the east side of the Stop 3 location at the time of the site visit.

Photo Direction: Looking north.

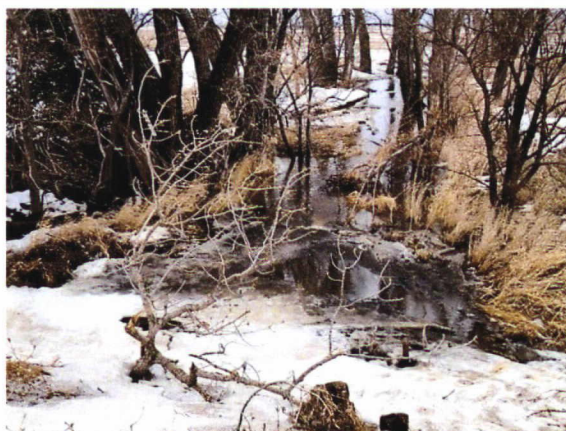
STOP 4 – County Road 8, North of Road H

Obvious signs of contamination (visual and/or olfactory) observed in water on the east side at this location. Observed flow at this location.

No active work was observed at the time of the site visit.

Photo Direction: Looking east.

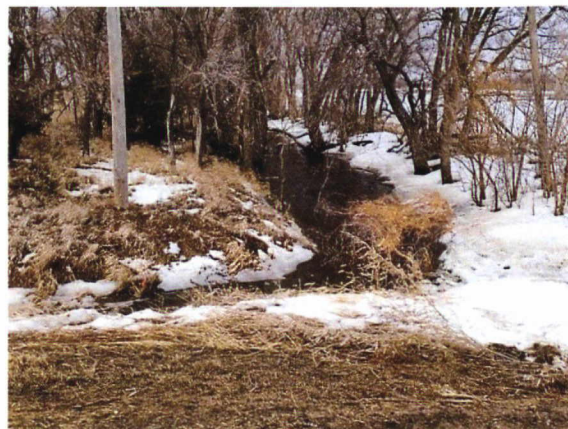
STOP 4 – County Road 8, North of Road H
GPS: 41.1677657, -96.4447025
Time: 0923

Obvious signs of contamination (visual and/or olfactory) observed in water on the west side at this location. Observed flow at this location.

No active work was observed at the time of the site visit.

Photo Direction: Looking west.

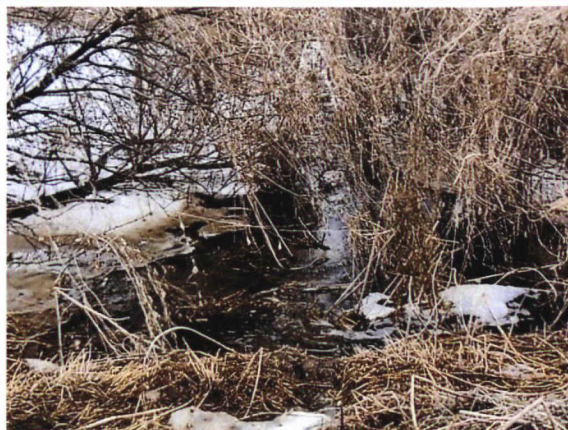
STOP 5 – UNL Eastern Extension – North of County Roads 9 & J
GPS: 41.1862613, -96.4638642
Time: 0935

Obvious signs of contamination (visual and/or olfactory) observed on the east side of Stop 5.

Observed flow from adjacent fields and west side through culvert coming into the area.

Photo Direction: Looking east.

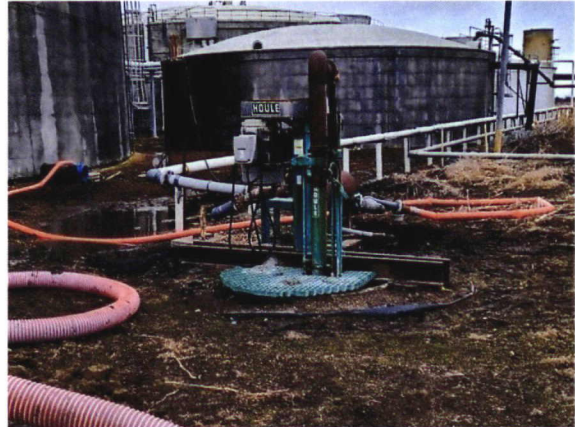
**STOP 6 – AltEn LLC Facility – East Side of
Digester 1**

Obvious signs of contamination (visual and/or olfactory) observed on the east side of Digester 1.

Pump proximal to the south lagoon connected to Digester 1 was inactive at the time of the site visit.

Photo Direction: Looking northwest.

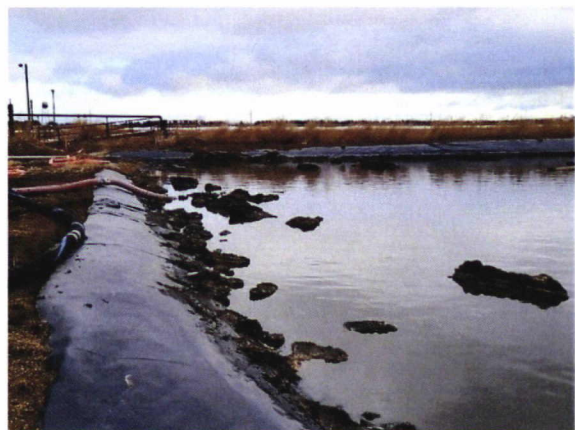
**STOP 6 – AltEn LLC Facility – Impacted
Material Disposal Site: South Lagoon**

Impacted material within AltEn's lagoon.

Photo Direction: Looking north.

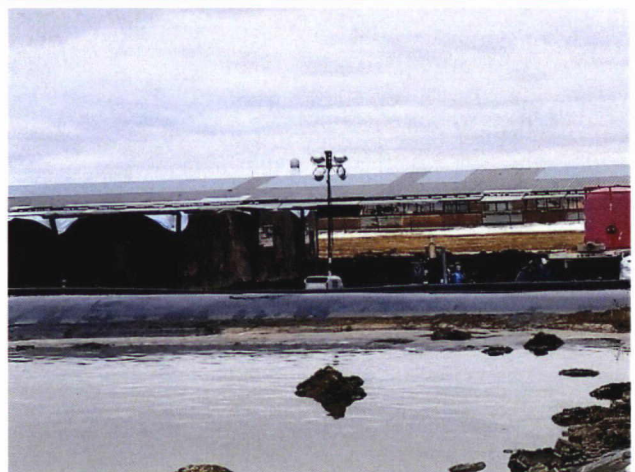
**STOP 6 – AltEn LLC Facility – South of
Emergency Lagoon**

Constructed holding tank associated with treatment vessels located south of the lagoon.

Photo Direction: Looking south.

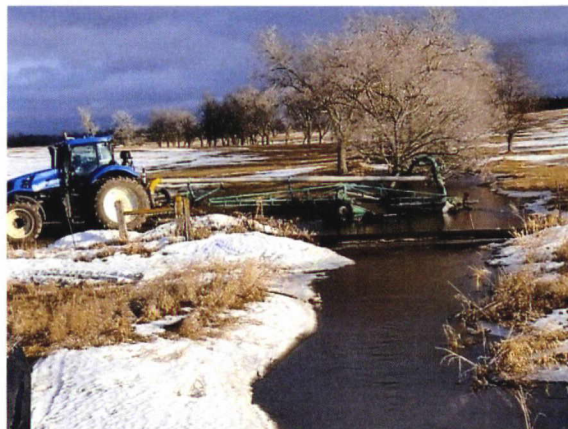
Between Stop 3 and Stop 4 – Hwy 66, East of Road 8

Obvious signs of contamination (visual and/or olfactory) observed on the north side of Hwy 66. Flow observed at this location

Soil berm placed within drainageway on the north side of Hwy 66 no longer visible.

Pumping of impacted material inactive during this visit.

Photo Direction: Looking north.

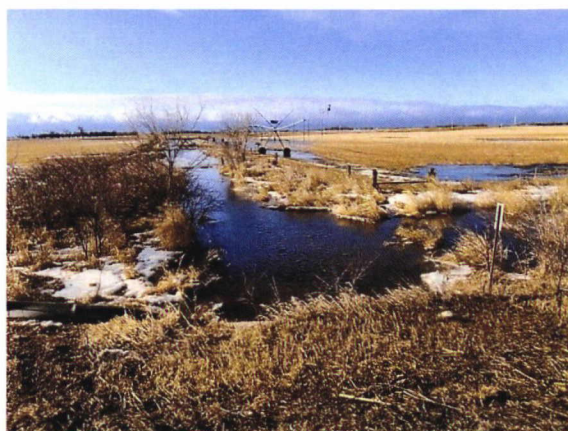
Between Stop 3 and Stop 4 – Hwy 66, East of Road 8

Obvious signs of contamination (visual and/or olfactory) observed on the south side of Hwy 66. Flow observed at this location.

Photo Direction: Looking south.

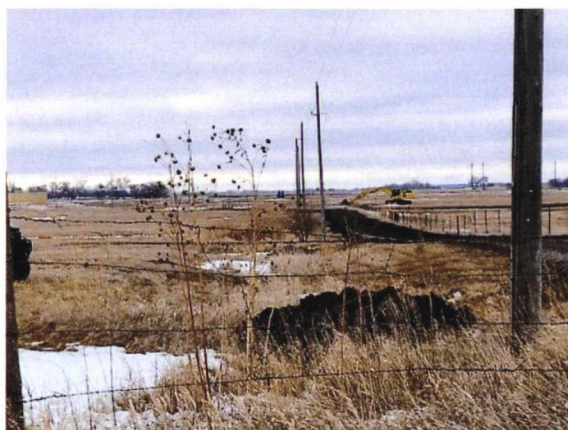
Between Stop 3 and Stop 4 – County Road H Between Roads 7 & 8

Heimes Corporation equipment inactive south of County Road H.

Photo Direction: Looking south.

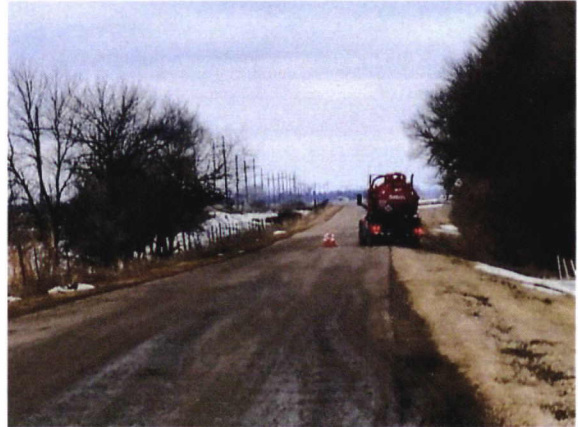
**Between Stop 3 and Stop 4 – County Road
H Between Roads 7 & 8
GPS: 41.161258, -96.437785
Time: 0915**

Vacuum truck staged at this location. Vacuum
truck inactive at time of visit.

Photo Direction: Looking west.
