Daily Observation Form – DAILY REPORT
AltEn LLC – Mead, NE Release
Facility ID: 84069; State Spill Report Number: 021221-NH-845
Date: March 3, 2021
Weather: Clear and Sunny, 63 °F

Terracon

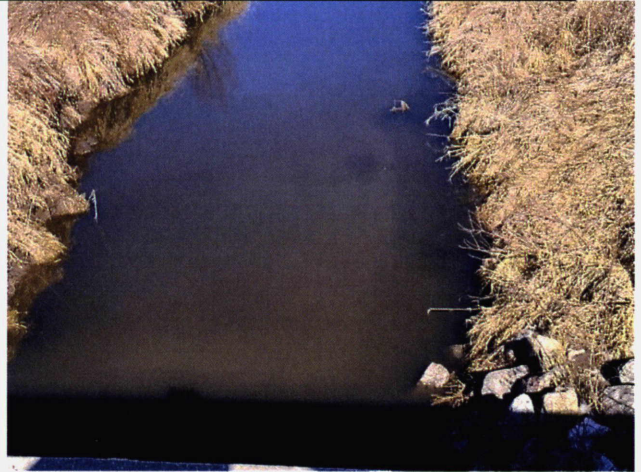
STOP 1 – Hwy 66 West of Ashland Gun Club
41.0886323, -96.380274
Time: 1126

Water is flowing at this location.

No suspect/obvious odor noted. No obvious visual signs of contamination observed at surface or on banks.

No active work was observed at the time of the site visit.

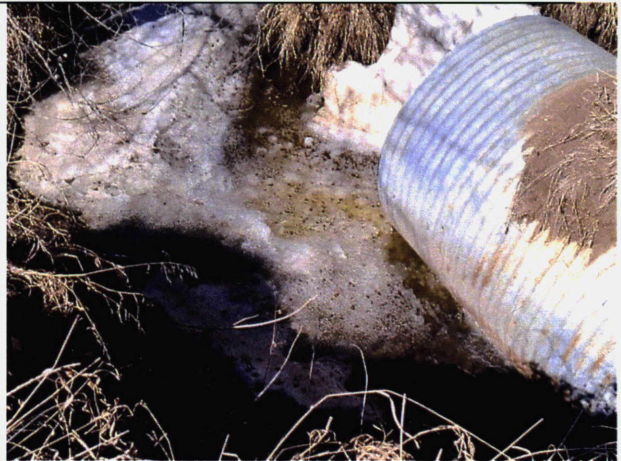
STOP 2 – North of the intersection of County Roads 6 & F
41.1334626, -96.4064519
Time: 1141

No suspect/obvious odor noted. Yellowish discoloration observed on the west side at surface near culvert opening.

Flow (audible) observed at this location.

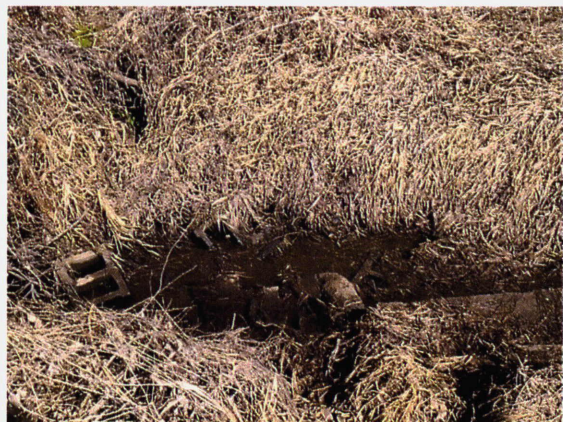
STOP 2 – North of the intersection of County Roads 6 & F
41.1334626, -96.4064519
Time: 1143

No suspect/obvious odor noted. Yellowish-brown discoloration observed on the east side at surface.

Flow (audible and visual) observed at this location.

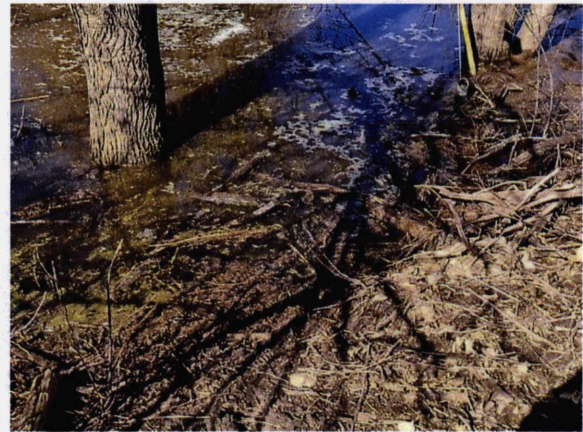
STOP 3 – Road 7/Hwy 66

Yellowish-brown discoloration and a slight odor observed on the west side of Stop 3. Water pooling at this location. No flow (audible and visual) observed at this location.

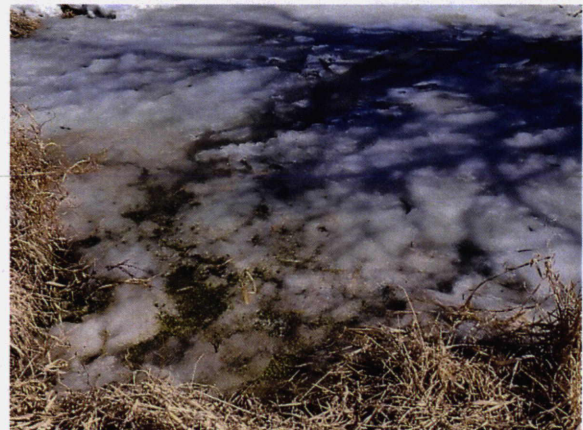
STOP 3 – Road 7/Hwy 66

Yellowish discoloration observed on the east side of Stop 3. No suspect/obvious odor noted. No flow (audible or visual) observed at this location.

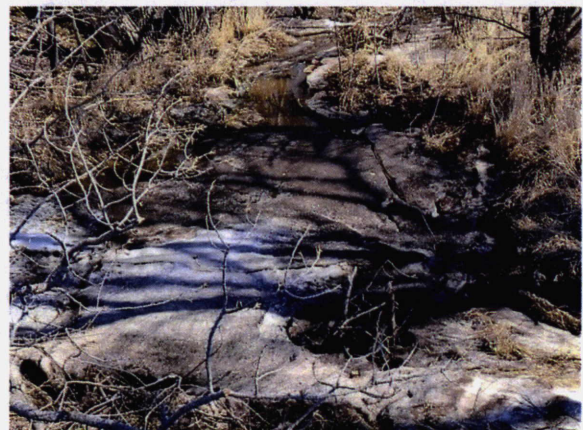
STOP 4 – County Road 8, North of Road H

Yellowish-brown discoloration observed at surface on the east side at this location. No suspect/obvious odor noted. Flow (audible and visual) observed at this location. Observed flow from adjacent fields coming into the area.

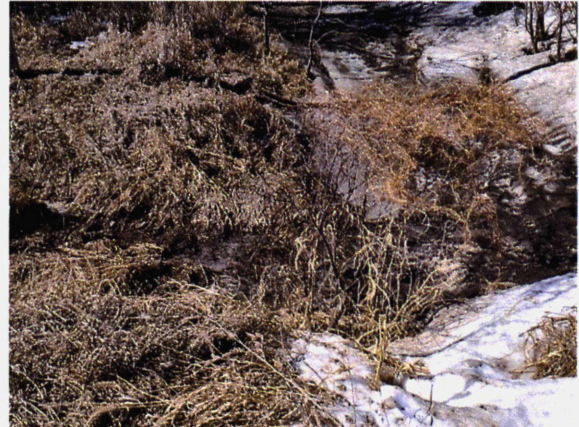
STOP 4 – County Road 8, North of Road H
GPS: 41.1677657, -96.4447025
Time: 1208

Yellowish-brown discoloration observed at surface on the west side at this location. No suspect/obvious odor noted. Flow (audible and visual) observed at this location. Observed flow from adjacent fields coming into the area.

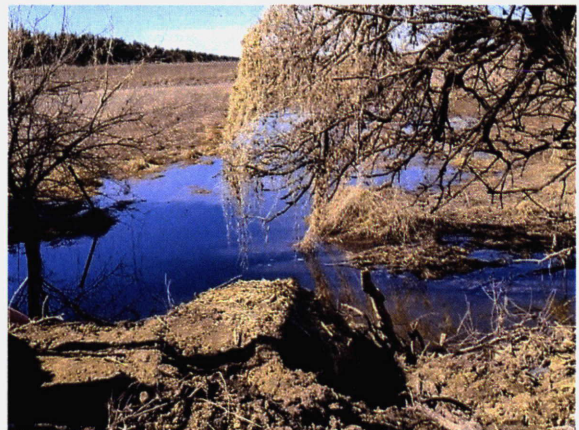
STOP 5 – UNL Eastern Extension – North of County Roads 9 & J
GPS: 41.1862613, -96.4638642
Time: 1220

Yellowish-brown discoloration observed on the west side of Stop 5 at surface. Moderate odor noted at this location.

No flow (audible or visual) observed at this location.

Pumping of impacted material inactive during this site visit.

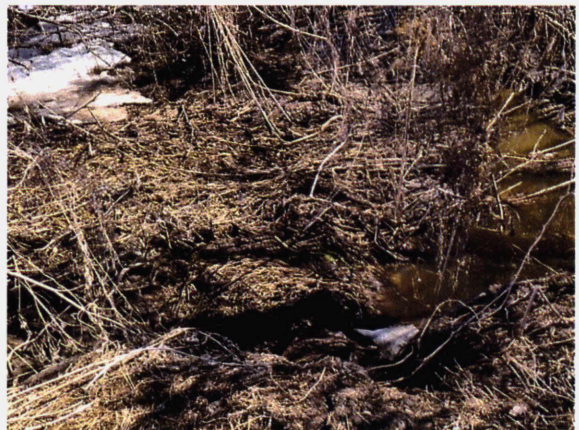
STOP 5 – UNL Eastern Extension – North of County Roads 9 & J
GPS: 41.1862613, -96.4638642
Time: 1226

Yellowish-brown discoloration observed on the east side of Stop 5 at surface. Slight odor noted at this location.

No flow (audible or visual) observed at this location.

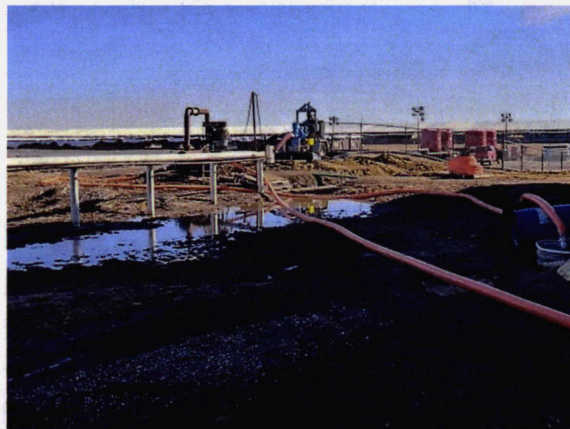
STOP 6 – AltEn LLC Facility – East Side of Digester 1

Yellowish-brown discoloration observed on the east side of Digester 1.

Strong odor noted at this location.

Pump proximal to the south lagoon connected to Digester 1 active at the time of this visit.

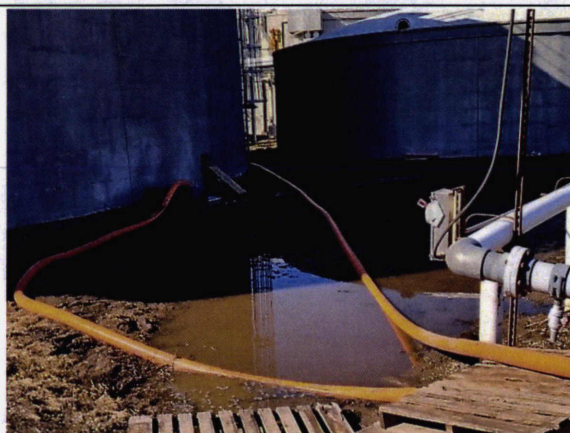
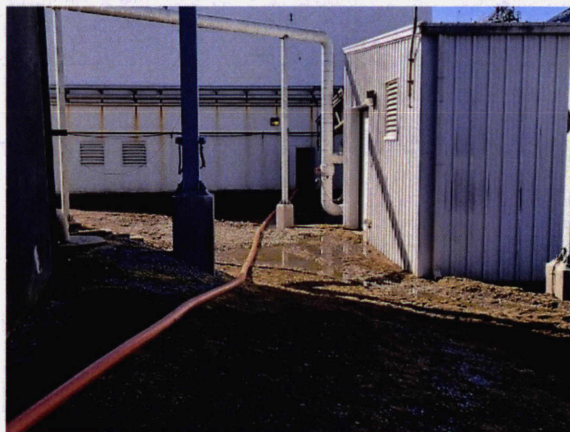
STOP 6 – AltEn LLC Facility – East Side of Digester 1

Pump proximal to the south lagoon connected to Digester 1 active at the time of this visit.

During this visit Terracon observed a second hose connected to the above referenced pump. The hose ran to the north of Digester 1 continuing into the open doorway of the building to the northwest of Digester 1.

According to a phone conversation with Ken Peterson (AltEn Facility Manager), this hose is moving lagoon material into AltEn's preclarifier continuing through the facility's filtration system and emptying into the constructed holding tank east of Clean Harbor's filtration system at the south side of the lagoon. Ken went on to say AltEn has been given permission by NDEE to do this

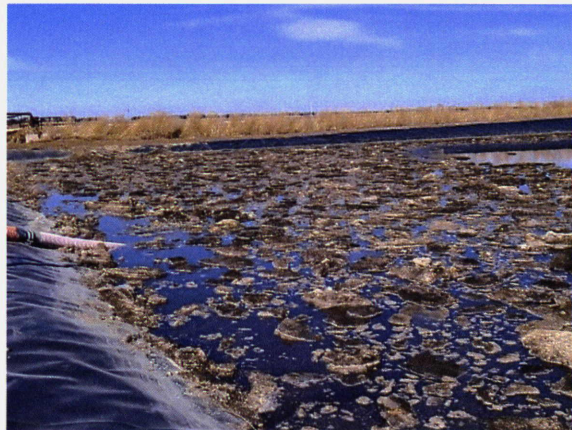
**STOP 6 – AltEn LLC Facility – Impacted
Material Disposal Site: South Lagoon**
GPS: 41.195558, -96.473923
Time: 1450

Impacted material within AltEn's lagoon.

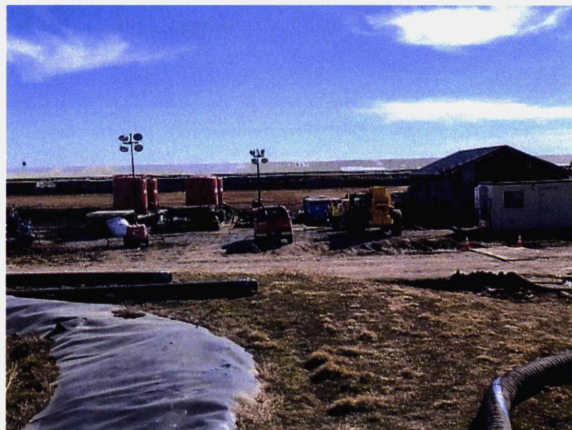
**STOP 6 – AltEn LLC Facility – South of
Emergency Lagoon**
GPS: 41.19470, -96.47611
Time: 1600

Treatment vessels located south of the lagoon.

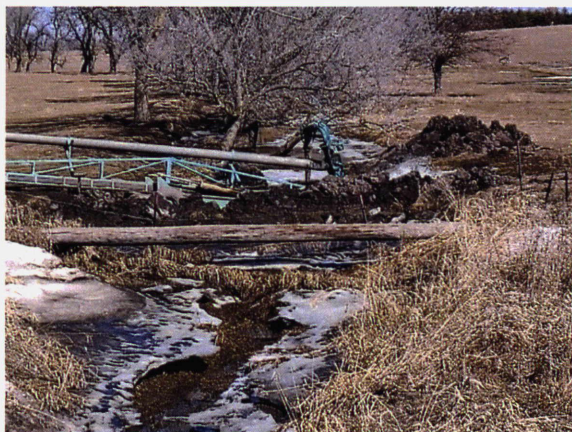
**Between Stop 3 and Stop 4 – Hwy 66, East
of Road 8**
GPS: 41.1464807, -96.4324881
Time: 1100

Yellowish-brown discoloration observed on the north side of Hwy 66 at surface.

No suspect/obvious odor noted.

Flow (visual) observed at this location.

Soil berm in place during time of this visit. Air compressor and pump active at the time of the site visit.

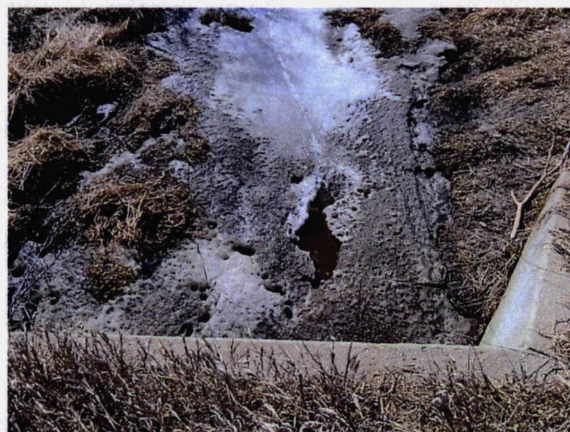
Between Stop 3 and Stop 4 – Hwy 66, East of Road 8

Yellowish discoloration observed on the south side of Hwy 66 at surface.

Slight odor noted at this location.

Flow (audible) observed at this location.

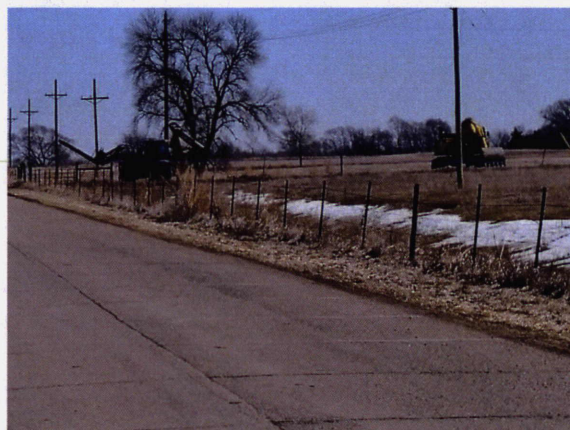
Between Stop 3 and Stop 4 – County Road H Between Roads 7 & 8

Heimes Corporation loading ground pads onto flatbed trailer. Excavator remains at location.

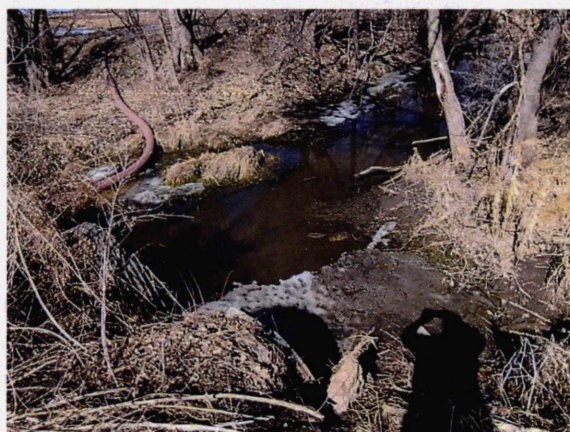
Between Stop 3 and Stop 4 – County Road H Between Roads 7 & 8

Yellowish-brown discoloration observed on the north side of County Road H. Slight odor noted at this location.

Flow (audible and visual) observed at this location.

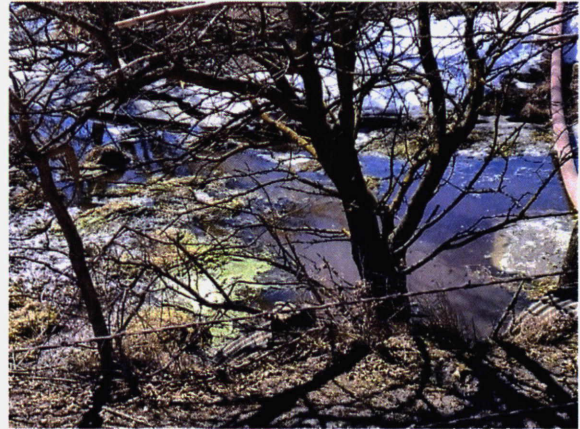
**Between Stop 3 and Stop 4 – County Road
H Between Roads 7 & 8**
GPS: 41.161258, -96.437785
Time: 1202

Yellowish-brown discoloration observed on the south side of County Road H. Slight odor noted at this location.

Flow (audible and visual) observed at this location.

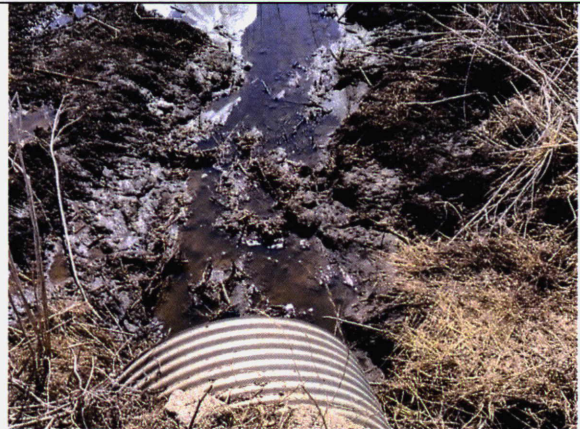
**Between Stop 4 and Stop 5 – UNL Eastern
Extension – Southeast of County Roads 9
& J**
GPS: 41.1850660, -96.4616990
Time: 1215

Yellowish discoloration observed on the south side of County Road J. Slight odor noted at this location.

Flow (audible and visual) observed at this location.

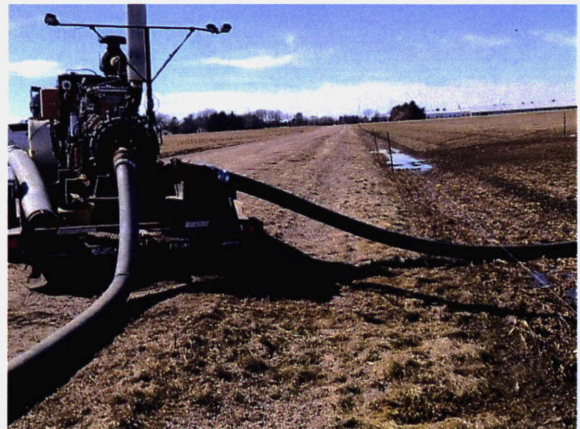
**Between Stop 4 and Stop 5 – County Road
I Between Roads 8 & 9**
GPS: 41.175810, -96.460914
Time: 1400

During the sampling activities between Stop 3 and Stop 4 – Hwy 66, East of Road 8, informed by University of Nebraska personnel the booster pump located between Stop 4 and Stop 5 was leaking from the hose connection(s).

Leaking connections were not observed at the time of the site visit. A pool of liquid can be seen in the background.

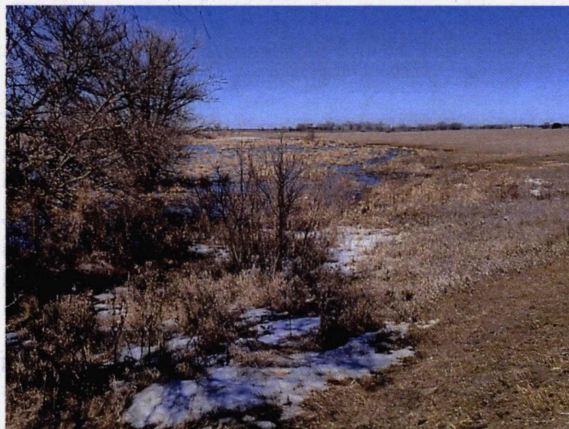
STOP 3 – Road 7/Hwy 66
41.1388323, -96.4257571
Time: 1112

Observation of water pooling on west side of
Stop 3 advancing to the north.

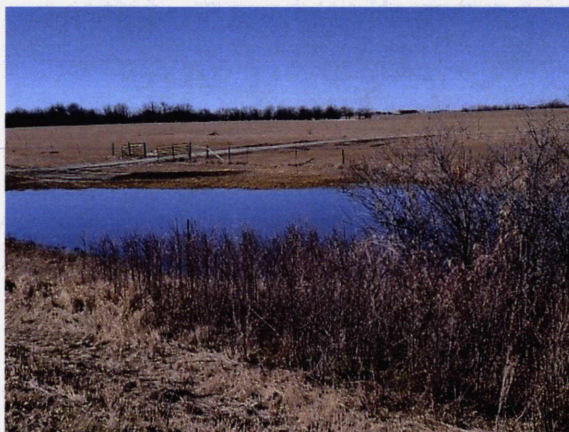
STOP 3 – Road 7/Hwy 66
41.1388323, -96.4257571
Time: 1115

Observation of water pooling on west side of
Stop 3 advancing to the south.

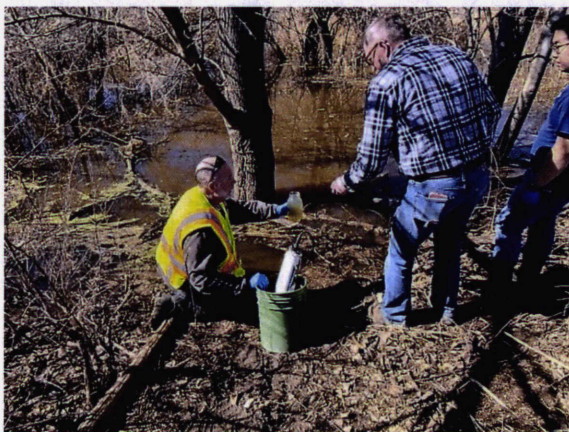
STOP 3 – Road 7/Hwy 66
41.1388323, -96.4257571
Time: 1305

Ken Peterson (AltEn Facility Manager), Chad Yang (AltEn Laboratory Manager), and Dave Bubb (NDEE) collecting sample on west side of Stop 3. Mr. Bubb filled the sample containers at this location and transferred the samples to AltEn.

Photo Direction: Looking west.

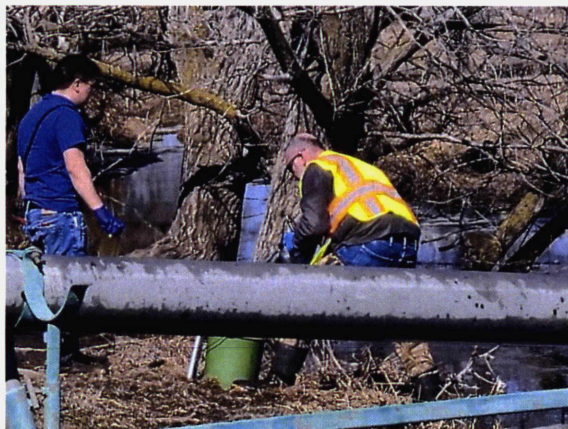
Between Stop 3 and Stop 4 – Hwy 66, East of Road 8

Chad Yang (AltEn Laboratory Manager) and Dave Bubb (NDEE) collecting sample on north side of Hwy 66. Mr. Bubb filled the sample containers at this location and transferred the samples to AltEn.

Photo Direction: Looking north.

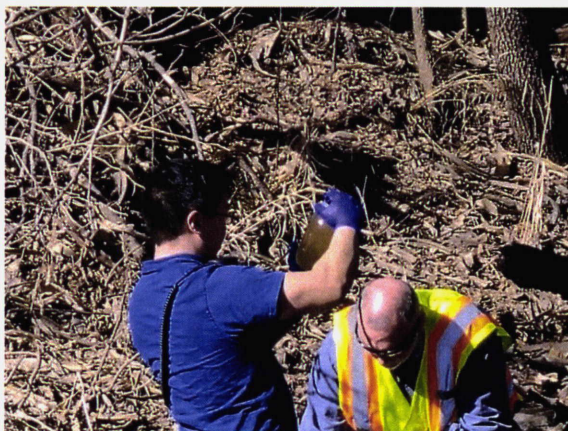
Between Stop 3 and Stop 4 – County Road H Between Roads 7 & 8

Chad Yang (AltEn Laboratory Manager) and Dave Bubb (NDEE) collecting sample on north side of County Road H. AltEn filled the sample containers at this location.

Photo Direction: Looking northwest.

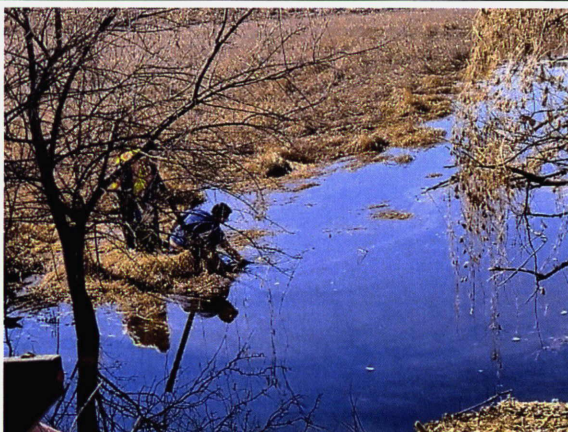
STOP 5 – UNL Eastern Extension – North of County Roads 9 & J

Chad Yang (AltEn Laboratory Manager) and Dave Bubb (NDEE) collecting sample on west side of Stop 5. AltEn filled the sample containers at this location.

Photo Direction: Looking west.

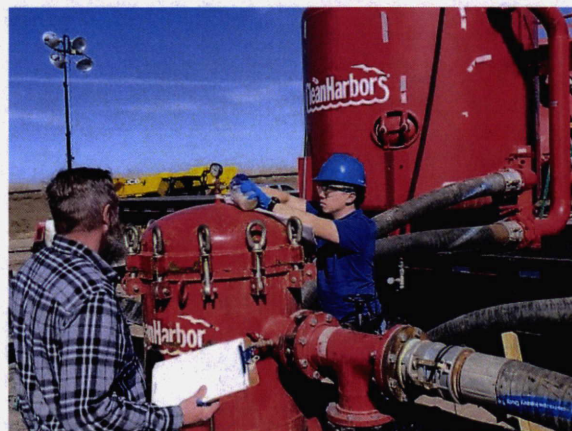
Ken Peterson (AltEn Facility Manager) and
Chad Yang (AltEn Laboratory Manager)
collecting sample of influent material entering
treatment vessels located proximal to Stop 6.
AltEn filled the sample containers at this
location.

Photo Direction: Looking northeast.
