Daily Observation Form – DAILY REPORT
 AltEn LLC – Mead, NE Release
 Facility ID: 84069; State Spill Report Number: 021221-NH-845
 Date: March 2, 2021
 Weather: Clear and Sunny with Strong Winds, 57 °F

Terracon

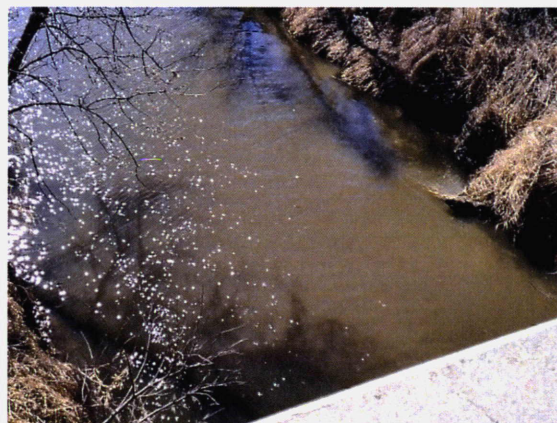
STOP 1 – Hwy 66 West of Ashland Gun Club
41.0886323, -96.380274
 Time: 1246

Water is flowing at this location.

No suspect/obvious odor noted. No obvious visual signs of contamination observed at surface or on banks.

No active work was observed at the time of the site visit.

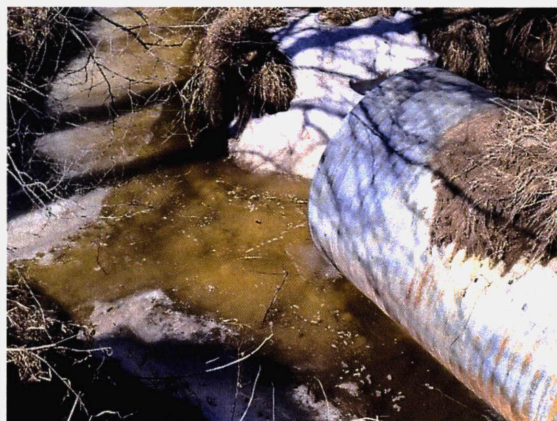
STOP 2 – North of the intersection of County Roads 6 & F
41.1334626, -96.4064519
 Time: 1304

No suspect/obvious odor noted. Yellowish discoloration observed on the west side at surface.

Flow (audible) observed at this location.

No active work was observed at the time of the site visit.

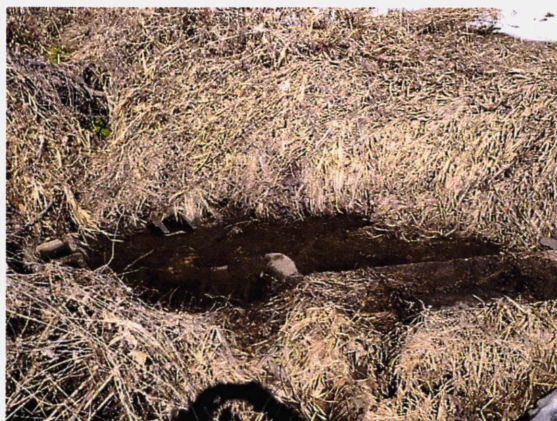
STOP 2 – North of the intersection of County Roads 6 & F
41.1334626, -96.4064519
 Time: 1307

No suspect/obvious odor noted. Yellowish-brown discoloration observed on the east side at surface.

Flow (audible and visual) observed at this location.

No active work was observed at the time of the site visit.

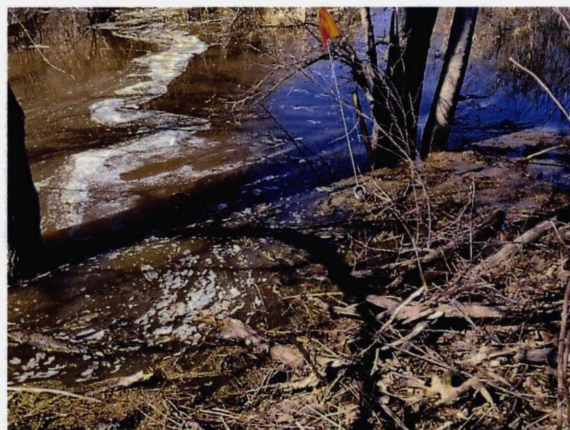
STOP 3 – Road 7/Hwy 66
41.1388323, -96.4257571
Time: 1226

Yellowish-brown discoloration and a slight odor observed on the west side of Stop 3. Water pooling at this location. No flow (audible and visual) observed at this location.

No active work was observed on the west side of the Stop 3 location at the time of the site visit.

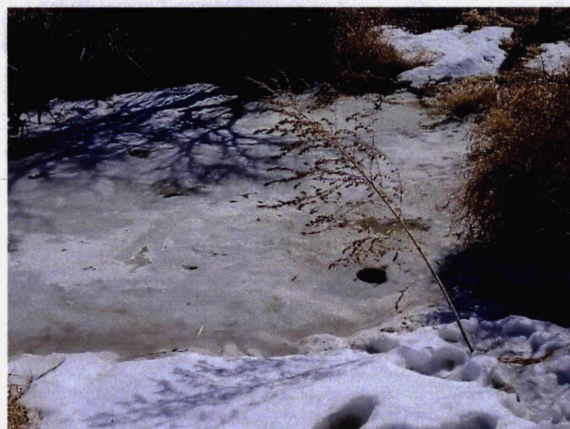
STOP 3 – Road 7/Hwy 66
41.1388323, -96.4257571
Time: 1229

Yellowish discoloration observed on the east side of Stop 3. No suspect/obvious odor noted. No flow (audible or visual) observed at this location.

No active work was observed on the east side of the Stop 3 location at the time of the site visit.

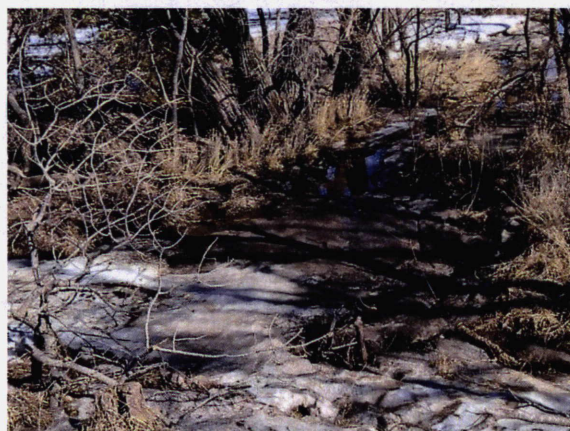
STOP 4 – County Road 8, North of Road H
GPS: 41.1677657, -96.4447025
Time: 1327

Yellowish-brown discoloration observed at surface on the east side at this location. No suspect/obvious odor noted. Observed flow from adjacent fields coming into the area.

No active work was observed at the time of the site visit.

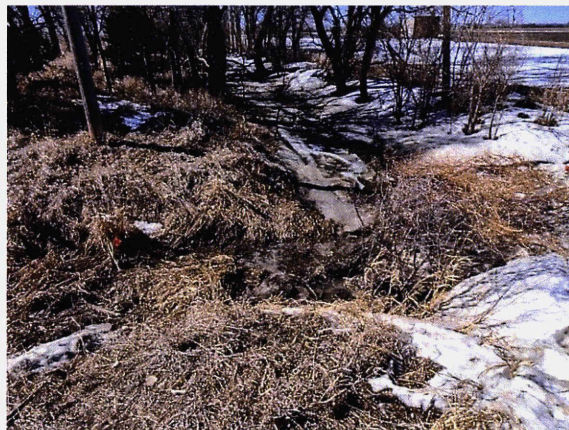
STOP 4 – County Road 8, North of Road H
GPS: 41.1677657, -96.4447025
Time: 1330

Yellowish-brown discoloration observed at surface on the west side at this location. No suspect/obvious odor noted. Observed flow from adjacent fields coming into the area.

No active work was observed at the time of the site visit.

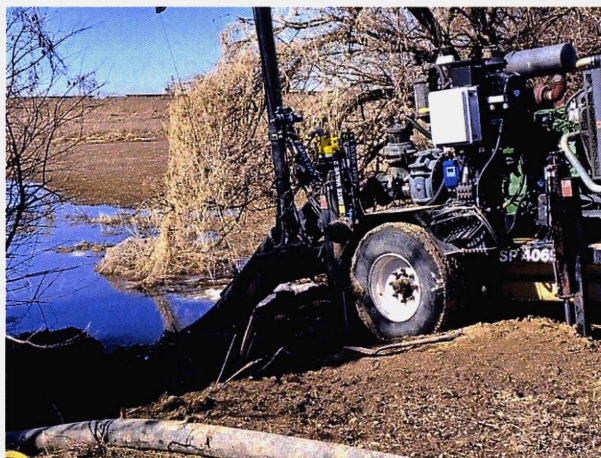
STOP 5 – UNL Eastern Extension – North of County Roads 9 & J
GPS: 41.1862613, -96.4638642
Time: 1352

Yellowish-brown discoloration observed on the west side of Stop 5 at surface. Moderate odor noted at this location. Pumping of impacted material active during this site visit.

Hose originating from the north side between Stop 3 and Stop 4 (Hwy 66, East of Road 8) was observed running parallel with hose from this location to the lagoon system as observed on March 1, 2021.

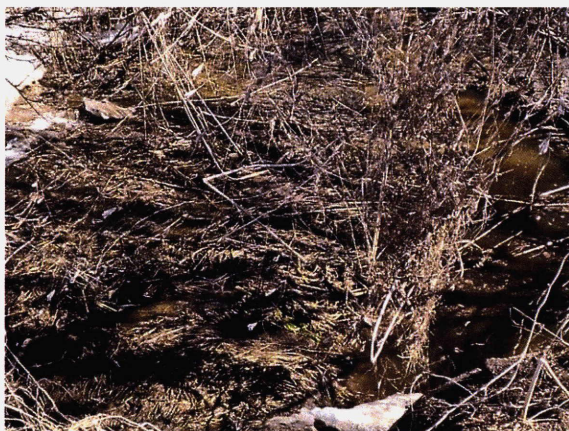
STOP 5 – UNL Eastern Extension – North of County Roads 9 & J
GPS: 41.1862613, -96.4638642
Time: 1355

Yellowish-brown discoloration observed on the east side of Stop 5 at surface. Slight odor noted at this location.

Observed flow from adjacent fields and through culvert coming into this area.

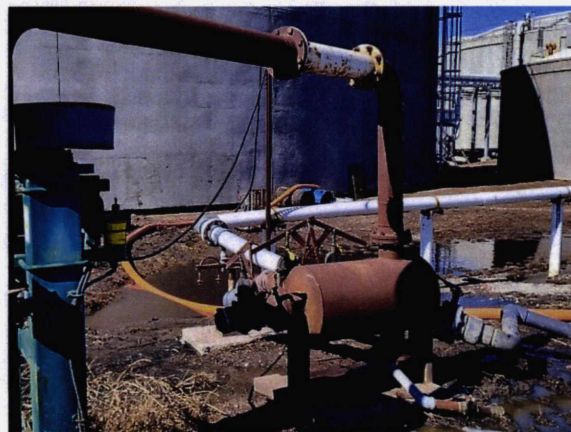
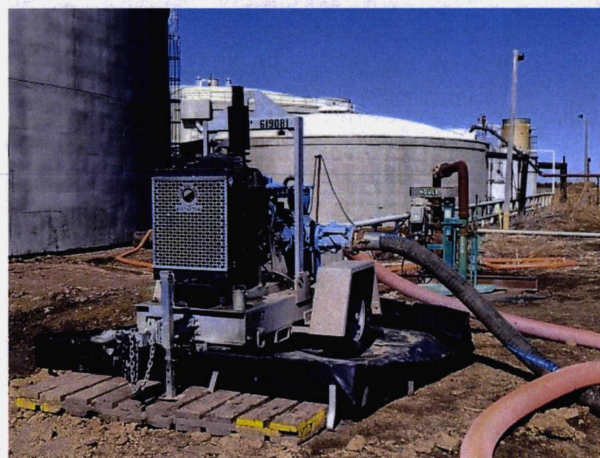
STOP 6 – AltEn LLC Facility – East Side of Digester 1

Yellowish-brown discoloration observed on the east side of Digester 1.

Pump proximal to the south lagoon connected to Digester 1 active at the time of this visit. According to a phone conversation with Ken Peterson (AltEn Facility Manager), the pump has been operating for the past two days with material from the lagoon being pumped into Digester 1.

Prior to this visit, Terracon noted the pump at this location was inactive due to the following observations: audible indications of pump operation were not observed as the noise from the pump was masked by the noise emitting from the adjacent pump associated with the treatment vessels located to the south (the pump for the treatment vessels was not operating at the time of this site visit); pump is self-contained and rotation of pump parts was not observed; and the associated hose was not completely filled and had little resistance when pressed.

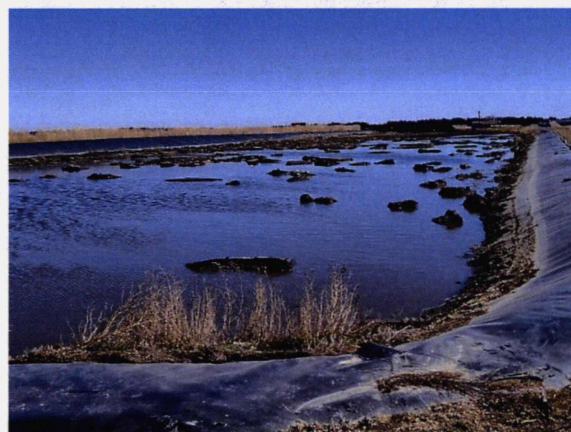
STOP 6 – AltEn LLC Facility – Impacted Material Disposal Site: South Lagoon

Impacted material within AltEn's lagoon.

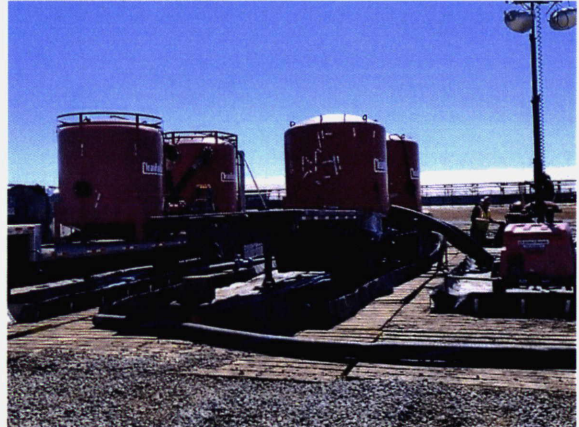
**STOP 6 – AltEn LLC Facility – South of
Emergency Lagoon**
GPS: 41.19470, -96.47611
Time: 1210

Treatment vessels associated with
constructed holding tank located south of the
lagoon.

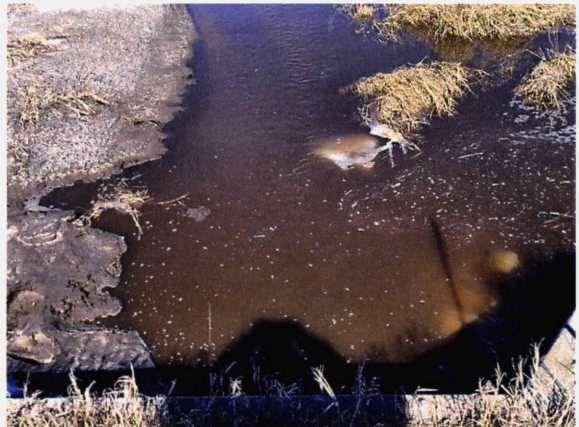
**Between Stop 3 and Stop 4 – Hwy 66, East
of Road 8**
GPS: 41.1464807, -96.4324881
Time: 1219

Yellowish-brown discoloration observed on
the north side of Hwy 66 at surface.

Slight odor noted at this location.

Flow (audible and visual) observed at this
location.

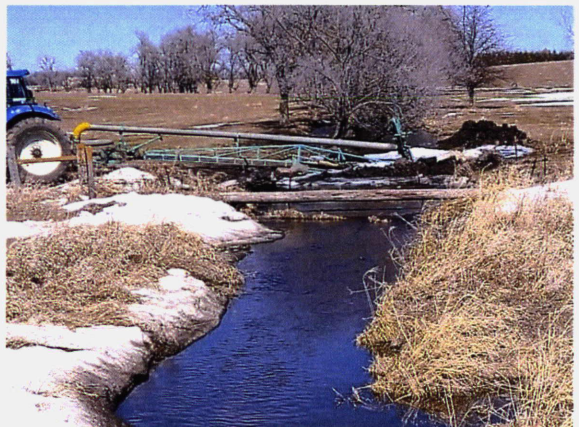
**Between Stop 3 and Stop 4 – Hwy 66, East
of Road 8**
GPS: 41.1464807, -96.4324881
Time: 1222

Pumping activities and soil berm on the north
side of Hwy 66.

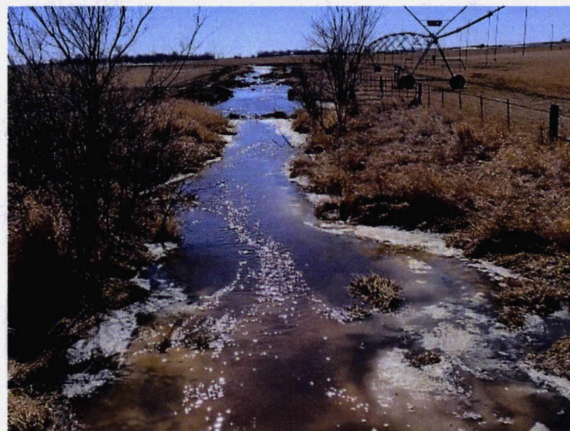
Between Stop 3 and Stop 4 – Hwy 66, East of Road 8

Yellowish discoloration observed on the south side of Hwy 66 at surface.

Slight odor noted at this location.

Flow (audible and visual) observed at this location.

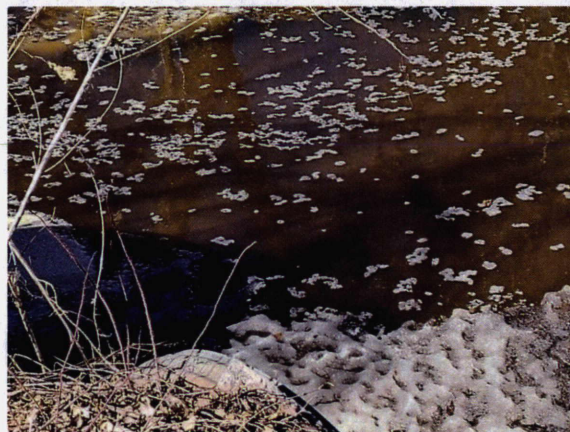
Between Stop 3 and Stop 4 – County Road H Between Roads 7 & 8

Yellowish-brown discoloration observed on the north side of County Road H. No suspect/obvious odor noted.

Flow (audible and visual) observed at this location.

No active work was observed at the time of the site visit.

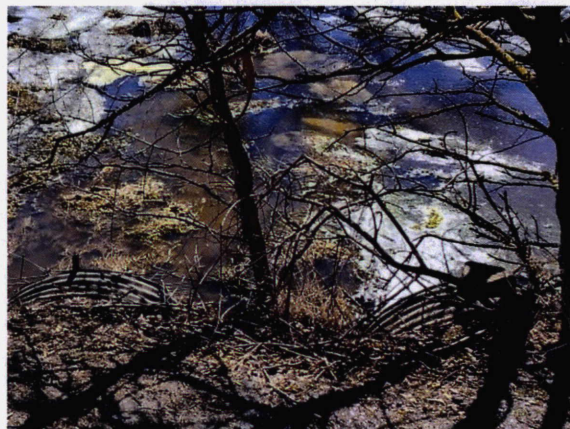
Between Stop 3 and Stop 4 – County Road H Between Roads 7 & 8

Yellowish-brown discoloration observed on the south side of County Road H. No suspect/obvious odor noted.

Flow (audible and visual) observed at this location.

No active work was observed at the time of the site visit.

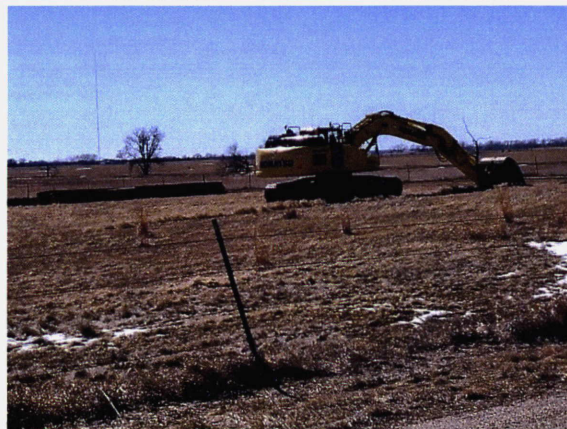
**Between Stop 3 and Stop 4 – County Road
H Between Roads 7 & 8**
GPS: 41.161258, -96.437785
Time: 1325

Observed Heimes equipment prepared for removal from location.

No active work was observed at the time of the site visit.

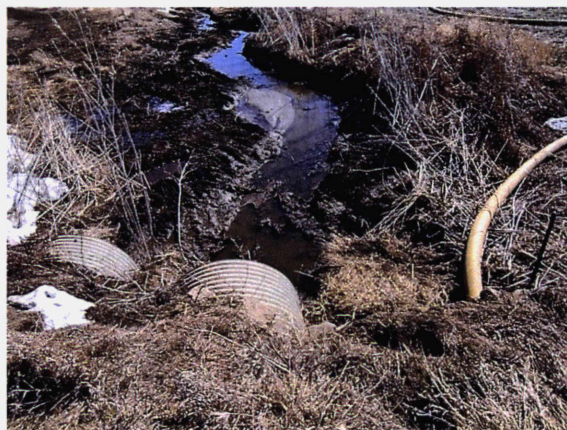
**Between Stop 4 and Stop 5 – UNL Eastern
Extension – Southeast of County Roads 9
& J**
GPS: 41.1850660, -96.4616990
Time: 1336

Yellowish discoloration observed on the south side of County Road J. Slight odor noted at this location.

Flow (audible and visual) observed at this location.

No active work was observed at the time of the site visit.

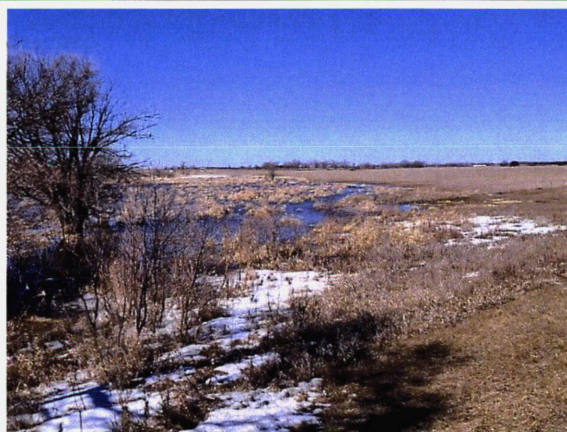
STOP 3 – Road 7/Hwy 66
41.1388323, -96.4257571
Time: 1232

Observation of water pooling on west side of Stop 3 advancing to the north.

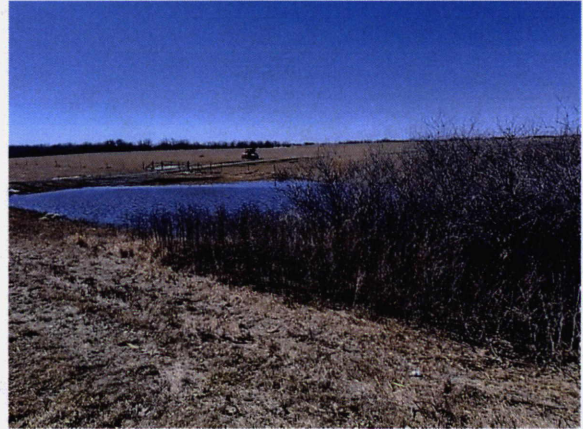
STOP 3 – Road 7/Hwy 66

Observation of water pooling on west side of
Stop 3 advancing to the south.
