Daily Observation Form – AM REPORT
AltEn LLC – Mead, NE Release
Facility ID: 84069; State Spill Report Number: 021221-NH-845
Date: March 1, 2021
Weather: Clear and Sunny, 36 °F

Terracon

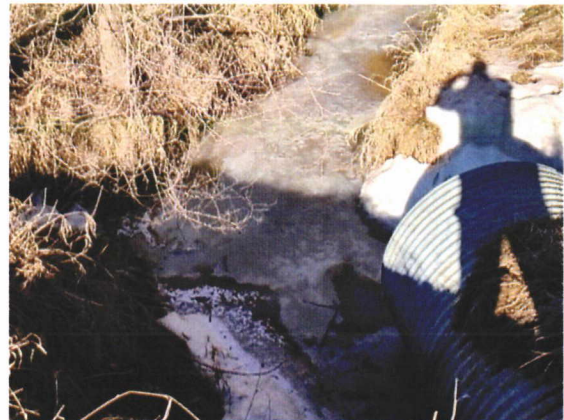
STOP 2 – North of the intersection of County Roads 6 & F
41.1334626, -96.4064519
Time: 0909

Obvious signs of contamination (visual and/or olfactory) observed on the west side in water.

Flow (audible and/or visual) observed at this location.

No active work was observed at the time of the site visit.

Photo Direction: Looking northwest.

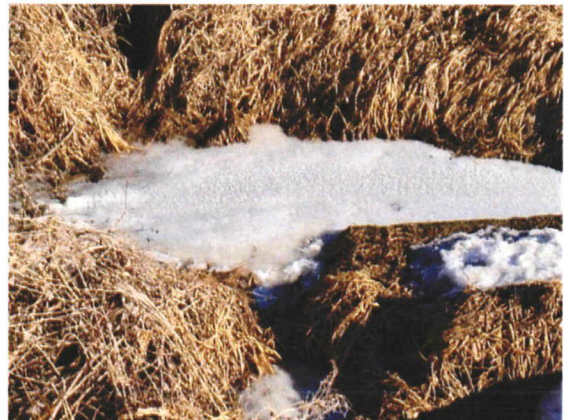
STOP 2 – North of the intersection of County Roads 6 & F
41.1334626, -96.4064519
Time: 0911

Obvious signs of contamination (visual and/or olfactory) observed on the east side in water.

Flow (audible and/or visual) observed at this location.

No active work was observed at the time of the site visit.

Photo Direction: Looking north.

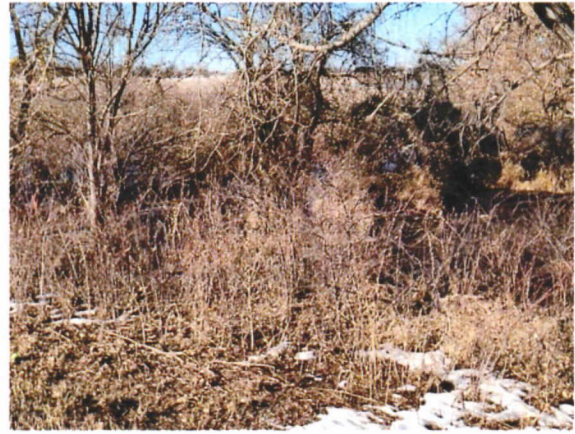
STOP 3 – Road 7/Hwy 66
41.1388323, -96.4257571
Time: 0855

Obvious signs of contamination (visual and/or olfactory) observed on the west side of Stop 3 in water. Water pooling at this location. No flow (audible and/or visual) observed at this location. The sandbags associated with the culvert plug/balloon are submerged.

No active work was observed on the west side of the Stop 3 location at the time of the site visit.

Photo Direction: Looking west.

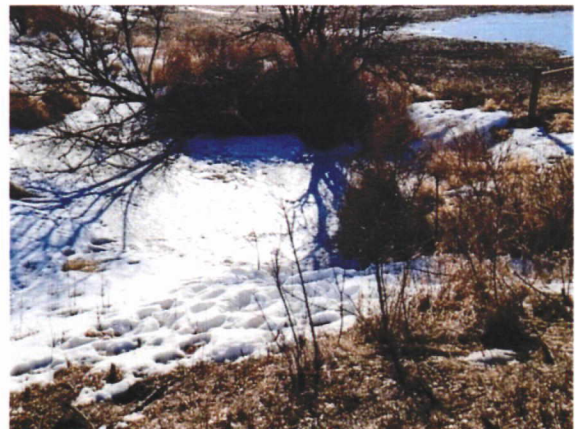
STOP 3 – Road 7/Hwy 66
41.1388323, -96.4257571
Time: 0857

Obvious signs of contamination (visual and/or olfactory) observed on the east side of Stop 3. No flow (audible and/or visual) observed at this location.

No active work was observed on the east side of the Stop 3 location at the time of the site visit.

Photo Direction: Looking north.

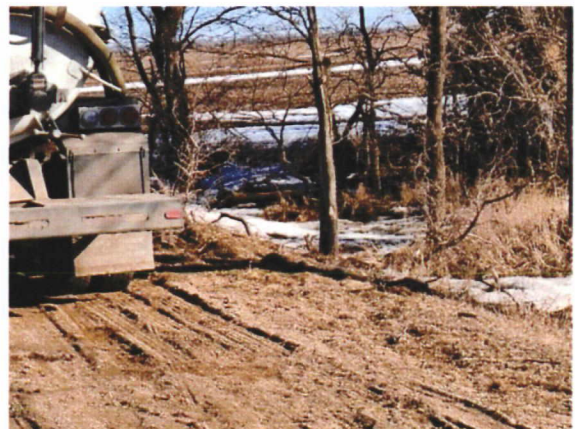
STOP 4 – County Road 8, North of Road H
GPS: 41.1677657, -96.4447025
Time: 0925

Obvious signs of contamination (visual and/or olfactory) observed in water on the east side at this location. No visible flow observed due to ice cover.

Vacuum truck staged at this location. Vacuum truck inactive at time of visit.

Photo Direction: Looking northeast.

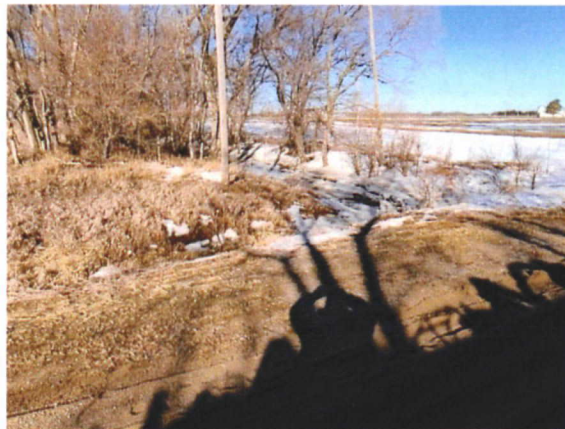
STOP 4 – County Road 8, North of Road H

Obvious signs of contamination (visual and/or olfactory) observed in water on the west side at this location. No visible flow observed due to ice cover.

Vacuum truck staged at this location. Vacuum truck inactive at time of visit.

Photo Direction: Looking northwest.

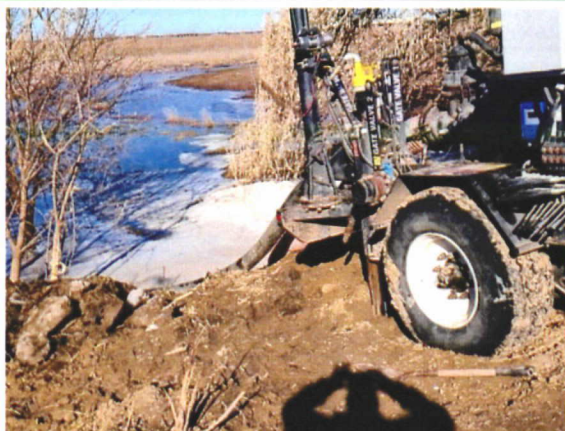
STOP 5 – UNL Eastern Extension – North of County Roads 9 & J

Obvious signs of contamination (visual and/or olfactory) observed on the west side of Stop 5 in water. Low odor at this location.

The liquid has extended beyond the defined drainageway. Pumping of impacted material active during this visit.

Photo Direction: Looking northwest.

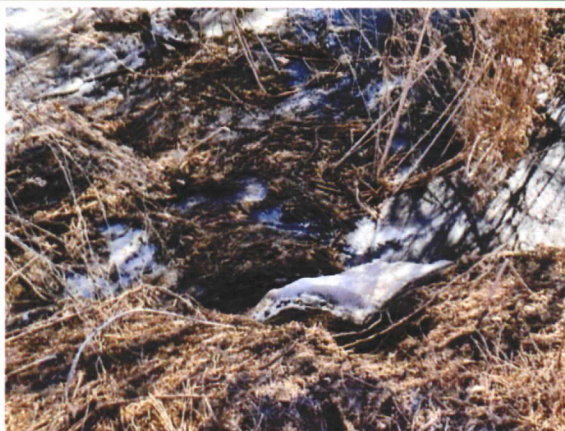
STOP 5 – UNL Eastern Extension – North of County Roads 9 & J

Obvious signs of contamination (visual and/or olfactory) observed in water on the east side.

Observed flow from adjacent fields and west side through culvert coming into the area.

Photo Direction: Looking east.

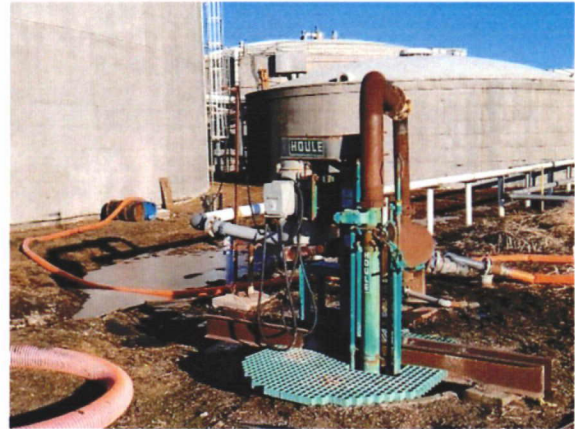
**STOP 6 – AltEn LLC Facility – East Side of
Digester 1**

Obvious signs of contamination (visual and/or olfactory) observed on the east side of Digester 1.

Pump proximal to the south lagoon connected to Digester 1 was inactive at the time of the site visit.

Photo Direction: Looking northwest.

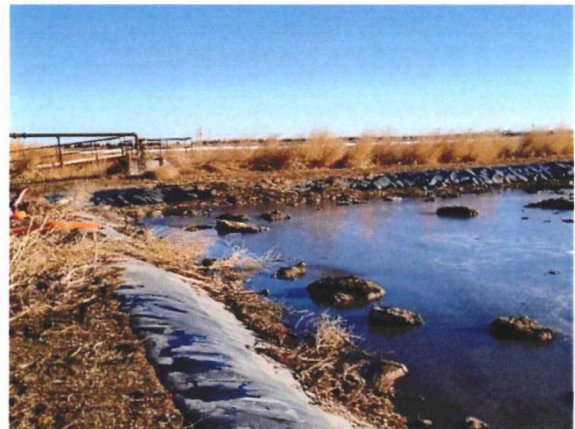
**STOP 6 – AltEn LLC Facility – Impacted
Material Disposal Site: South Lagoon**

Impacted material stockpiled within AltEn's lagoon.

Photo Direction: Looking north.

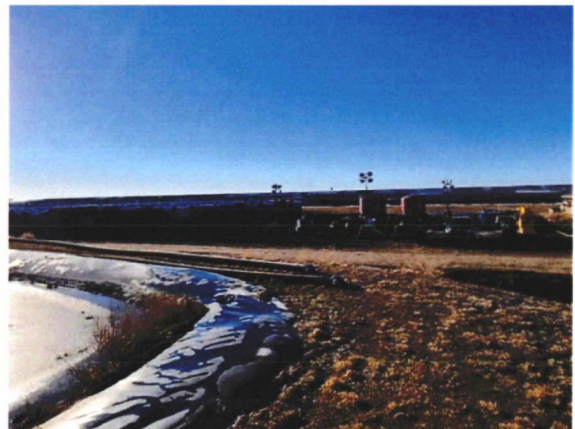
**STOP 6 – AltEn LLC Facility – South of
Emergency Lagoon**

Constructed holding tank associated with treatment vessels located south of the lagoon.

Photo Direction: Looking south.

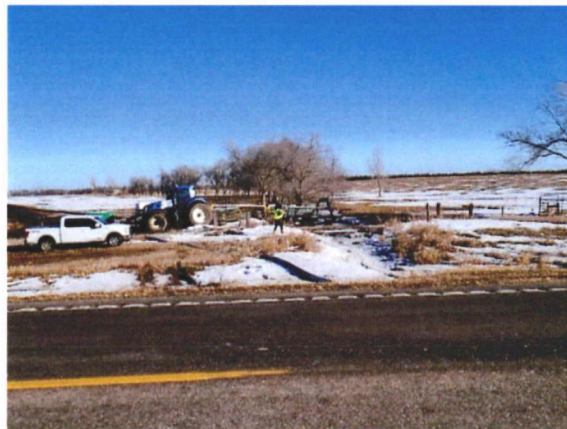
Between Stop 3 and Stop 4 – Hwy 66, East of Road 8

Obvious signs of contamination (visual and/or olfactory) observed on the north side of Hwy 66. No visible flow observed due to ice cover.

Soil berm placed within drainageway on the north side of Hwy 66 no longer visible.

Pumping of impacted material active during this visit.

Photo Direction: Looking north.

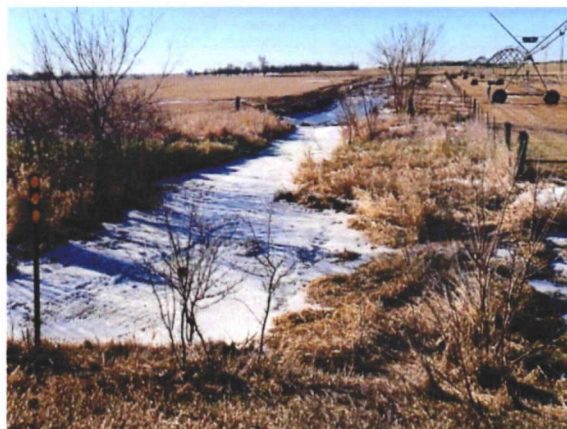
Between Stop 3 and Stop 4 – Hwy 66, East of Road 8

Obvious signs of contamination (visual and/or olfactory) observed on the south side of Hwy 66. No visible flow observed due to ice cover.

No active work was observed at this location at the time of the site visit.

Photo Direction: Looking south.

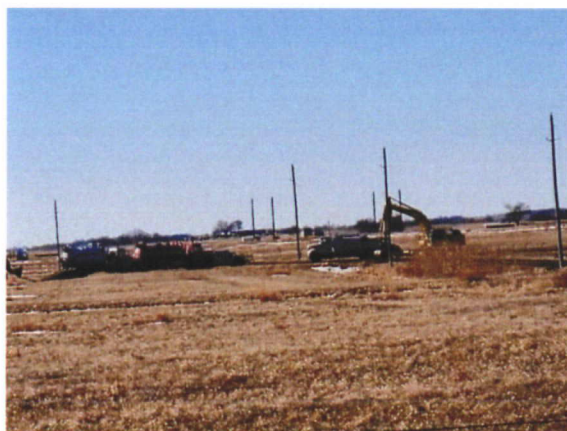
Between Stop 3 and Stop 4 – County Road H Between Roads 7 & 8

Heimes Corporation equipment inactive south of County Road H.

Photo Direction: Looking south.

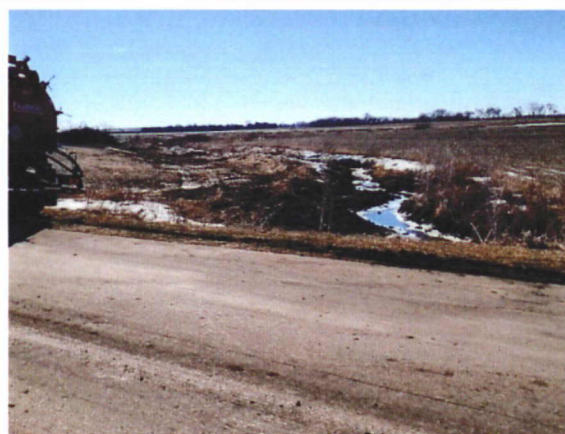
Between Stop 4 and Stop 5 – UNL Eastern
Extension – Southeast of County Roads 9
& J
GPS: 41.1850660, -96.4616990
Time: 0934

Vacuum truck staged at this location. Vacuum
truck inactive at time of visit.

Flow observed at this location.

Photo Direction: Looking southeast.
