Daily Observation Form – PM REPORT
AltEn LLC – Mead, NE Release
Facility ID: 84069; State Spill Report Number: 021221-NH-845
Date: March 1, 2021
Weather: Sunny and slight breeze, 43 °F

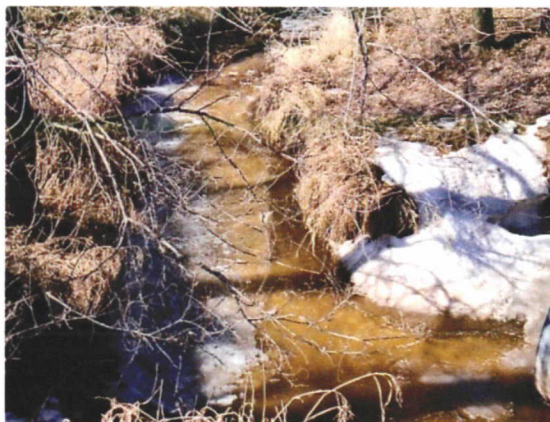
STOP 2 – North of the intersection of County Roads 6 & F
41.1334626, -96.4064519
Time: 1441

No suspect/obvious odor noted. Obvious signs of contamination (visual) observed on the west side in water.

Flow (audible and/or visual) observed at this location.

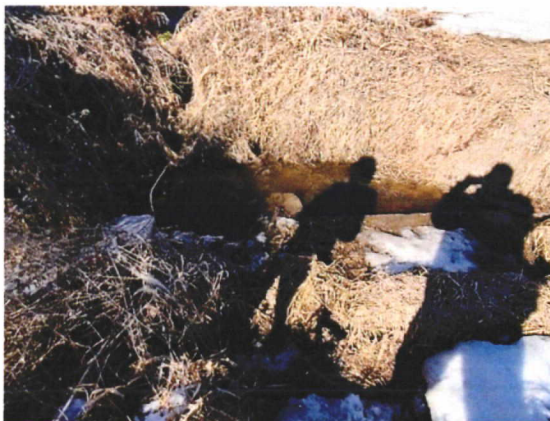
STOP 2 – North of the intersection of County Roads 6 & F
41.1334626, -96.4064519
Time: 1444

No suspect/obvious odor noted. Obvious signs of contamination (visual) observed on the east side in water.

Flow (audible and/or visual) observed at this location.

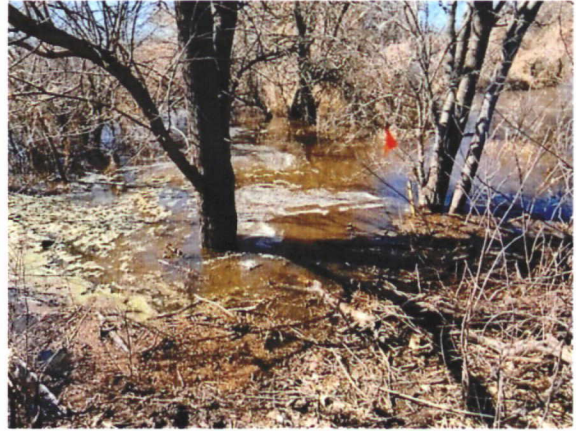
STOP 3 – Road 7/Hwy 66
41.1388323, -96.4257571
Time: 1402

Obvious signs of contamination (visual and/or olfactory) observed on the west side of Stop 3 in water. Water pooling at this location. No flow (audible and/or visual) observed at this location.

No active work was observed on the west side of the Stop 3 location at the time of the site visit.

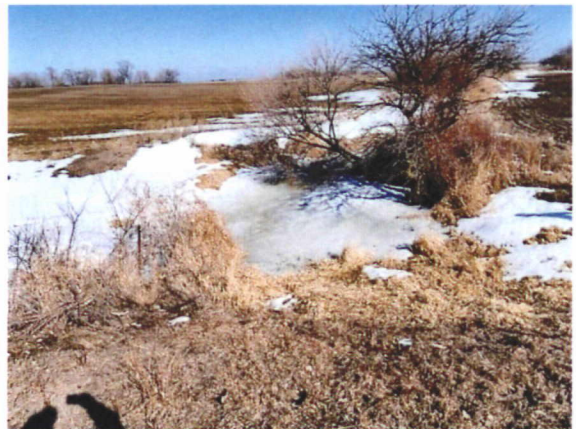
STOP 3 – Road 7/Hwy 66
41.1388323, -96.4257571
Time: 1405

Obvious signs of contamination (visual and/or olfactory) observed on the east side of Stop 3. No flow (audible and/or visual) observed at this location.

No active work was observed on the east side of the Stop 3 location at the time of the site visit.

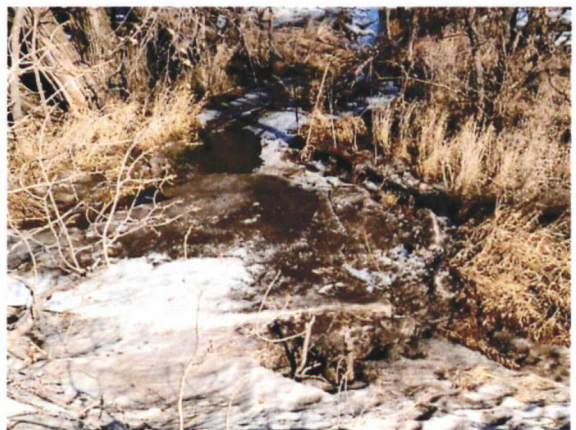
STOP 4 – County Road 8, North of Road H
GPS: 41.1677657, -96.4447025
Time: 1424

Obvious signs of contamination (visual and/or olfactory) observed in water on the east side at this location. Observed flow from adjacent fields coming into the area.

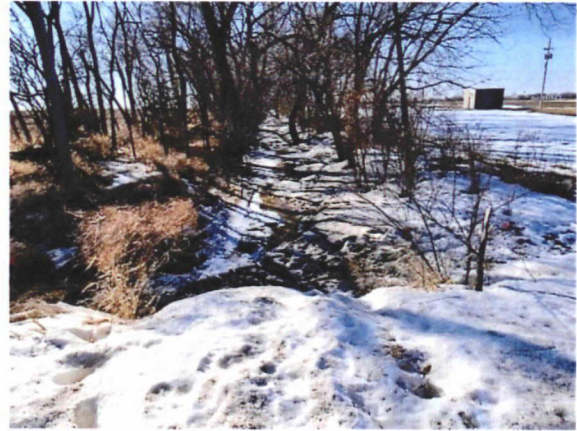
STOP 4 – County Road 8, North of Road H

Obvious signs of contamination (visual and/or olfactory) observed in water on the west side at this location.

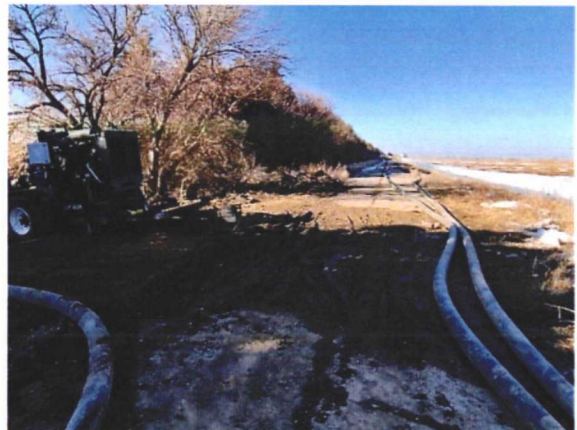
STOP 5 – UNL Eastern Extension – North of County Roads 9 & J

Obvious signs of contamination (visual and/or olfactory) observed on the west side of Stop 5 in water. Odor noted at this location. Pumping of impacted material active during this site visit.

Hose originating from the north side between Stop 3 and Stop 4 (Hwy 66, East of Road 8) was observed running parallel with hose from this location to the lagoon system (additional details on second entry of page 5).

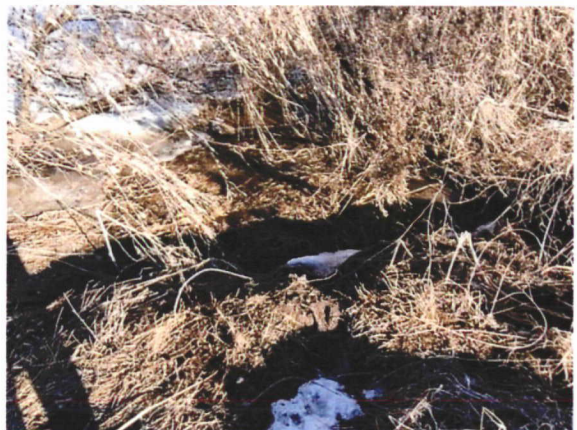
STOP 5 – UNL Eastern Extension – North of County Roads 9 & J

Obvious signs of contamination (visual and/or olfactory) observed on the east side of Stop 5.

Observed flow at this location. Vacuum truck staged at this location. No active work was observed at the time of the site visit.

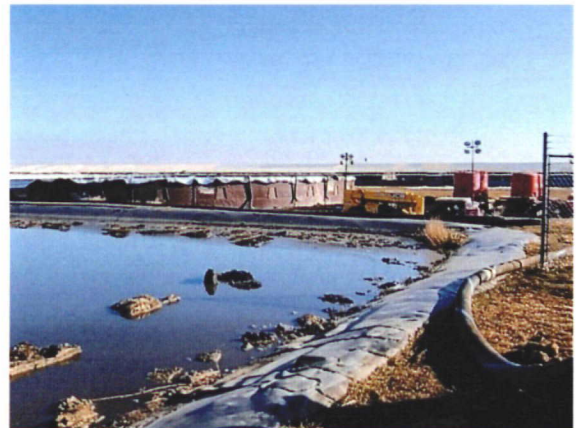
**STOP 6 – AltEn LLC Facility – Impacted
Material Disposal Site: South Lagoon**

Impacted material within AltEn's lagoon in the foreground of the photograph. Treatment vessels and constructed holding tank in the background of the photograph.

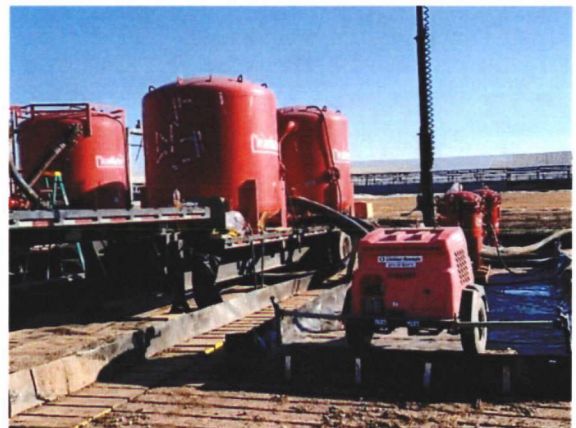
**STOP 6 – AltEn LLC Facility – South of
Emergency Lagoon**

Treatment vessels associated with constructed holding tank located south of the lagoon.

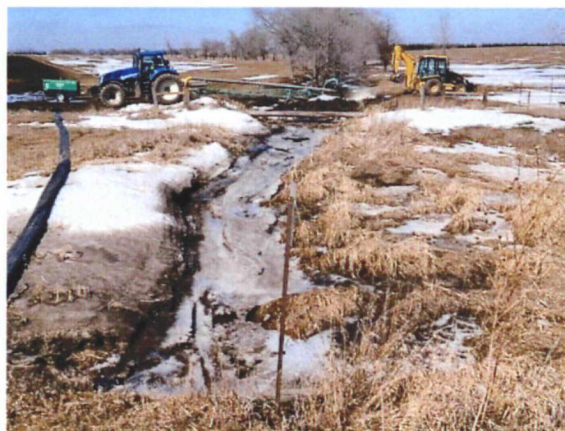
Between Stop 3 and Stop 4 – Hwy 66, East of Road 8

Obvious signs of contamination (visual and/or olfactory) observed on the north side of Hwy 66. A soil berm was placed/rebuilt in the drainageway which limited flow at this location.

Pumping of impacted material active; using pressurized air in the liquid at the suction hose/pipe inlet to aid pumping.

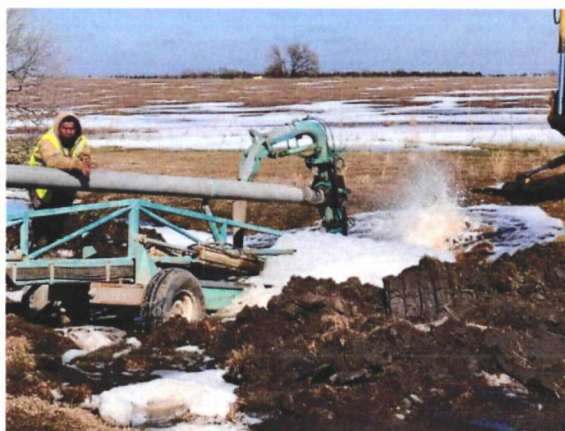
Between Stop 3 and Stop 4 – Hwy 66, East of Road 8

Pumping activities and soil berm on the north side of Hwy 66. Previously, pumped liquid from this location was discharged to the west side of Stop 5 where a second pump unit pumped the liquid to AltEn's lagoon system. As noted at Stop 5 at 1549, additional hose was attached to the section originating from this location and is discharging directly into the lagoon system.

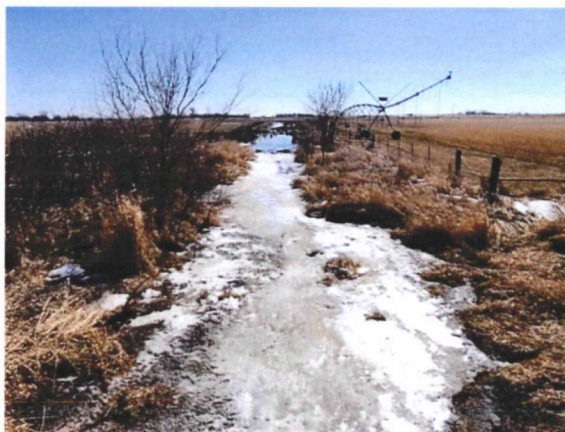
Between Stop 3 and Stop 4 – Hwy 66, East of Road 8

Obvious signs of contamination (visual and/or olfactory) observed on the south side of Hwy 66. Flow observed at this location.

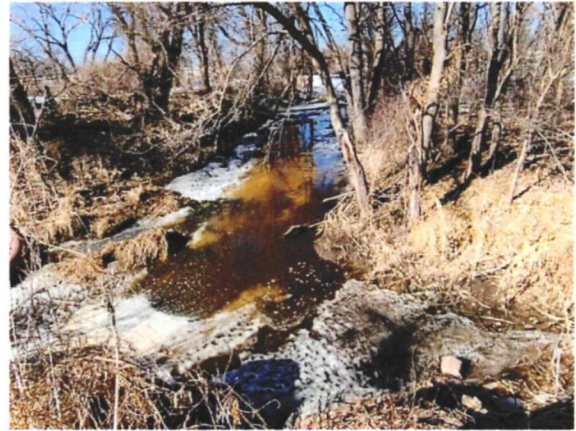
**Between Stop 3 and Stop 4 – County Road
H Between Roads 7 & 8**
GPS: 41.161258, -96.437785
Time:1457

Obvious signs of contamination (visual and/or olfactory) observed on the north side of County Road H. Flow observed at this location.

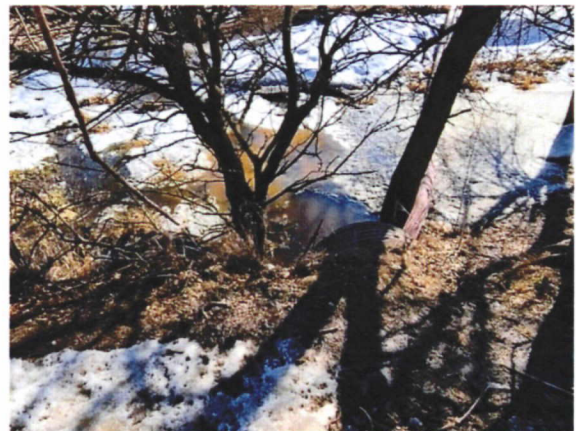
**Between Stop 3 and Stop 4 – County Road
H Between Roads 7 & 8**
GPS: 41.161258, -96.437785
Time:1501

Obvious signs of contamination (visual and/or olfactory) observed on the south side of County Road H. Flow observed at this location.

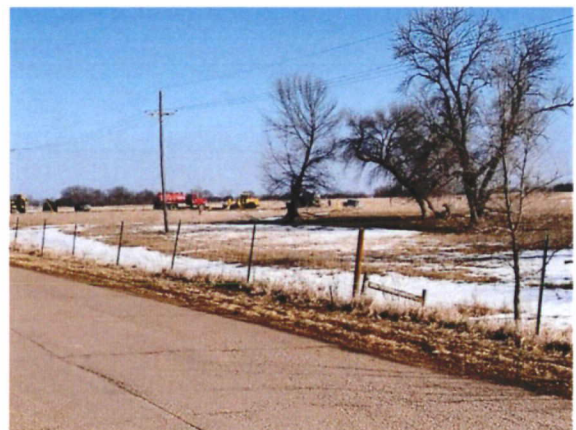
**Between Stop 3 and Stop 4 – County Road
H Between Roads 7 & 8**
GPS: 41.161258, -96.437785
Time:1453

Observed Heimes and Clean Harbors preparing equipment for removal from location.

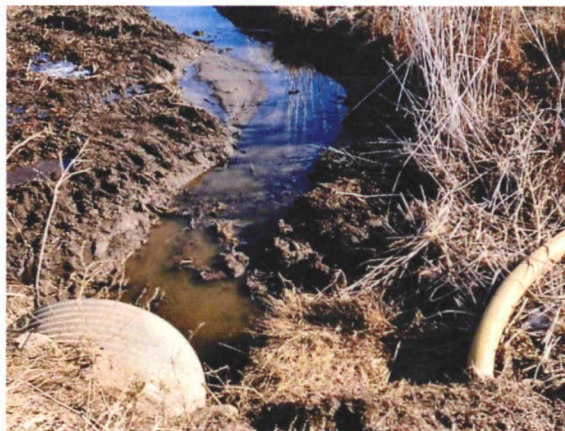
Between Stop 4 and Stop 5 – UNL Eastern Extension – Southeast of County Roads 9 & J

Vacuum truck staged at this location. Vacuum truck inactive at time of visit.

Observed flow at this location.

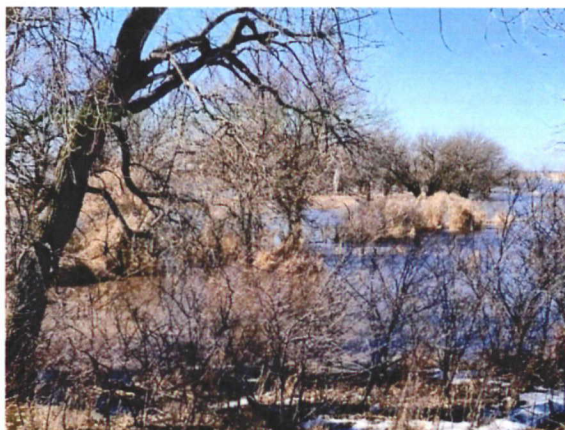
STOP 3 – Road 7/Hwy 66

Observation of water pooling on west side of Stop 3 advancing to the north.

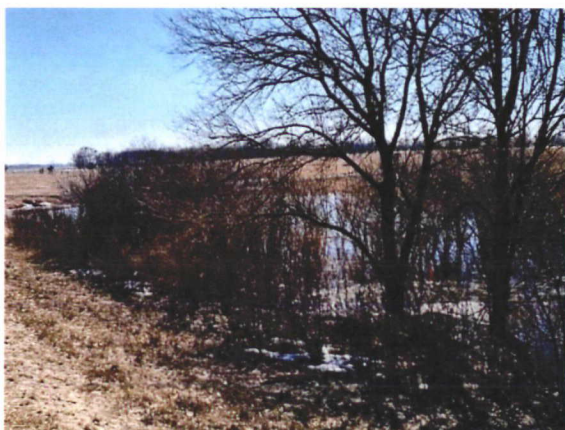
STOP 3 – Road 7/Hwy 66

Observation of water accumulation on west side of Stop 3 advancing to the south.
