AltEn Field Observations
March 14, 2021
Tom Buell
NDEE

On Sunday, March 14, 2021 I made the following observations of the AltEn facility. At the time of the observations it was raining and very windy. I did not make contact with the facility.

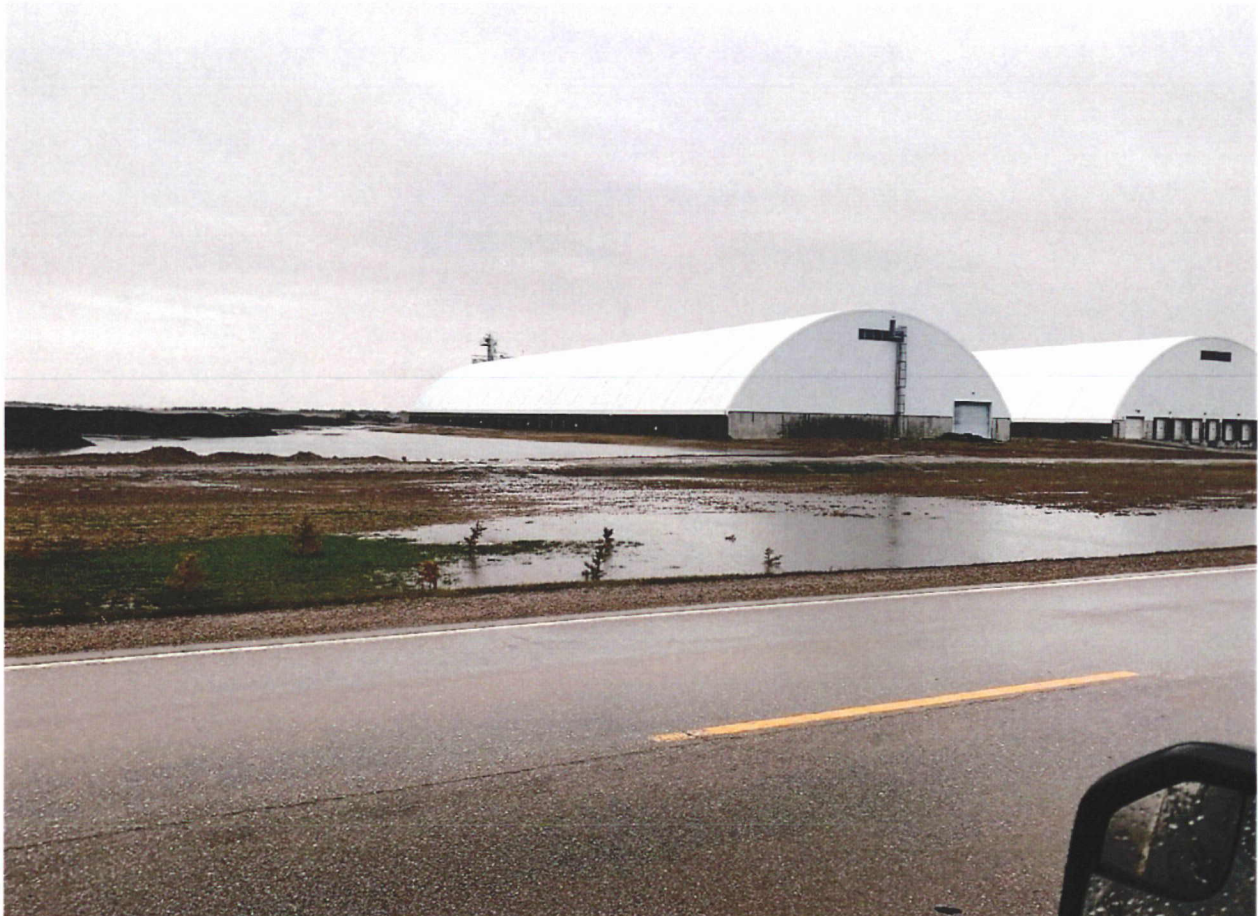
-At 10:48 I drove past the facility on Road 10 and took the photo below. Water was flowing over the stormwater berm. Following this observation I left the area. After I left the facility I contact Brad Pracheil, NDEE Inspection and Compliance Division Administrator, to discuss my findings. Brad said he would contact the facility to notify them of our stormwater concerns.
