Daily Observation Form – DAILY REPORT  
AltEn LLC – Mead, NE Release  
Facility ID: 84069; State Spill Report Number: 021221-NH-845  
Date: March 9, 2021  
Weather: Clear, Sunny and Windy, 75 °F

**STOP 1 – Hwy 66 West of Ashland Gun Club**

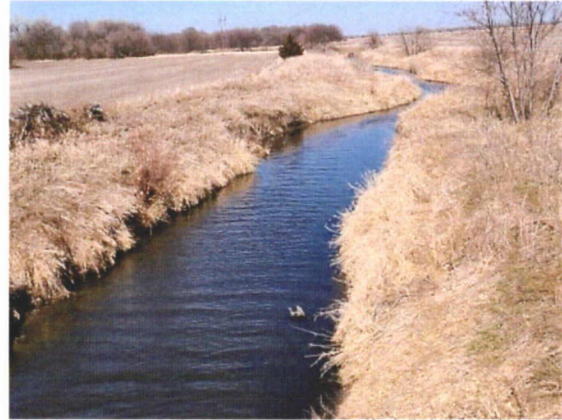
Flow observed at this location.

No suspect/obvious odor noted. No obvious visual signs of contamination observed at surface or on banks.

No active work was observed at the time of the site visit.

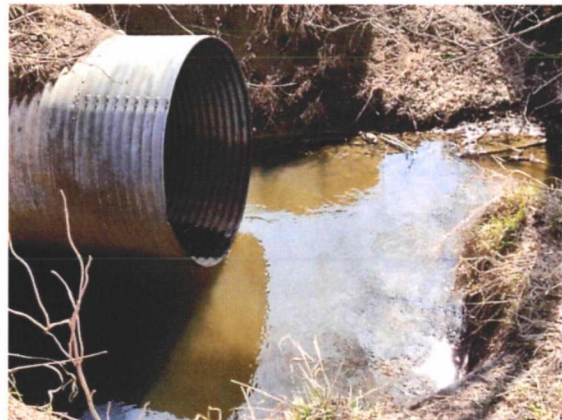
**STOP 2 – North of the intersection of County Roads 6 & F**

No suspect/obvious odor noted. Brownish discoloration observed on the west side at surface near culvert opening. Liquid appeared turbid.

Flow (audible) observed at this location.

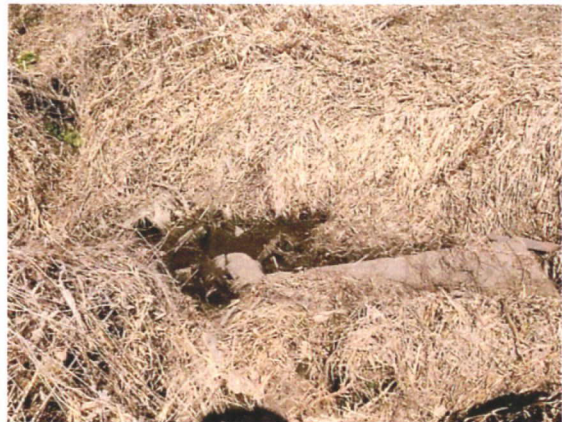
**STOP 2 – North of the intersection of County Roads 6 & F**

No suspect/obvious odor noted. Liquid appeared brownish in color and turbid.

No flow (audible or visual) observed at this location.

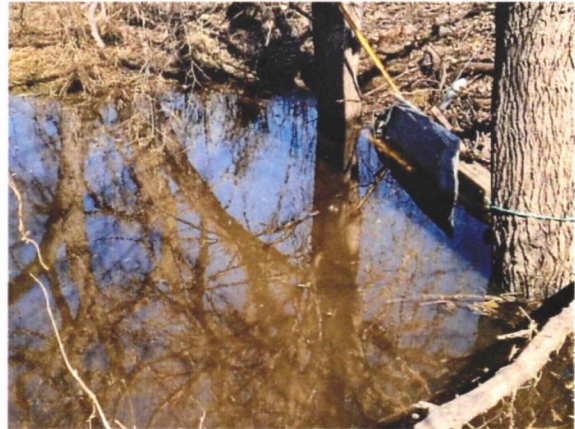
**STOP 3 – Road 7/Hwy 66**

Yellowish-brown discoloration observed on the west side of Stop 3. Liquid appeared turbid. Water pooling at this location. No flow (audible and visual) observed at this location. Strong organic decay odor noted.

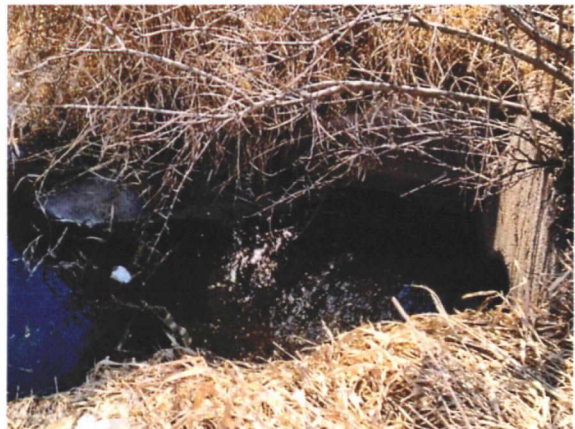
**STOP 3 – Road 7/Hwy 66**

Brownish discoloration observed on the east side of Stop 3. Liquid appeared turbid. Slight odor noted. No flow (audible or visual) observed at this location.

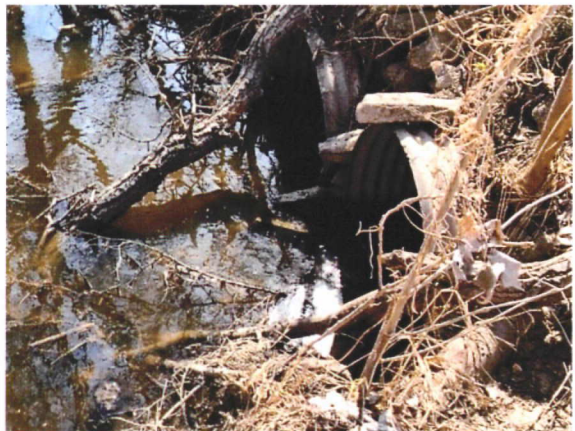
**STOP 4 – County Road 8, North of Road H**

Brownish discoloration observed at surface on the east side at this location. Liquid appeared turbid. No suspect/obvious odor noted. Flow (visual) observed at this location.

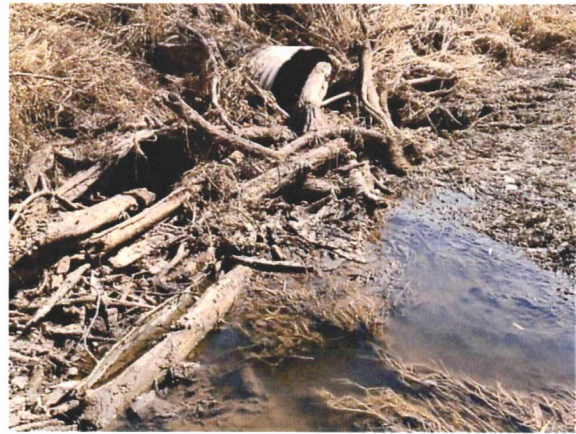
**STOP 4 – County Road 8, North of Road H**  
**GPS: 41.1677657, -96.4447025**  
Time: 1335

Brownish discoloration observed at surface on the west side at this location. Slight turbid appearance. Slight odor noted. Flow (visual) observed at this location. Observed milky/oily film at several spots along the banks.

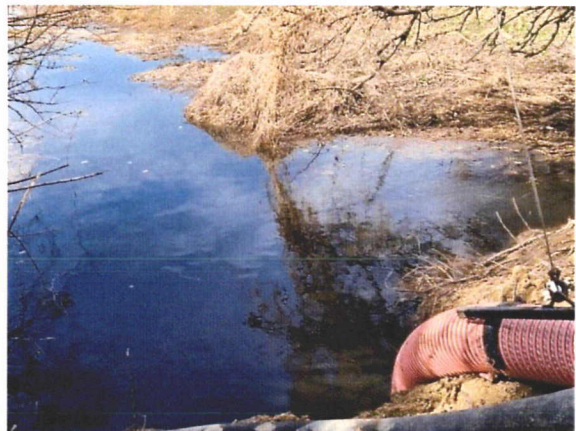
**STOP 5 – UNL Eastern Extension – North of County Roads 9 & J**  
**GPS: 41.1862613, -96.4638642**  
Time: 1347

Brownish discoloration observed on the west side of Stop 5. Liquid appeared turbid. Moderate odor noted at this location.

No flow (audible or visual) observed at this location.

Pumping of impacted material inactive during this site visit.

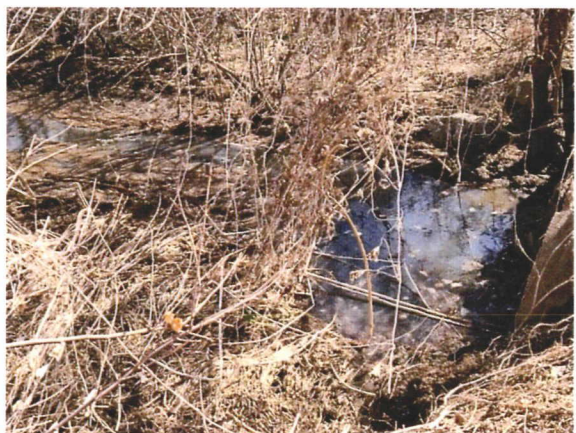
**STOP 5 – UNL Eastern Extension – North of County Roads 9 & J**  
**GPS: 41.1862613, -96.4638642**  
Time: 1351

Yellowish-brown discoloration observed on the east side of Stop 5. Liquid appeared turbid. Slight odor noted at this location. Observed milky/oily film near the culvert opening.

No flow (audible or visual) observed at this location.

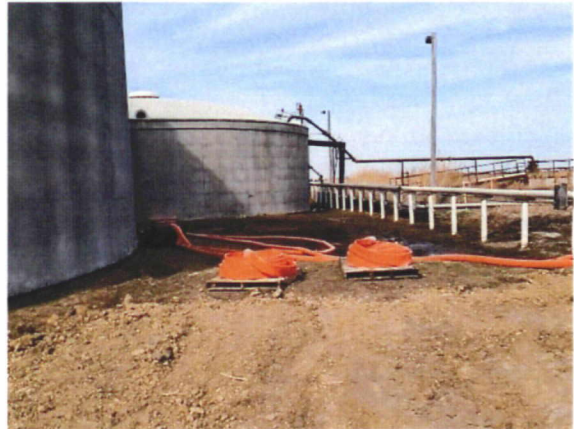
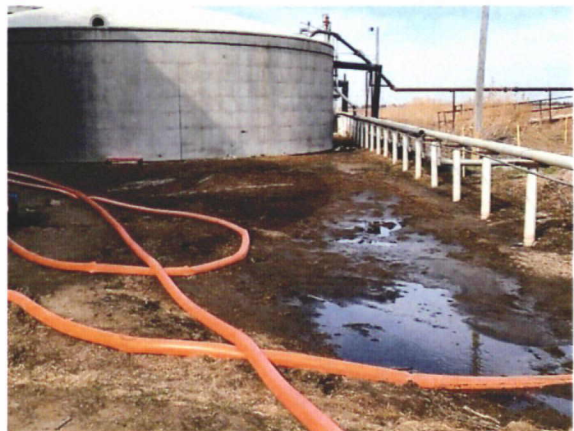
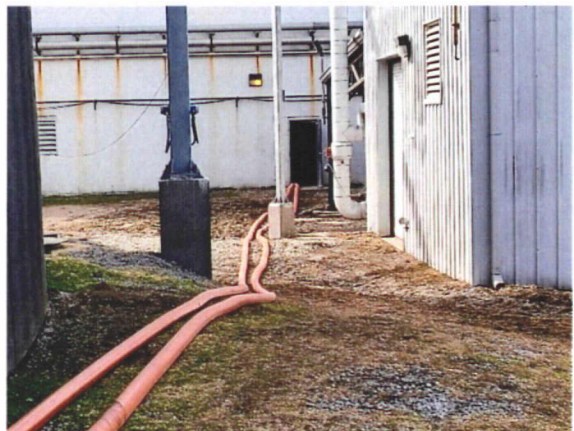
**STOP 6 – AltEn LLC Facility – East Side of Digester 1**

Yellowish-brown discoloration observed in puddles/pooling on the east side of Digester 1. Liquid appeared turbid. Strong odor noted at this location.

Pump proximal to the south lagoon was inactive at the time of this visit. The pump was previously connected to Digester 1. The hose from the pump was disconnected at Digester 1.

A hose connected to Digester 1 was observed running into the open doorway of the building to the northwest of Digester 1.

A second hose was observed in the open doorway of the building to the northwest of Digester 1. The hose was observed running to the lagoon. Active discharge from the hose coming from the open doorway of the building to the northwest of Digester 1 into the lagoon was observed at the time of the site visit.

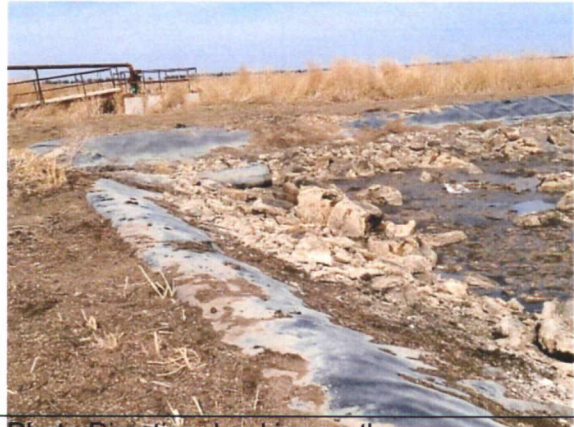
**STOP 6 – AltEn LLC Facility – Impacted  
Material Disposal Site: South Lagoon**  
GPS: 41.195558, -96.473923  
Time: 1414

Impacted material within AltEn's lagoon.

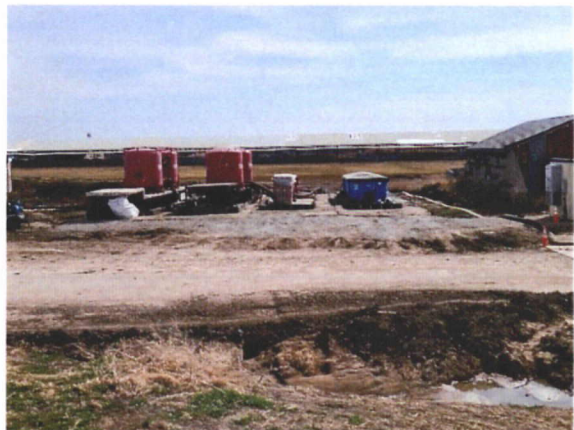
**STOP 6 – AltEn LLC Facility – South of  
Emergency Lagoon**  
GPS: 41.19470, -96.47611  
Time: 1420

Treatment vessels and holding tank located south of the lagoon inactive at the time of this visit. Clean Harbors personnel was not observed onsite.

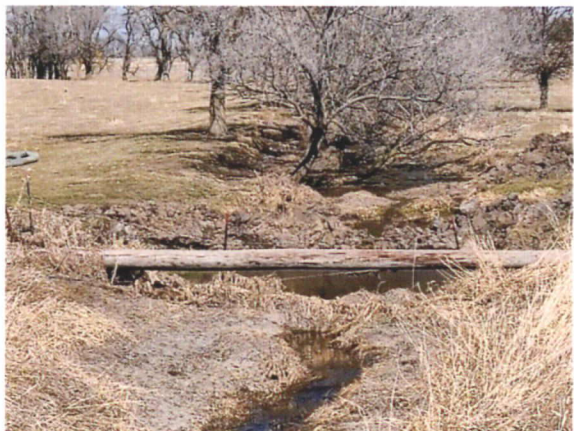
**Between Stop 3 and Stop 4 – Hwy 66, East  
of Road 8**  
GPS: 41.1464807, -96.4324881  
Time: 1145

Brownish discoloration observed on the north side of Hwy 66 at surface. Liquid appeared turbid. Flow (visual) observed at this location. No suspect/obvious odor noted.

Pumping equipment/equipment was not observed at this location at the time of the site visit.

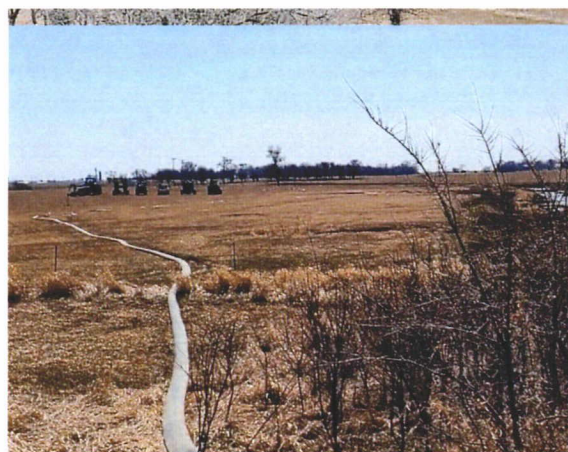
**Between Stop 3 and Stop 4 – Hwy 66, East of Road 8**

Pumping equipment/equipment staged approximately 30 yards east of the drainage ditch.

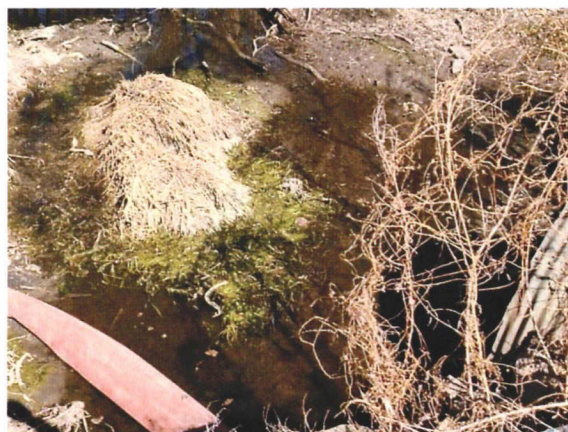
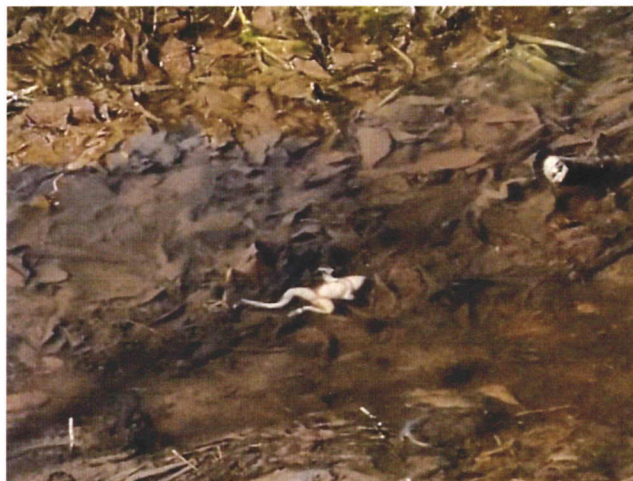
**Between Stop 3 and Stop 4 – County Road H Between Roads 7 & 8**

Brownish discoloration observed on the north side of County Road H. Moderate odor noted close to liquid at this location.

Flow (visual) observed at this location.

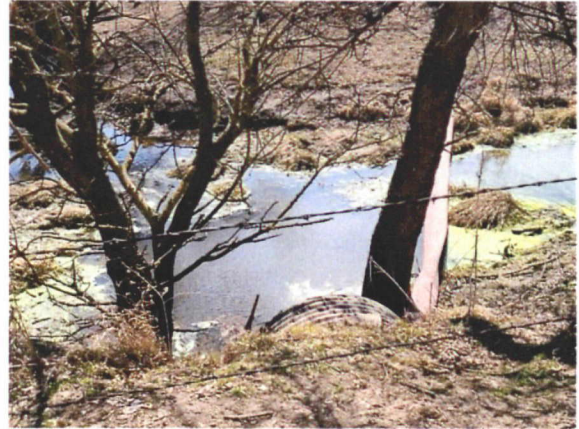
**Between Stop 3 and Stop 4 – County Road  
H Between Roads 7 & 8**  
**GPS: 41.161258, -96.437785**  
Time: 1315

Brownish discoloration observed on the south side of County Road H. Liquid appeared turbid. Moderate odor noted at this location.

Flow (visual) observed at this location.

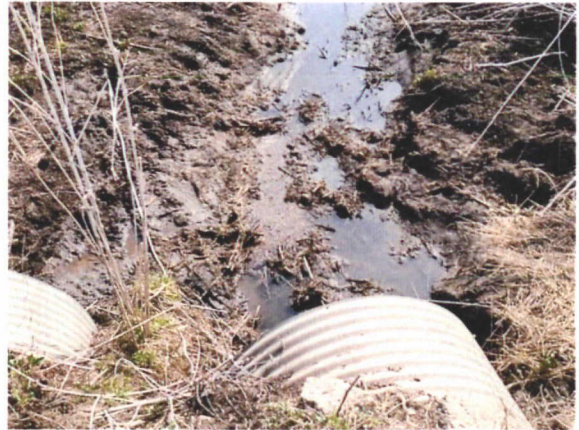
**Between Stop 4 and Stop 5 – UNL Eastern  
Extension – Southeast of County Roads 9  
& J**  
**GPS: 41.1850660, -96.4616990**  
Time: 1338

Brownish discoloration observed on the south side of County Road J. Liquid appeared turbid. Slight odor noted at this location.

Flow (visual) observed at this location.

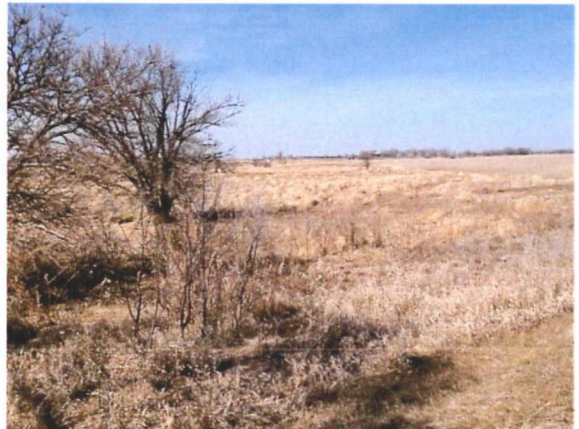
**STOP 3 – Road 7/Hwy 66**  
**41.1388323, -96.4257571**  
Time: 1201

Observation of liquid pooling on west side of Stop 3 advancing to the north. Liquid has receded from this area.

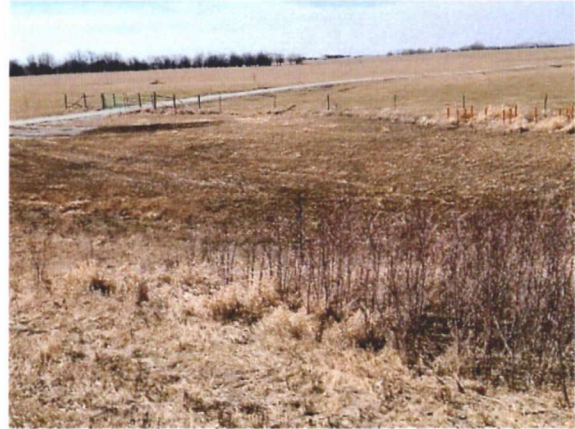
**STOP 3 – Road 7/Hwy 66**  
**41.1388323, -96.4257571**  
Time: 1214

Observation of water pooling on west side of Stop 3 advancing to the south. Liquid has receded from this area.
