Daily Observation Form – DAILY REPORT
AltEn LLC – Mead, NE Release
Facility ID: 84069; State Spill Report Number: 021221-NH-845
Date: March 4, 2021
Weather: Clear and Sunny, 67 °F

STOP 1 – Hwy 66 West of Ashland Gun Club
41.0886323, -96.380274
Time: 1223

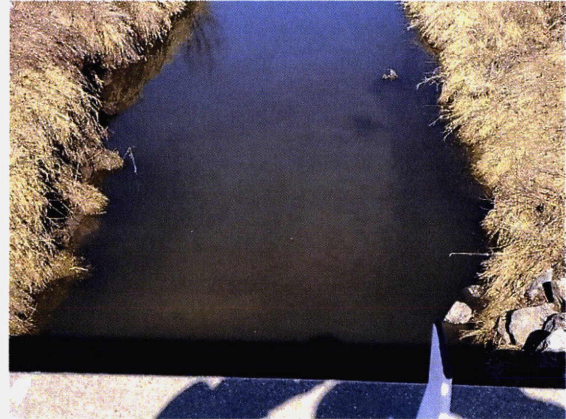
Water is flowing at this location.

No suspect/obvious odor noted. No obvious visual signs of contamination observed at surface or on banks.

No active work was observed at the time of the site visit.

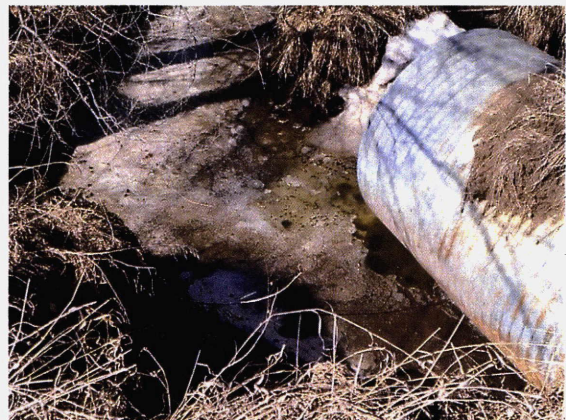
STOP 2 – North of the intersection of County Roads 6 & F
41.1334626, -96.4064519
Time: 1239

No suspect/obvious odor noted. Yellowish-brown discoloration observed on the west side at surface near culvert opening. Liquid appeared turbid.

Flow (audible) observed at this location.

No active work was observed at the time of the site visit.

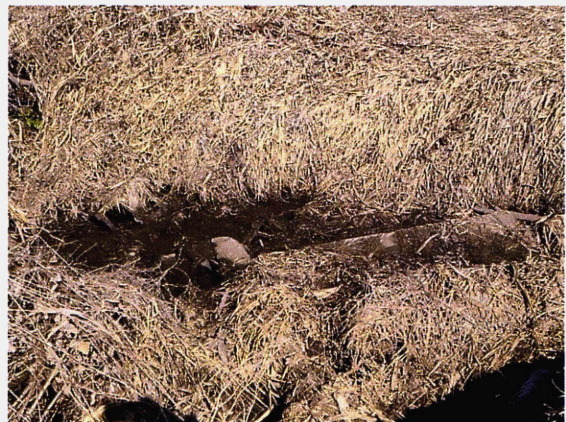
STOP 2 – North of the intersection of County Roads 6 & F
41.1334626, -96.4064519
Time: 1241

No suspect/obvious odor noted. Yellowish-brown discoloration observed on the east side at surface. Liquid appeared turbid.

Flow (audible and visual) observed at this location.

No active work was observed at the time of the site visit.

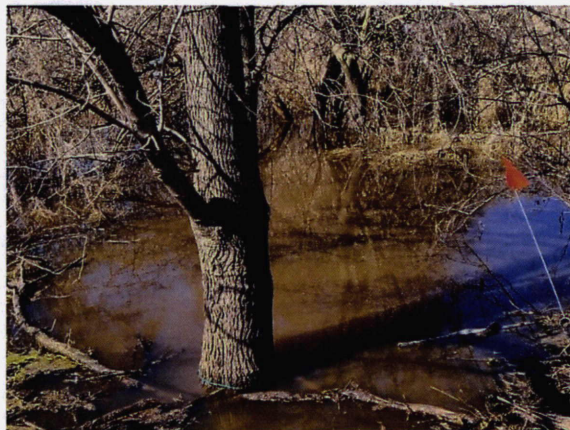
STOP 3 – Road 7/Hwy 66
41.1388323, -96.4257571
Time: 1203

Yellowish-brown discoloration observed on the west side of Stop 3. Liquid appeared turbid. Water pooling at this location. No flow (audible and visual) observed at this location.

No active work was observed on the west side of the Stop 3 location at the time of the site visit.

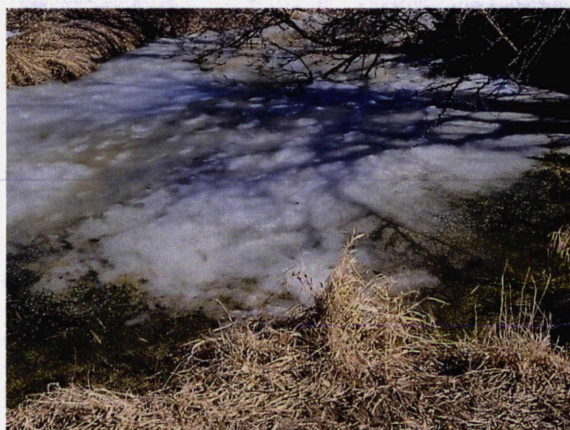
STOP 3 – Road 7/Hwy 66
41.1388323, -96.4257571
Time: 1207

Yellowish discoloration observed on the east side of Stop 3. No suspect/obvious odor noted. No flow (audible or visual) observed at this location. Ice covered observed.

No active work was observed on the east side of the Stop 3 location at the time of the site visit.

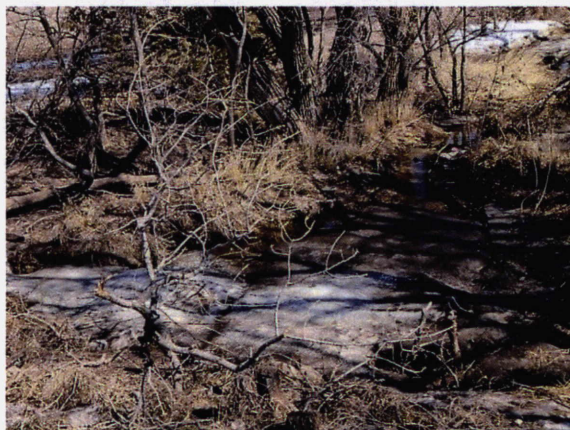
STOP 4 – County Road 8, North of Road H
GPS: 41.1677657, -96.4447025
Time: 1304

Yellowish-brown discoloration observed at surface on the east side at this location. No suspect/obvious odor noted. Flow (audible and visual) observed at this location. Observed flow from adjacent fields coming into the area.

No active work was observed at the time of the site visit.

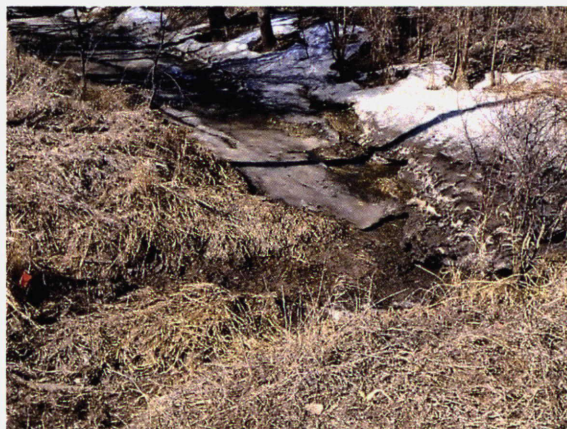
STOP 4 – County Road 8, North of Road H

Yellowish-brown discoloration observed at surface on the west side at this location. No suspect/obvious odor noted. Flow (audible and visual) observed at this location. Observed flow from adjacent fields coming into the area.

No active work was observed at the time of the site visit.

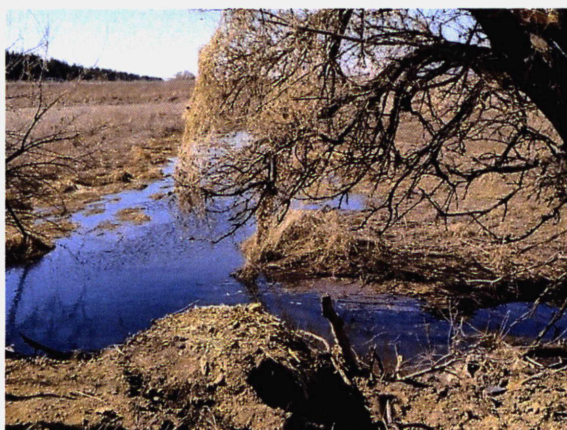
STOP 5 – UNL Eastern Extension – North of County Roads 9 & J

Yellowish-brown discoloration observed on the west side of Stop 5. Liquid appeared turbid. Moderate odor noted at this location.

No flow (audible or visual) observed at this location.

Pumping of impacted material inactive during this site visit.

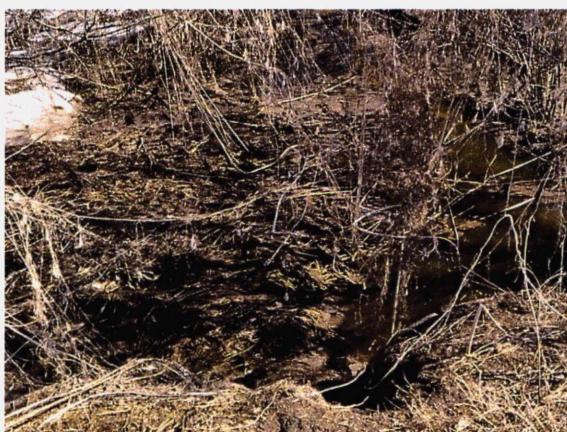
STOP 5 – UNL Eastern Extension – North of County Roads 9 & J

Yellowish-brown discoloration observed on the east side of Stop 5. Liquid appeared turbid. Slight odor noted at this location.

No flow (audible or visual) observed at this location.

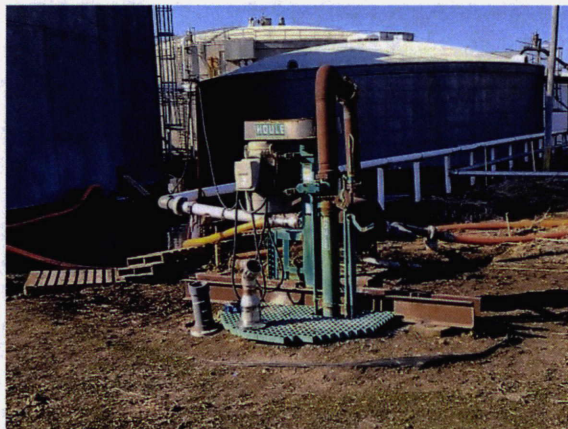
STOP 6 – AltEn LLC Facility – East Side of Digester 1

Yellowish-brown discoloration observed on the east side of Digester 1.

Strong odor noted at this location.

Pump proximal to the south lagoon connected to Digester 1 active at the time of this visit.

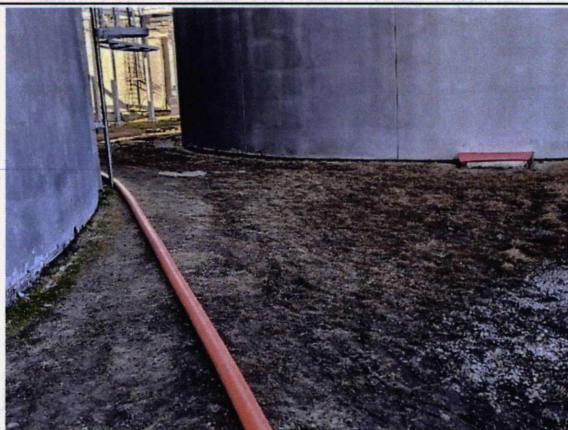
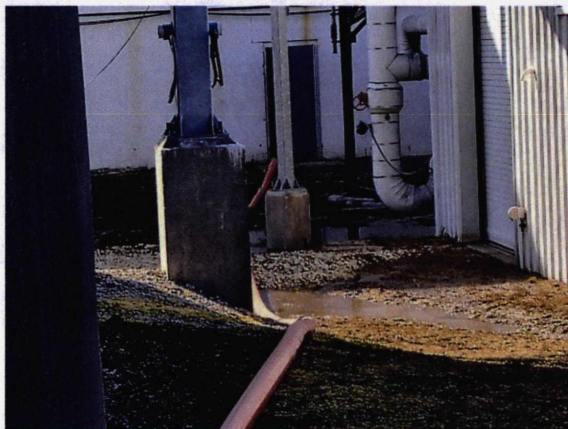
STOP 6 – AltEn LLC Facility – East Side of Digester 1

Pump proximal to the south lagoon connected to Digester 1 active at the time of this visit.

Second hose connected to the above referenced pump continues to run to the north of Digester 1 into the open doorway of the building to the northwest of Digester 1.

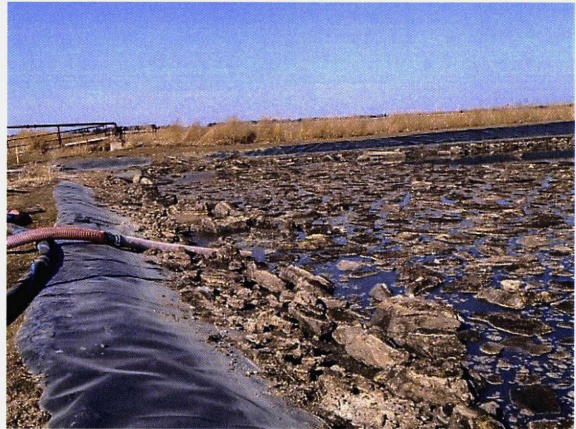
**STOP 6 – AltEn LLC Facility – Impacted
Material Disposal Site: South Lagoon**
GPS: 41.195558, -96.473923
Time: 1535

Impacted material within AltEn's lagoon.

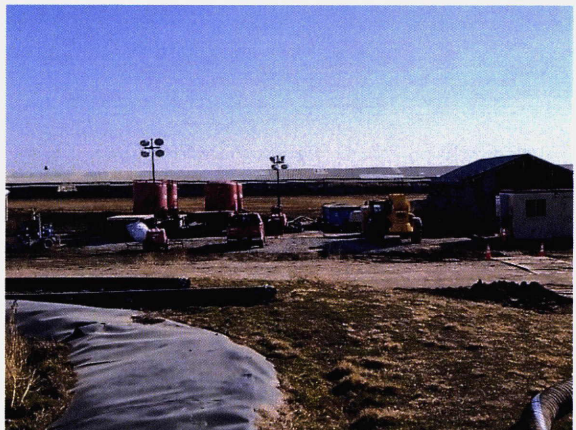
**STOP 6 – AltEn LLC Facility – South of
Emergency Lagoon**
GPS: 41.19470, -96.47611
Time: 1541

Treatment vessels located south of the lagoon.

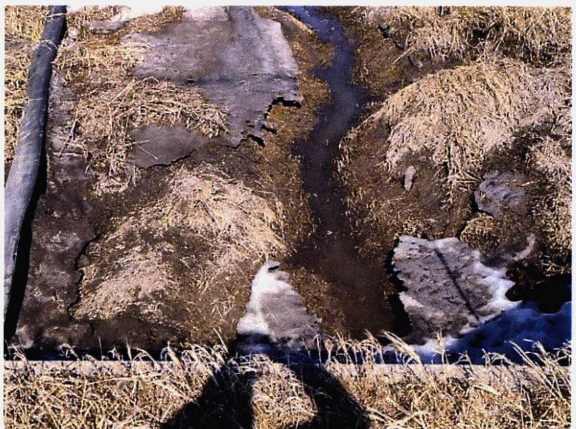
**Between Stop 3 and Stop 4 – Hwy 66, East
of Road 8**
GPS: 41.1464807, -96.4324881
Time: 1150

Yellowish-brown discoloration observed on the north side of Hwy 66 at surface. Minimal flow (visual) observed at this location. No suspect/obvious odor noted.

Soil berm in place during time of this visit. Pump active at the time of the site visit. The air compressor associated with pumping activities was not active at the time of the site visit.

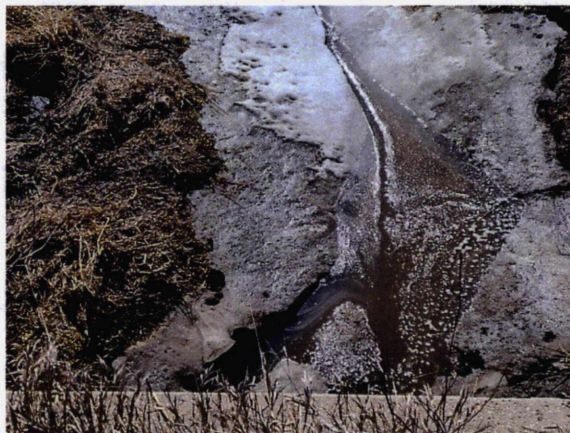
Between Stop 3 and Stop 4 – Hwy 66, East of Road 8

Yellowish discoloration observed on the south side of Hwy 66 at surface.

No suspect/obvious odor noted at this location.

Minimal flow (visual and audible) observed at this location.

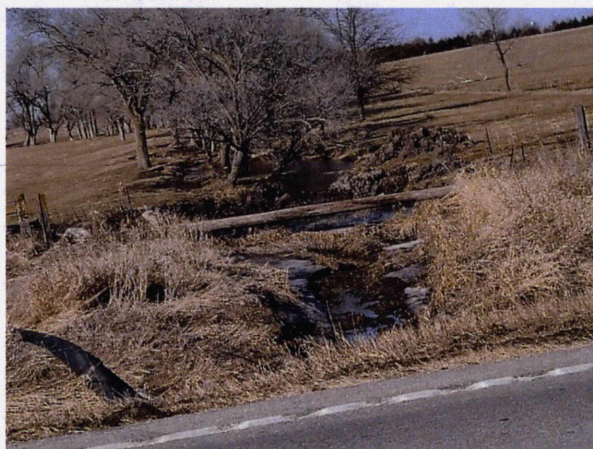
Between Stop 3 and Stop 4 – Hwy 66, East of Road 8

The pump and tractor have been removed from this location. The trailer mounted air compressor was observed (inactive). Soil berm in place at the time of this visit.

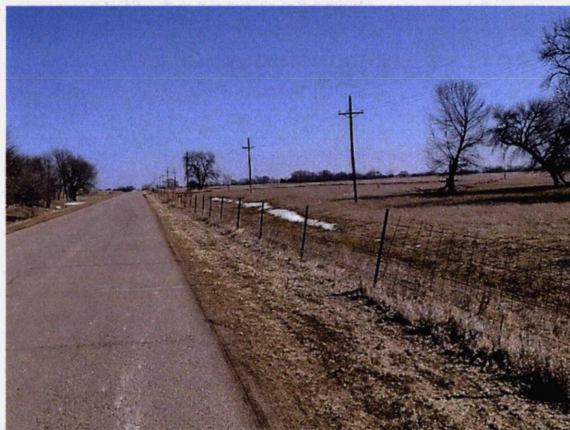
Between Stop 3 and Stop 4 – County Road H Between Roads 7 & 8

Heimes Corporation equipment has been removed from this location.

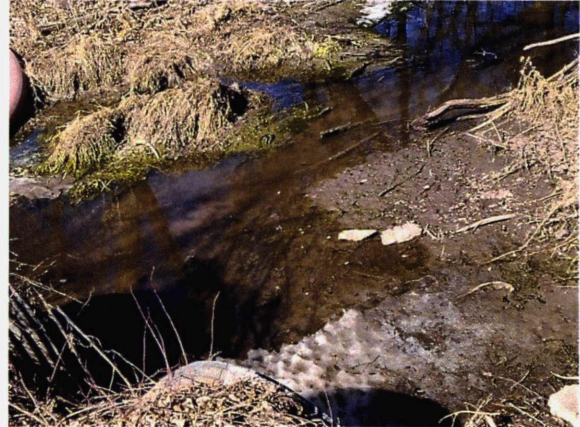
**Between Stop 3 and Stop 4 – County Road
H Between Roads 7 & 8**
GPS: 41.161258, -96.437785
Time: 1255

Yellowish-brown discoloration observed on the north side of County Road H. Slight odor noted at this location.

Flow (audible and visual) observed at this location.

No active work was observed at the time of the site visit.

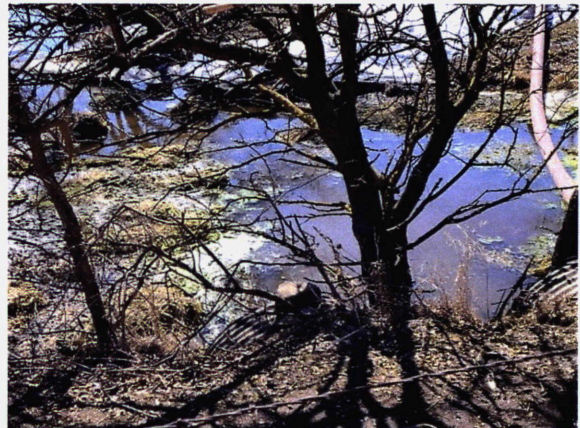
**Between Stop 3 and Stop 4 – County Road
H Between Roads 7 & 8**
GPS: 41.161258, -96.437785
Time: 1257

Yellowish-brown discoloration observed on the south side of County Road H. Slight odor noted at this location.

Flow (audible and visual) observed at this location.

No active work was observed at the time of the site visit.

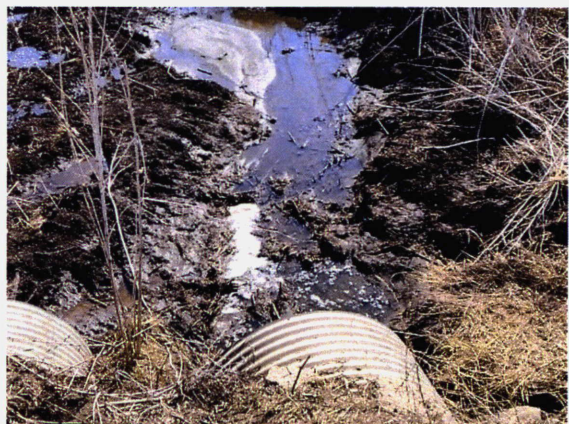
**Between Stop 4 and Stop 5 – UNL Eastern
Extension – Southeast of County Roads 9
& J**
GPS: 41.1850660, -96.4616990
Time: 1315

Yellowish discoloration with turbidity observed on the south side of County Road J. Slight odor noted at this location.

Flow (audible and visual) observed.

No active work was observed at the time of the site visit.

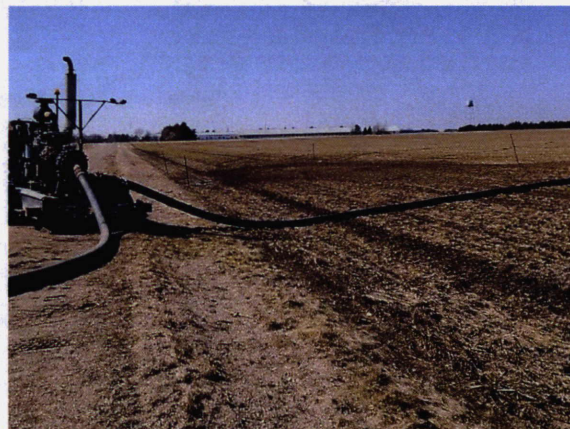
**Between Stop 4 and Stop 5 – County Road
I Between Roads 8 & 9**
GPS: 41.1757201, -96.4589467
Time: 1335

During the sampling activities March 3, 2021, between Stop 3 and Stop 4 – Hwy 66, East of Road 8, informed by University of Nebraska personnel the booster pump located between Stop 4 and Stop 5 was leaking from the hose connection(s).

Leaking connections were not observed at the time of this site visit.

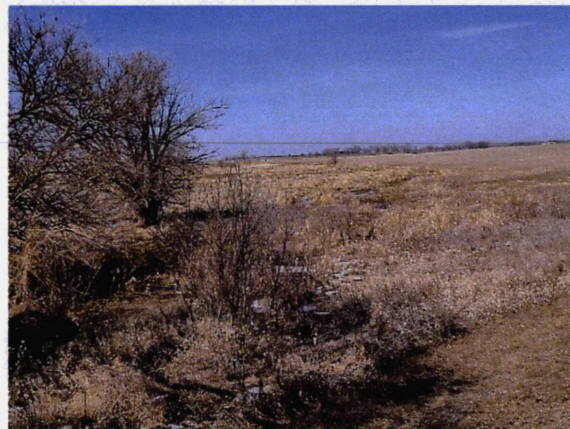
STOP 3 – Road 7/Hwy 66
41.1388323, -96.4257571
Time: 1210

Observation of water pooling on west side of Stop 3 advancing to the north.

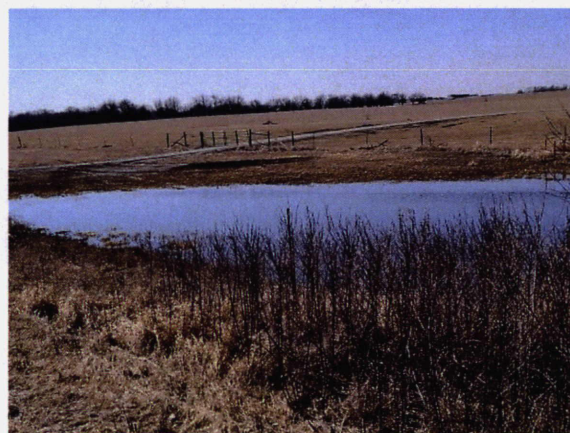
STOP 3 – Road 7/Hwy 66
41.1388323, -96.4257571
Time: 1214

Observation of water pooling on west side of Stop 3 advancing to the south.
