Daily Observation Form – DAILY REPORT
AltEn LLC – Mead, NE Release
Facility ID: 84069; State Spill Report Number: 021221-NH-845
Date: March 11, 2021
Weather: Clear, Sunny and Windy, 55 °F

Terracon

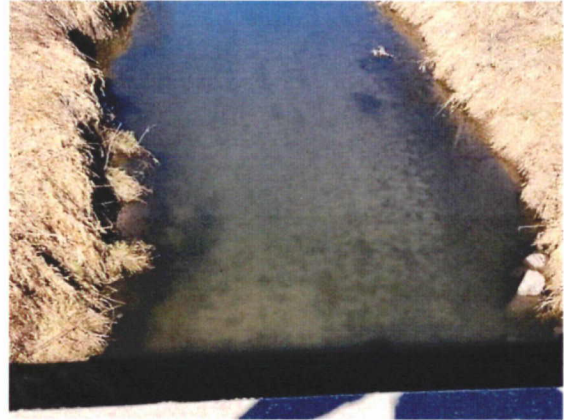
STOP 1 – Hwy 66 West of Ashland Gun Club
41.0886323, -96.380274
Time: 1314

Water is flowing at this location.

No obvious odor noted. No obvious visual signs of contamination observed at surface or on banks.

No active work was observed at the time of the site visit.

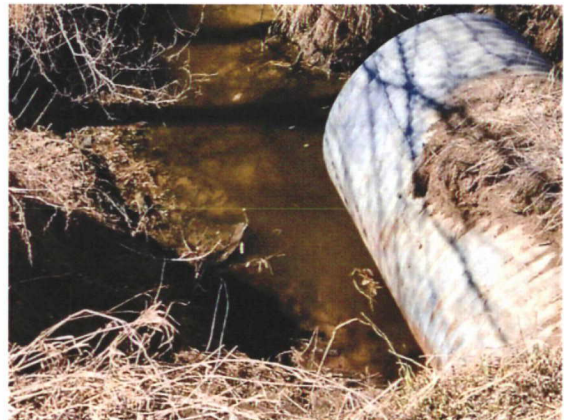
STOP 2 – North of the intersection of County Roads 6 & F
41.1334626, -96.4064519
Time: 1332

Slight odor noted. Brownish discoloration observed on the west side at surface near culvert opening.

No flow (audible or visual) observed at this location.

No active work was observed at the time of the site visit.

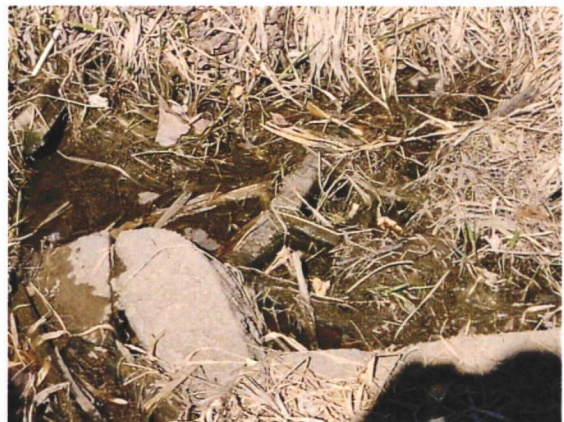
STOP 2 – North of the intersection of County Roads 6 & F
41.1334626, -96.4064519
Time: 1335

No obvious odor noted. No discoloration/minimal liquid observed on the east side at surface.

No flow (audible or visual) observed at this location.

No active work was observed at the time of the site visit.

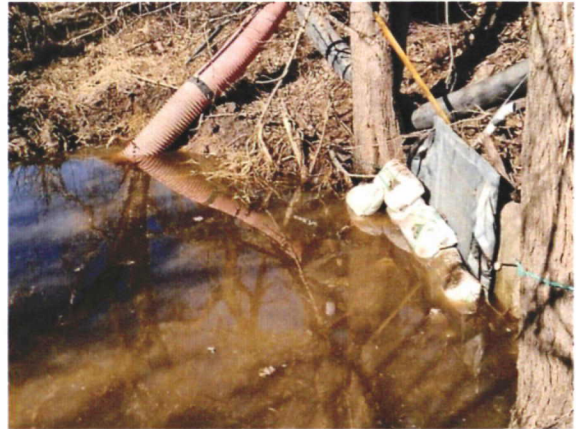
STOP 3 – Road 7/Hwy 66

Yellowish-brown discoloration observed on the west side of Stop 3. Liquid appeared turbid. Water pooling at this location. No flow (audible and visual) observed at this location. Slight suspect/obvious odor noted.

At approximately 1230, observed a mini excavator digging a “sump” in preparation of pumping activities. Pumping of liquid from west side of Stop 3 location observed at the time of this site visit.

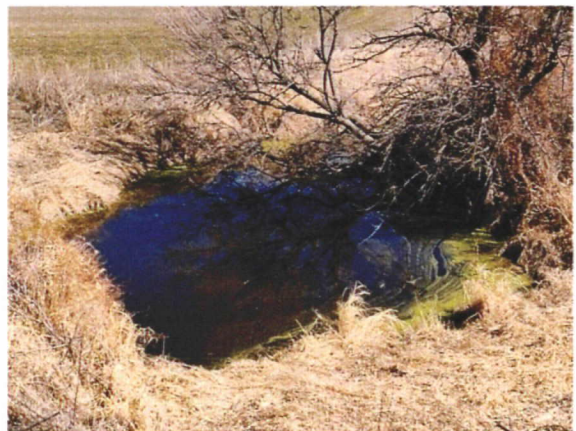
STOP 3 – Road 7/Hwy 66

Brownish discoloration observed on the east side of Stop 3. Liquid appeared turbid. No obvious odor noted. No flow (audible or visual) observed at this location.

No active work was observed on the east side of the Stop 3 location at the time of the site visit.

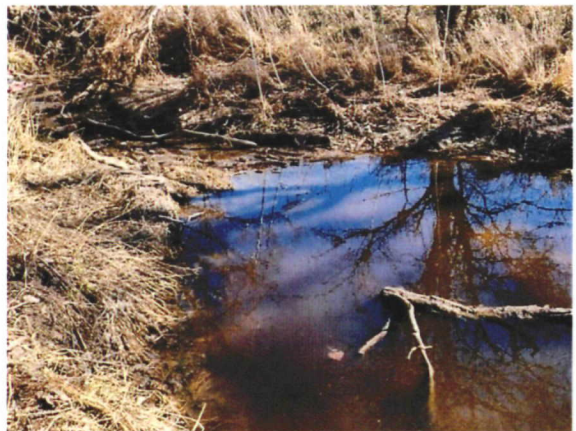
STOP 4 – County Road 8, North of Road H

Brownish discoloration observed at surface on the east side at this location. No obvious odor noted. Flow (visual) observed at this location.

No active work was observed at the time of the site visit.

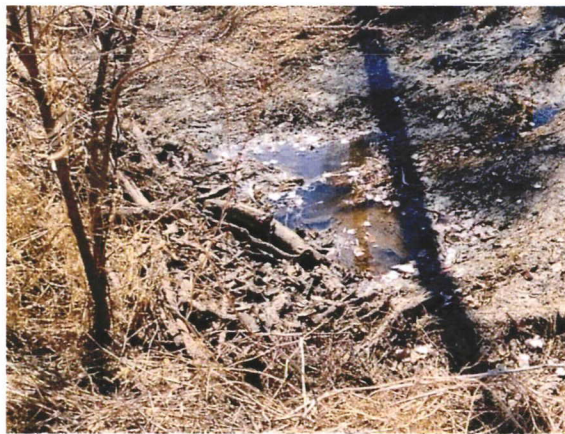
STOP 4 – County Road 8, North of Road H

Brownish discoloration observed at surface on the west side at this location. Slight odor noted. Flow (visual) observed at this location.

No active work was observed at the time of the site visit.

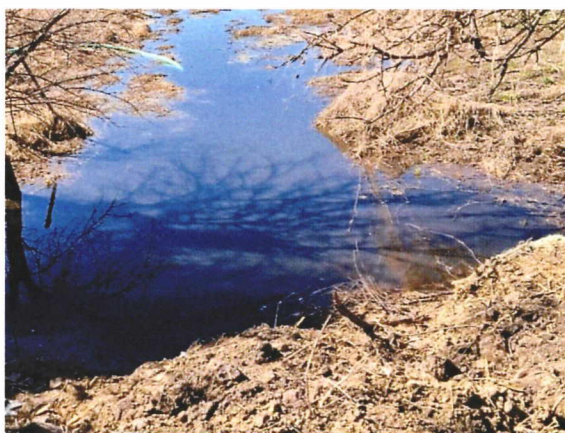
STOP 5 – UNL Eastern Extension – North of County Roads 9 & J

Brownish discoloration observed on the west side of Stop 5. Liquid appeared turbid. Strong odor noted at this location.

No flow (audible or visual) observed at this location.

Pumping of liquid inactive during this site visit.

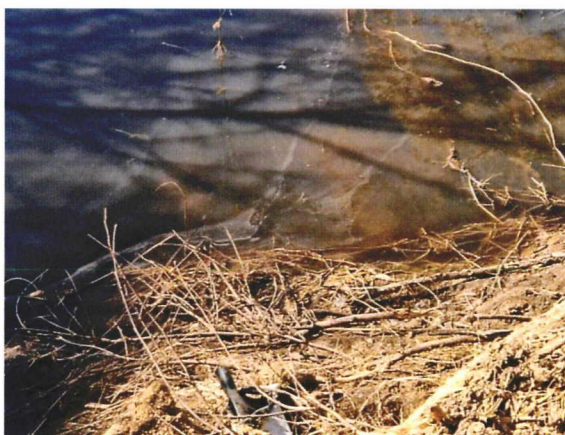
STOP 5 – UNL Eastern Extension – North of County Roads 9 & J

Brownish discoloration observed on the east side of Stop 5. Moderate odor noted at this location. Observed milky/oily film near the culvert opening.

No flow (audible or visual) observed at this location.

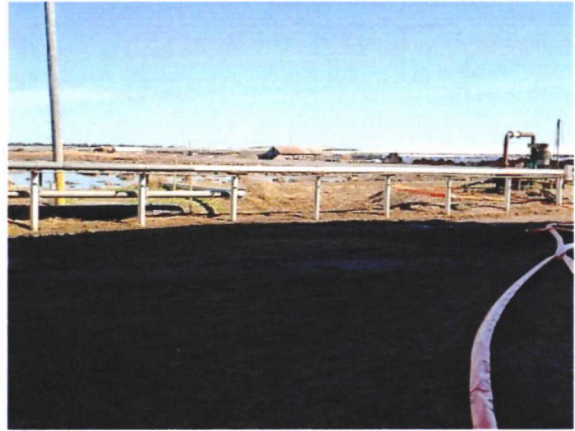
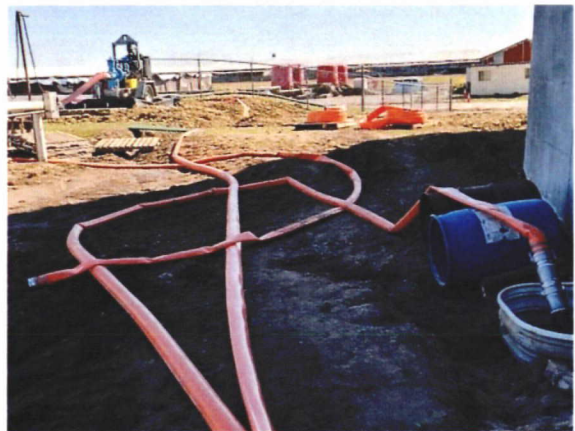
**STOP 6 – AltEn LLC Facility – East Side of
Digester 1**

No liquid observed on east side of Digester 1.
Muddy surface at the time of this visit.

Moderate odor noted at this location.

Pump proximal to the south lagoon was
inactive at the time of the site visit. The hose
connected to the pump was disconnected
from Digester 1 at the time of this visit.

A hose connected to Digester 1 continues to
run to the north of Digester 1 into the open
doorway of the building to the northwest of
Digester 1.

In addition, a hose continues to run from the
open doorway of the building to the northwest
of Digester 1, around the north and east sides
of Digester 1, and into the lagoon. Discharge
into the lagoon from the hose was not
observed at the time of the site visit.

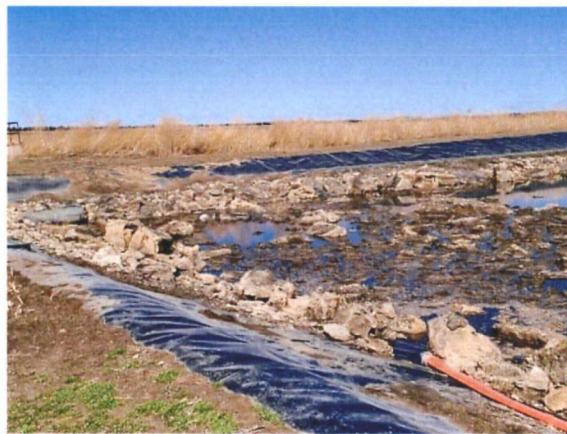
**STOP 6 – AltEn LLC Facility – Impacted
Material Disposal Site: South Lagoon
GPS: 41.195558, -96.473923
Time: 1435**

Impacted material within AltEn's lagoon.

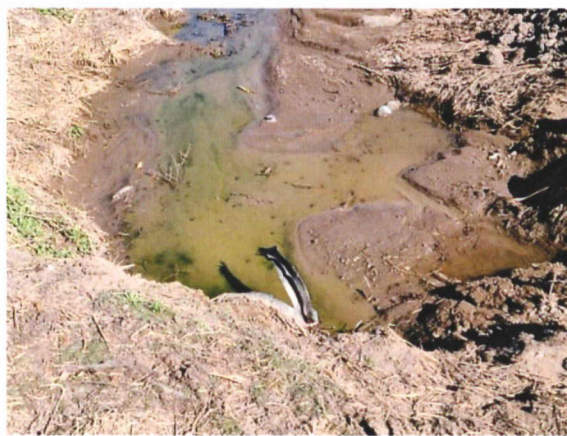
**STOP 6 – AltEn LLC Facility – Impacted
Material Disposal Site: South Lagoon
GPS: 41.195558, -96.473923
Time: 1440**

Yellowish-green discoloration observed at water surface in the drainage ditch south of the lagoon (located southeast of Digester 1). Moderate odor noted. No flow (audible or visual) observed at this location.

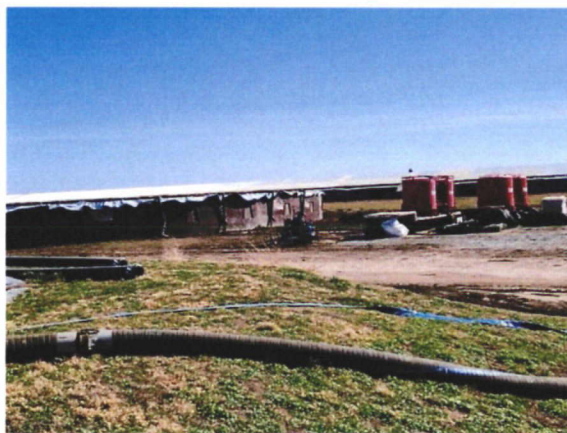
**STOP 6 – AltEn LLC Facility – South of
Emergency Lagoon
GPS: 41.19470, -96.47611
Time: 1443**

Treatment vessels and holding tank located south of the lagoon inactive at the time of this visit. Clean Harbors personnel was not observed onsite.

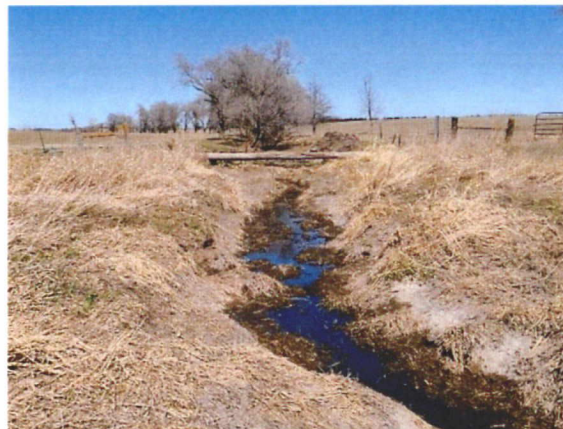
**Between Stop 3 and Stop 4 – Hwy 66,
East of Road 8**
GPS: 41.1464807, -96.4324881
Time:1215

Brownish discoloration observed on the north side of Hwy 66 at surface. Flow (audible and visual) observed at this location. Slight odor noted.

Pumping equipment and related equipment was not observed at this location at the time of the site visit.

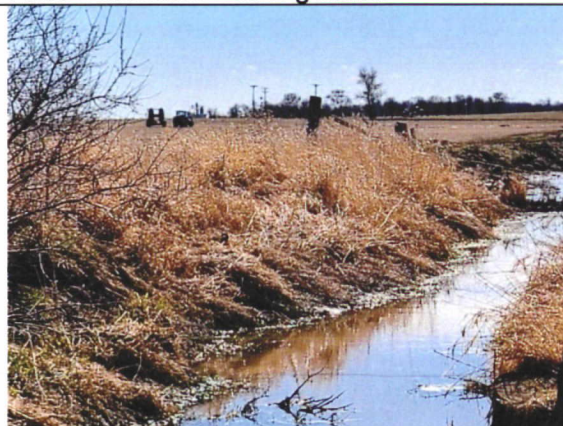
**Between Stop 3 and Stop 4 – Hwy 66,
East of Road 8**
GPS: 41.1447025, -96.4325937
Time:1220

Pumping equipment and related equipment staged approximately 30 yards east of the drainageway.

No active work was observed at the time of the site visit.

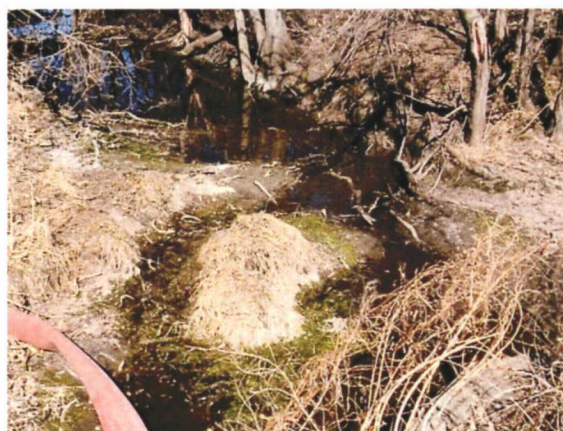
**Between Stop 3 and Stop 4 – County
Road H Between Roads 7 & 8**
GPS: 41.161258, -96.437785
Time:1344

Brownish discoloration observed on the north side of County Road H. Slight odor noted close to water at this location.

Flow (visual) observed at this location.

No active work was observed at the time of the site visit.

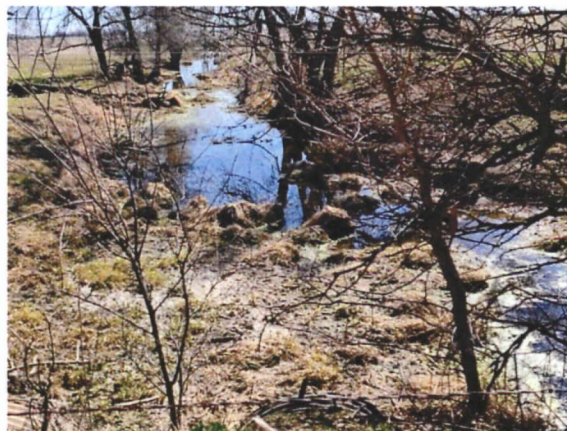
Between Stop 3 and Stop 4 – County Road H Between Roads 7 & 8
GPS: 41.161258, -96.437785
Time: 1347

Brownish discoloration observed on the south side of County Road H. Slight odor noted at this location.

Flow (visual) observed at this location.

No active work was observed at the time of the site visit.

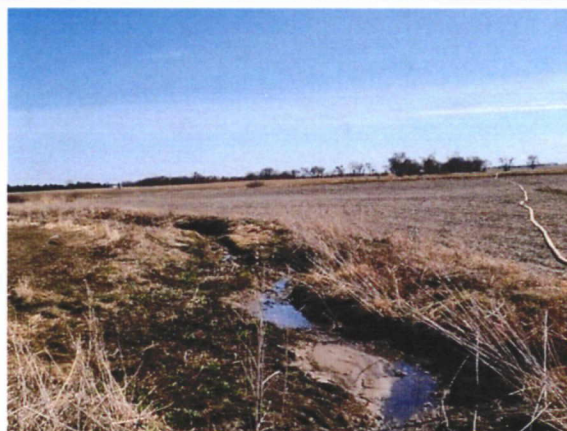
Between Stop 4 and Stop 5 – UNL Eastern Extension – Southeast of County Roads 9 & J
GPS: 41.1850660, -96.4616990
Time: 1402

Brownish discoloration observed on the south side of County Road J. Moderate odor noted at this location.

No flow (audible or visual) observed at this location.

No active work was observed at the time of

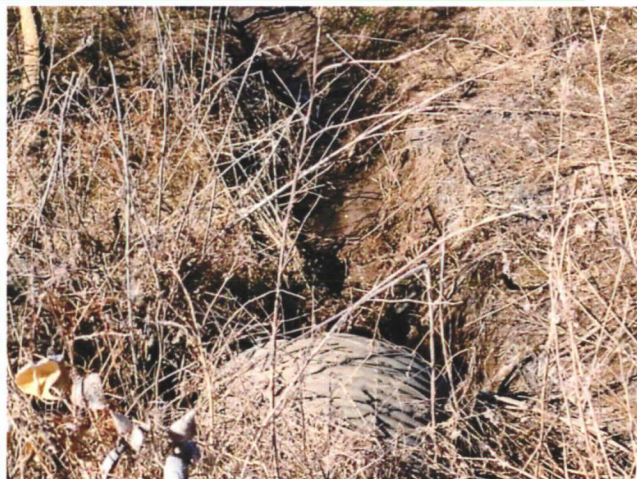
Between Stop 4 and Stop 5 – UNL Eastern Extension – Southeast of County Roads 9 & J
GPS: 41.1850660, -96.4616990
Time: 1402

Minimal liquid observed on the north side of County Road J. Moderate odor noted at this location.

No flow (audible or visual) observed at this location.

No active work was observed at the time of the site visit.
