Daily Observation Form – DAILY REPORT
AltEn LLC – Mead, NE Release
Facility ID: 84069; State Spill Report Number: 021221-NH-845
Date: March 5, 2021
Weather: Clear and Sunny, 57 °F

Terracon

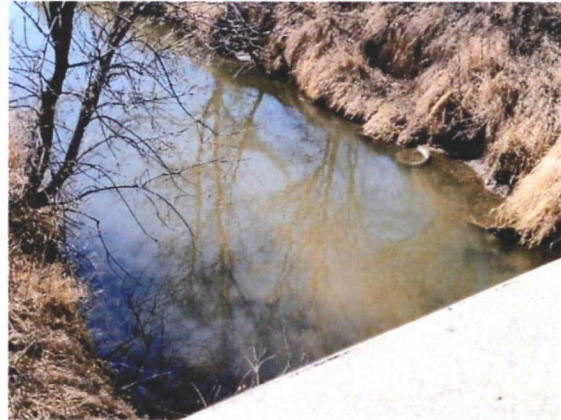
STOP 1 – Hwy 66 West of Ashland Gun Club
41.0886323, -96.380274
Time: 1204

Water is flowing at this location.

No suspect/obvious odor noted. No obvious visual signs of contamination observed at surface or on banks.

No active work was observed at the time of the site visit.

Photo Direction: Looking southwest.

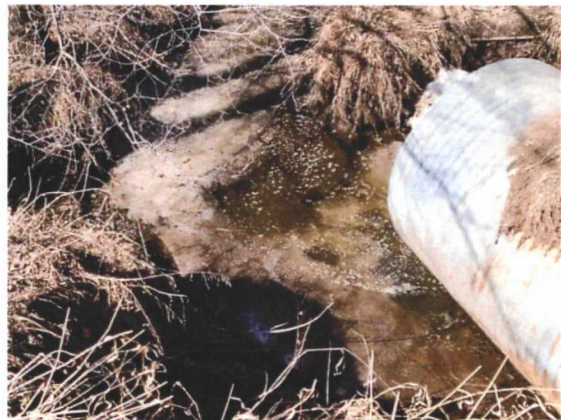
STOP 2 – North of the intersection of County Roads 6 & F
41.1334626, -96.4064519
Time: 1221

Slight odor noted. Yellowish-brown discoloration observed on the west side at surface near culvert opening. Liquid appeared turbid.

Flow (audible) observed at this location.

No active work was observed at the time of the site visit.

Photo Direction: Looking northwest.

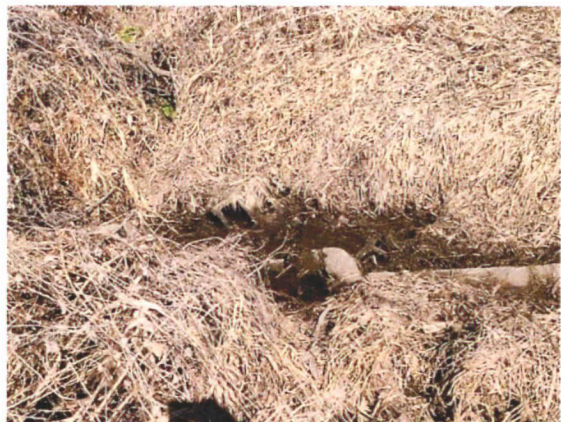
STOP 2 – North of the intersection of County Roads 6 & F
41.1334626, -96.4064519
Time: 1224

Slight odor noted. No discoloration observed on the east side at surface. Liquid appeared turbid.

Flow (audible and visual) observed at this location.

No active work was observed at the time of the site visit.

Photo Direction: Looking north.

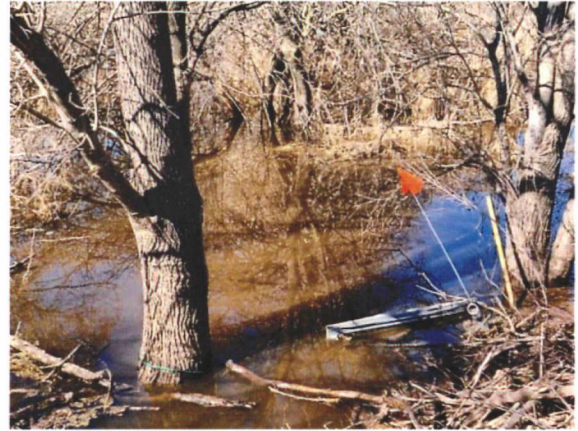
STOP 3 – Road 7/Hwy 66

Yellowish-brown discoloration observed on the west side of Stop 3. Liquid appeared turbid. Water pooling at this location. No flow (audible and visual) observed at this location. No suspect/obvious odor noted.

No active work was observed on the west side of the Stop 3 location at the time of the site visit.

Photo Direction: Looking northwest.

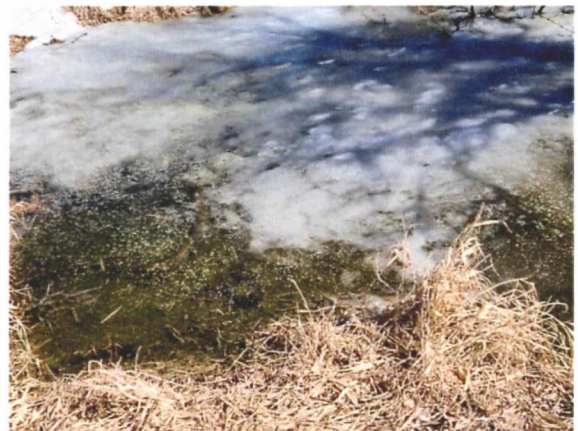
STOP 3 – Road 7/Hwy 66

Yellowish discoloration observed on the east side of Stop 3. No suspect/obvious odor noted. No flow (audible or visual) observed at this location. Ice covered observed.

No active work was observed on the east side of the Stop 3 location at the time of the site visit.

Photo Direction: Looking northeast.

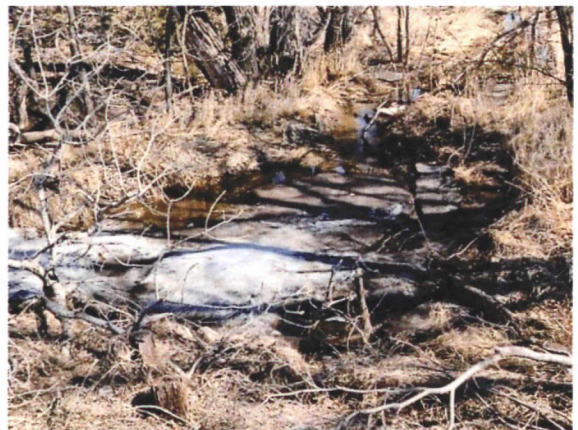
STOP 4 – County Road 8, North of Road H

Yellowish-brown discoloration observed at surface on the east side at this location. Slight odor noted. Flow (audible and visual) observed at this location. Observed flow from adjacent fields coming into the area.

No active work was observed at the time of the site visit.

Photo Direction: Looking east.

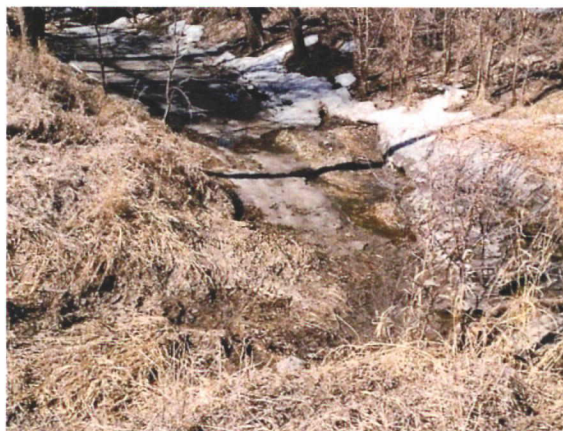
STOP 4 – County Road 8, North of Road H
GPS: 41.1677657, -96.4447025
Time: 1248

Yellowish-brown discoloration observed at surface on the west side at this location. Slight odor noted. Flow (audible and visual) observed at this location. Observed flow from adjacent fields coming into the area.

No active work was observed at the time of the site visit.

Photo Direction: Looking west.

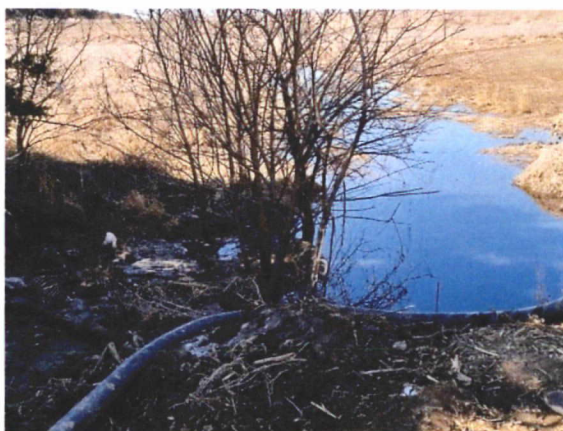
STOP 5 – UNL Eastern Extension – North of County Roads 9 & J
GPS: 41.1862613, -96.4638642
Time: 1308

Yellowish-brown discoloration observed on the west side of Stop 5. Liquid appeared turbid. Moderate odor noted at this location.

No flow (audible or visual) observed at this location.

Pumping of impacted material inactive during this site visit. In addition, pump was inactive at 1423 during a second visit at this location.

Photo Direction: Looking west.

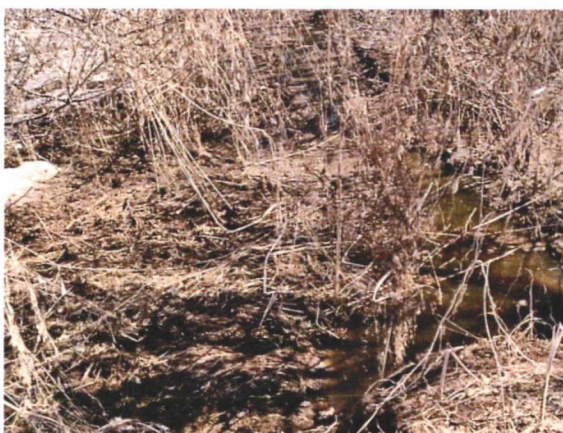
STOP 5 – UNL Eastern Extension – North of County Roads 9 & J
GPS: 41.1862613, -96.4638642
Time: 1311

Yellowish-brown discoloration observed on the east side of Stop 5. Liquid appeared turbid. Slight odor noted at this location. Observed flow from adjacent fields coming into the area.

No flow (audible or visual) observed within the drainageway at this location.

Photo Direction: Looking east.

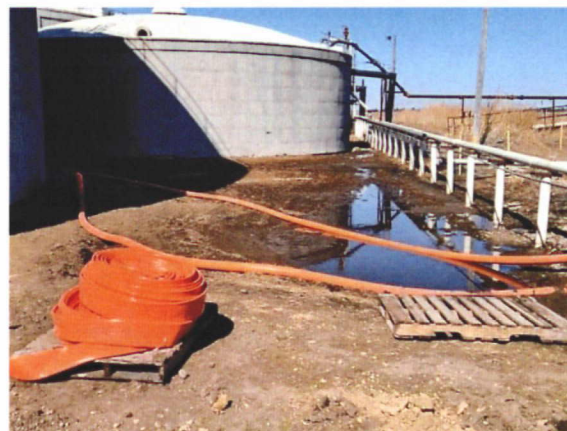
STOP 6 – AltEn LLC Facility – East Side of Digester 1

Yellowish-brown discoloration observed on the east side of Digester 1.

Strong odor noted at this location.

Pump proximal to the south lagoon connected to Digester 1 active at the time of this visit.

Photo Direction: Looking northwest.

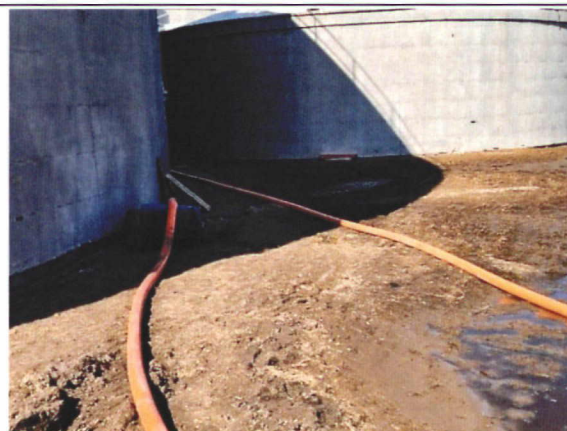
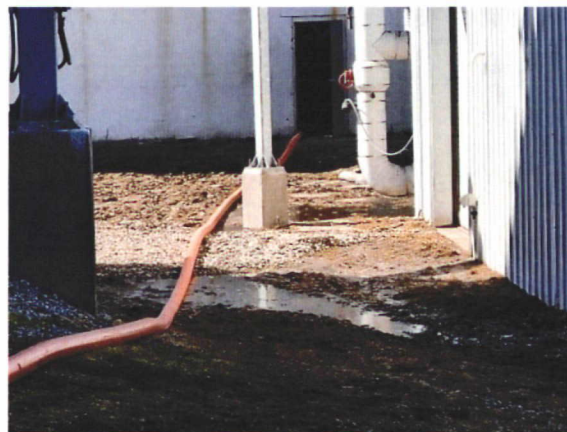
STOP 6 – AltEn LLC Facility – East Side of Digester 1

Pump proximal to the south lagoon connected to Digester 1 active at the time of this visit.

Second hose connected to the above referenced pump continues to run to the north of Digester 1 into the open doorway of the building to the northwest of Digester 1.

Photo Direction: Looking northwest.

Photo Direction: Looking west/northwest.

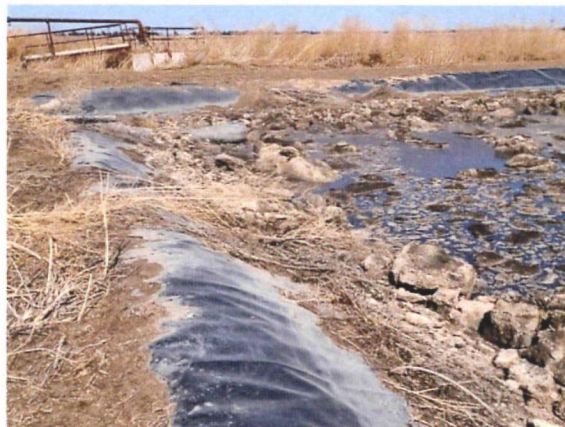
**STOP 6 – AltEn LLC Facility – Impacted
Material Disposal Site: South Lagoon
GPS: 41.195558, -96.473923
Time: 1331**

Impacted material within AltEn's lagoon.

Photo Direction: Looking north.

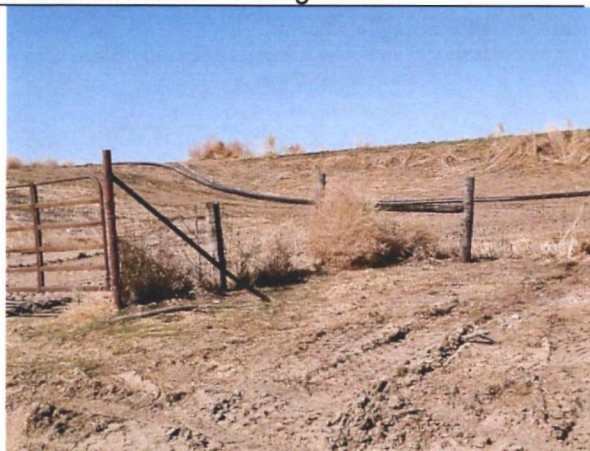
**STOP 6 – AltEn LLC Facility – Impacted
Material Disposal Site: South Lagoon
GPS: 41.195534, -96.4737120
Time: 1359**

Hoses from pumping locations between Stop 3 and Stop 4 – Hwy 66, East of Road 8 and Stop 5 entering AltEn's lagoon system.

Photo Direction: Looking northwest.

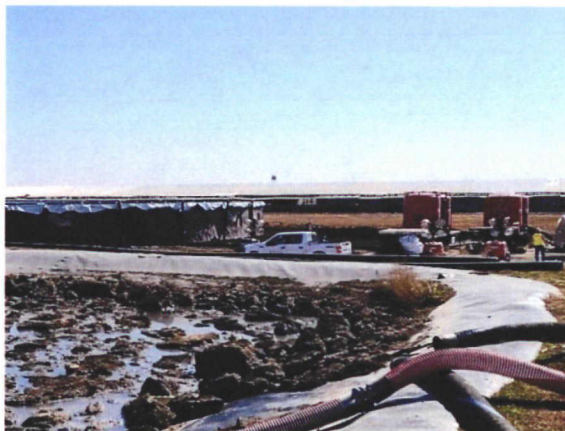
**STOP 6 – AltEn LLC Facility – South of
Emergency Lagoon
GPS: 41.19470, -96.47611
Time: 1333**

Treatment vessels and containment tank located south of the lagoon. The pump associated with the treatment vessels was inactive at the time of the site visit. Based on conversations with Clean Harbors, pumping of liquid through the treatment vessels was being suspended as they had pumped the practical limit of recoverable liquid. According to Clean Harbors, the remaining material in the lagoon comprised mostly of sediment, slurry, and solids.

Photo Direction: Looking south.

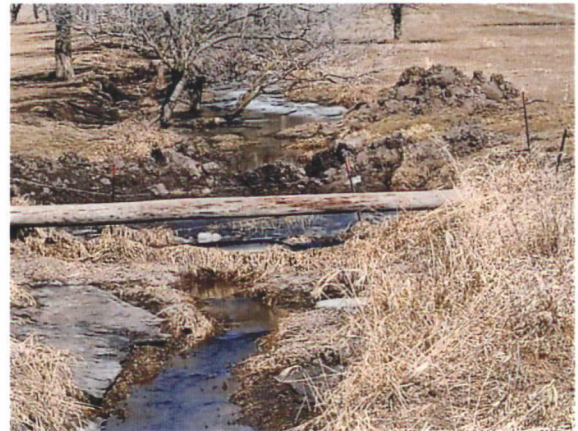
Between Stop 3 and Stop 4 – Hwy 66, East of Road 8

Yellowish-brown discoloration observed on the north side of Hwy 66 at surface. Liquid appeared turbid. Flow (visual) observed at this location. No suspect/obvious odor noted.

Soil berm partially in place during time of this visit.

All equipment has been relocated to the south side of Hwy 66.

Photo Direction: Looking north.

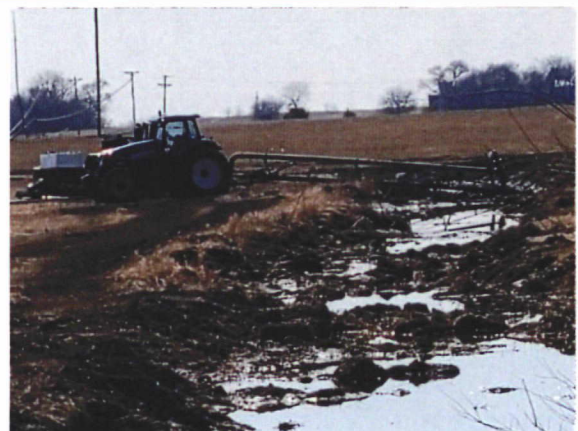
Between Stop 3 and Stop 4 – Hwy 66, East of Road 8

Pumping equipment observed on the south side of Hwy 66.

The air compressor (minimizes solids being pulled into the pump) and pump were active during this visit.

Photo Direction: Looking south.

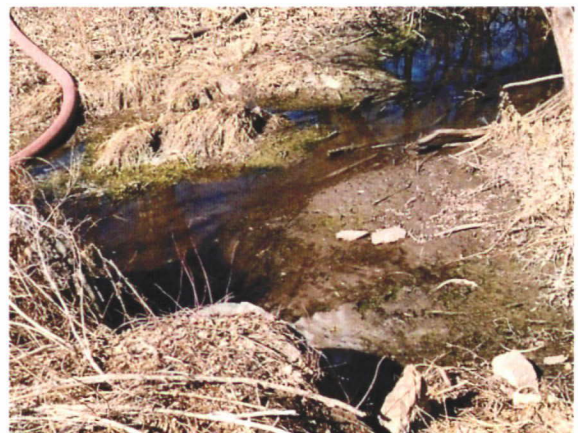
Between Stop 3 and Stop 4 – County Road H Between Roads 7 & 8

Yellowish-brown discoloration observed on the north side of County Road H. Slight odor noted at this location.

Flow (audible) observed at this location.

No active work was observed at the time of the site visit.

Photo Direction: Looking northwest.

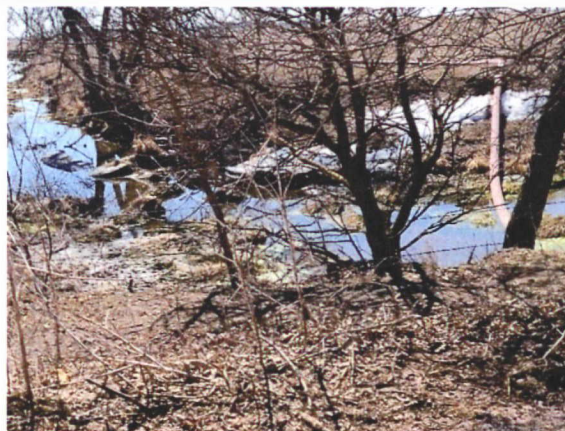
Between Stop 3 and Stop 4 – County Road H Between Roads 7 & 8
GPS: 41.161258, -96.437785
Time: 1237

Yellowish-brown discoloration observed on the south side of County Road H. Liquid appeared turbid. Slight odor noted at this location.

Flow (audible and visual) observed.

No active work was observed at the time of the site visit.

Photo Direction: Looking southwest.

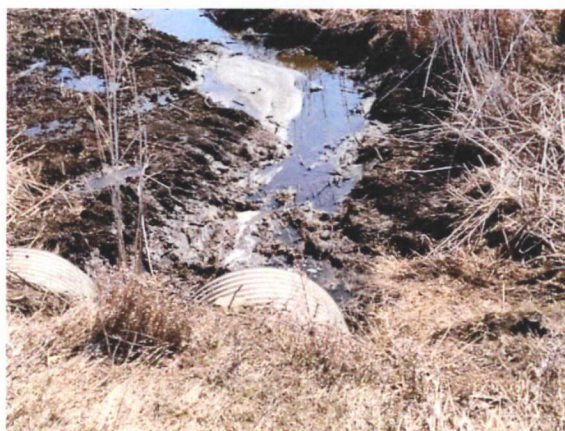
Between Stop 4 and Stop 5 – UNL Eastern Extension – Southeast of County Roads 9 & J
GPS: 41.1850660, -96.4616990
Time: 1302

Yellowish discoloration with turbidity observed on the south side of County Road J. Slight odor noted at this location.

Flow (audible and visual) observed.

No active work was observed at the time of the site visit.

Photo Direction: Looking south.

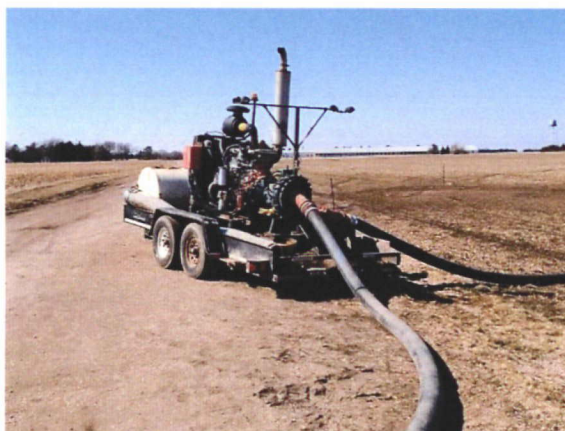
Between Stop 4 and Stop 5 – County Road I Between Roads 8 & 9
GPS: 41.1757201, -96.4589467
Time: 1254

During the sampling activities March 3, 2021, between Stop 3 and Stop 4 – Hwy 66, East of Road 8, informed by University of Nebraska personnel the booster pump located between Stop 4 and Stop 5 was leaking from the hose connection(s).

Leaking connections were not observed at the time of this site visit.

Photo Direction: Looking west.

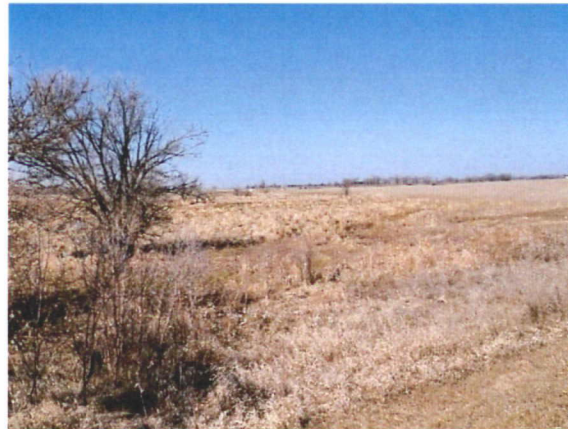
STOP 3 – Road 7/Hwy 66
41.1388323, -96.4257571
Time: 1151

Observation of water pooling on west side of
Stop 3 advancing to the north.

Photo Direction: Looking northwest.

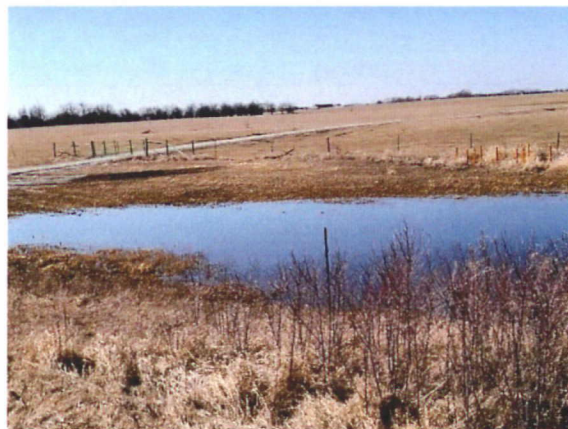
STOP 3 – Road 7/Hwy 66
41.1388323, -96.4257571
Time: 1153

Observation of water pooling on west side of
Stop 3 advancing to the south.

Photo Direction: Looking southwest.
