# Above the Flood: Elevating Your Floodprone House

FEMA 347/ May 2000

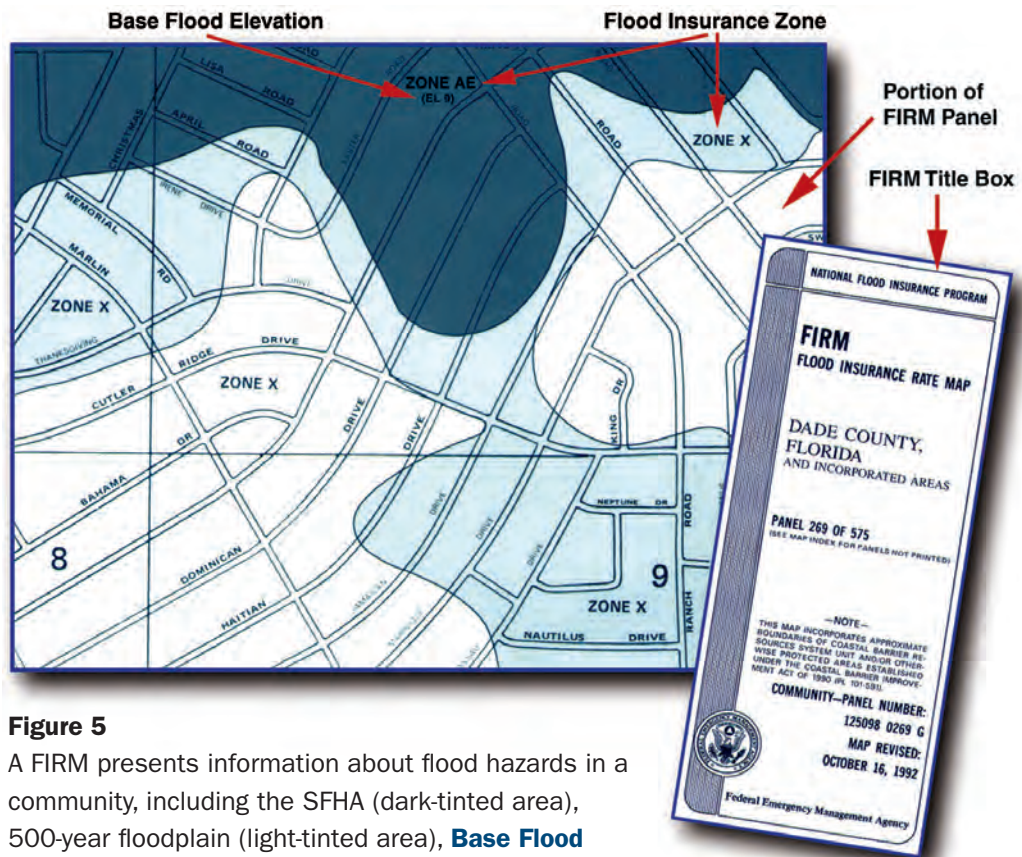
**Figure 5**

A FIRM presents information about flood hazards in a community, including the SFHA (dark-tinted area), 500-year floodplain (light-tinted area), **Base Flood Elevations**, (BFEs) (number in parentheses), and flood insurance zones (AE and X in this example).

Note that the SFHA in the example in Figure 5 is designated Zone AE. This zone is only one of several applied to SFHAs under the NFIP, including V, VE, V1-V30, A, AE, A1-A30, AO, and AH. These zones indicate differences in the types and severity of flood hazards in SFHAs. For the purposes of this publication, it is sufficient to focus on the basic differences between the two main types of SFHA zones—V zones and A zones. The distinction is important because regulatory requirements associated with V zones and A zones differ significantly. As explained later in this chapter, these requirements affect the types of building elevation techniques that may be used under the NFIP.

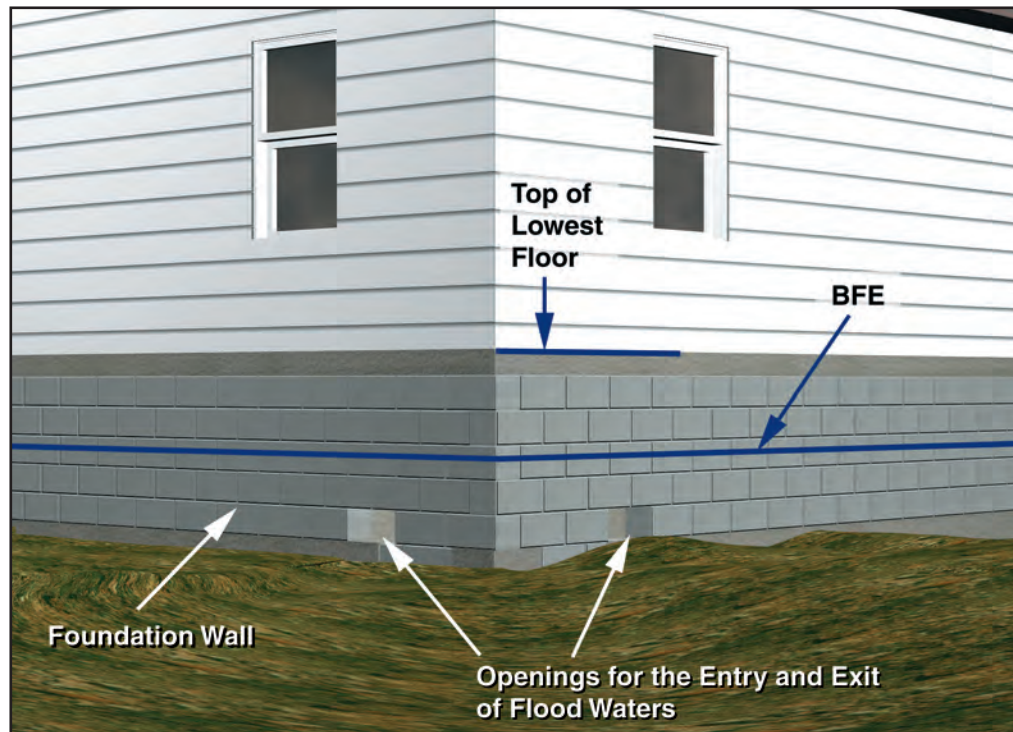
**Figure 6**

In a new, substantially improved, or substantially damaged building in an A zone, the elevation of the lowest floor must be at or above the BFE.

In A zones, where flood hazards are less severe, buildings may be elevated either on an open foundation or on continuous foundation walls below the BFE (Figure 6). Regardless of the type of foundation used, A-zone buildings must be elevated so that the **lowest floor** is at or above the BFE, as shown in Figure 6. If continuous walls are used below the BFE, they must be equipped with openings that allow flood waters to flow into and out of the area enclosed by the walls (Figure 6). Allowing the entry and exit of flood waters ensures that water pressures will be the same on both sides of the walls and reduces the likelihood that water pressure will cause the walls to fail.

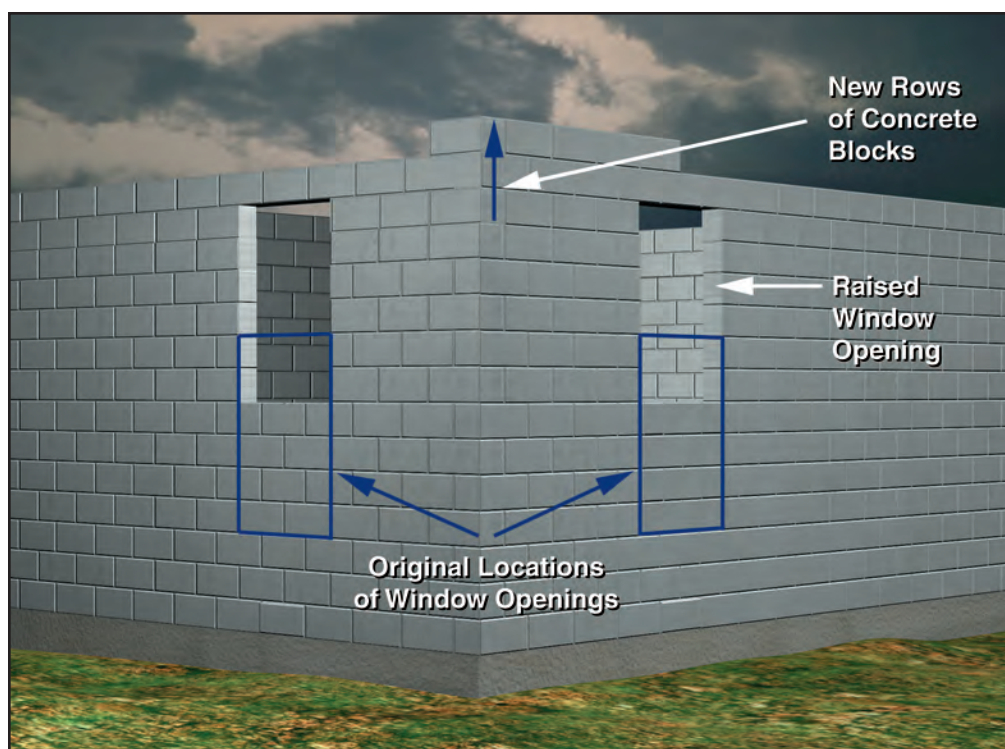
The tops of the walls and bottoms of the window openings are raised with concrete blocks.

After the roof, windows, and doors are removed, several courses of concrete block are added to the tops of the existing walls and to the bottoms of the window openings (Figure 11). A corresponding number of blocks are removed from the tops of the window openings so that the size of the windows will remain the same. In addition, although not shown in Figure 11, concrete bond beams are formed in place at the tops of the extended walls to provide structural reinforcement.

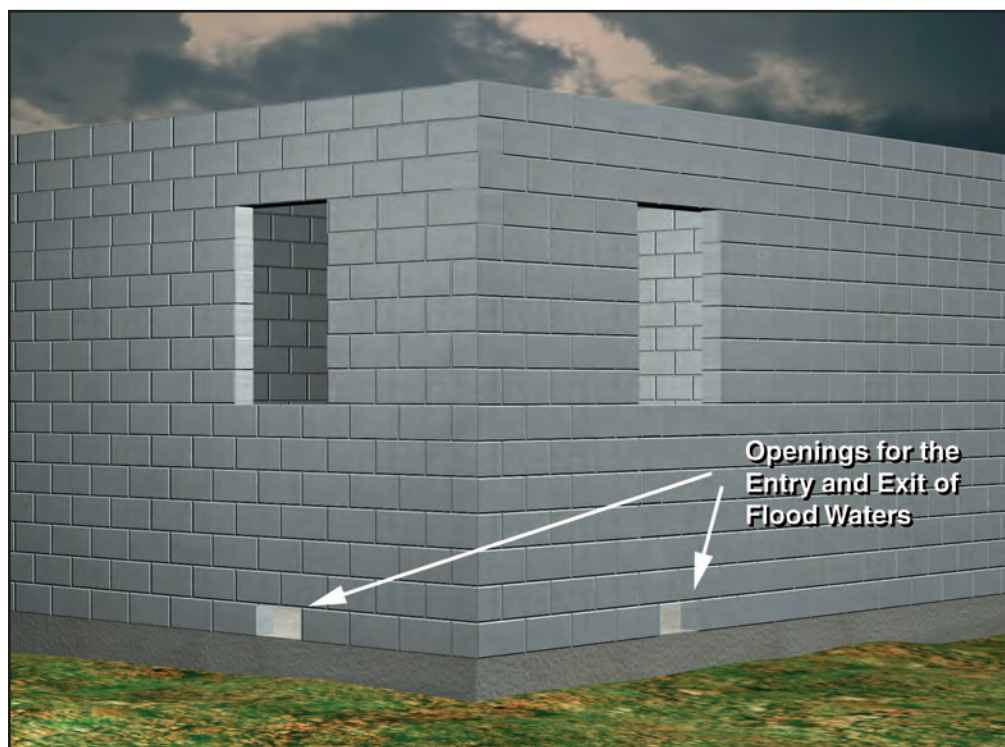
**Figure 12**  
Openings are created  
in the walls near the  
ground.

Blocks are removed from the walls of the house at selected locations within 1 foot of the ground (Figure 12). The resulting openings will allow flood waters to flow into and out of the lower area of the house so that the water pressures on both sides of the walls will remain the same. The roof and windows are then replaced, and a new wood-frame floor is constructed above the flood level (Figure 13).

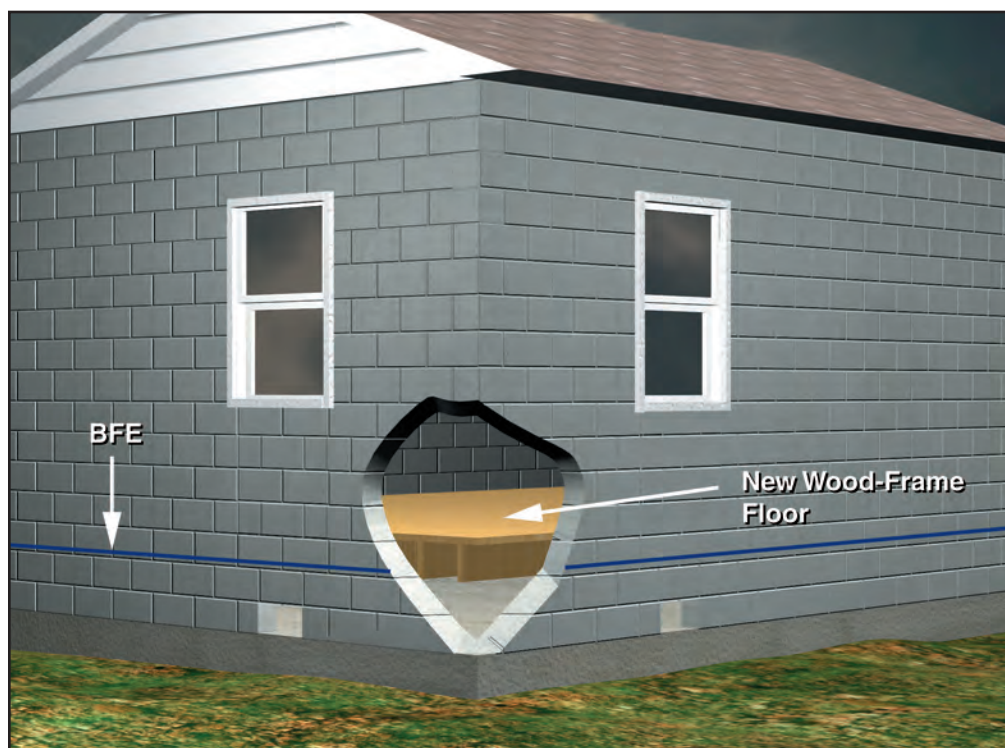
**Figure 13**  
A new wood-frame  
lowest floor is  
constructed above the  
flood level, and the  
roof, windows, and  
doors are reinstalled.

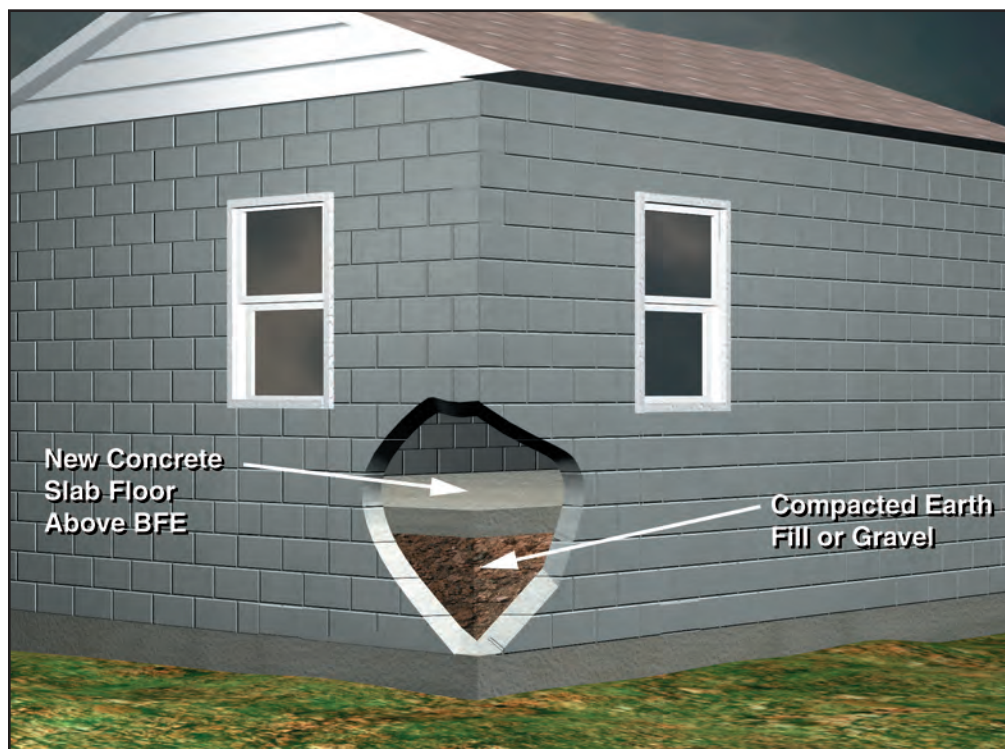
**Figure 14**  
An alternative to building an elevated wood-frame floor is installing a new, elevated concrete slab floor on fill placed over the old slab.

A homeowner who chooses Technique 1 may decide to build a new concrete slab floor instead of a wood floor (Figure 14). When this option is chosen, compacted fill dirt or gravel is placed on top of the old slab and the new slab floor is poured on top. Because the area below the new floor is filled with dirt or gravel, wall openings are not required.

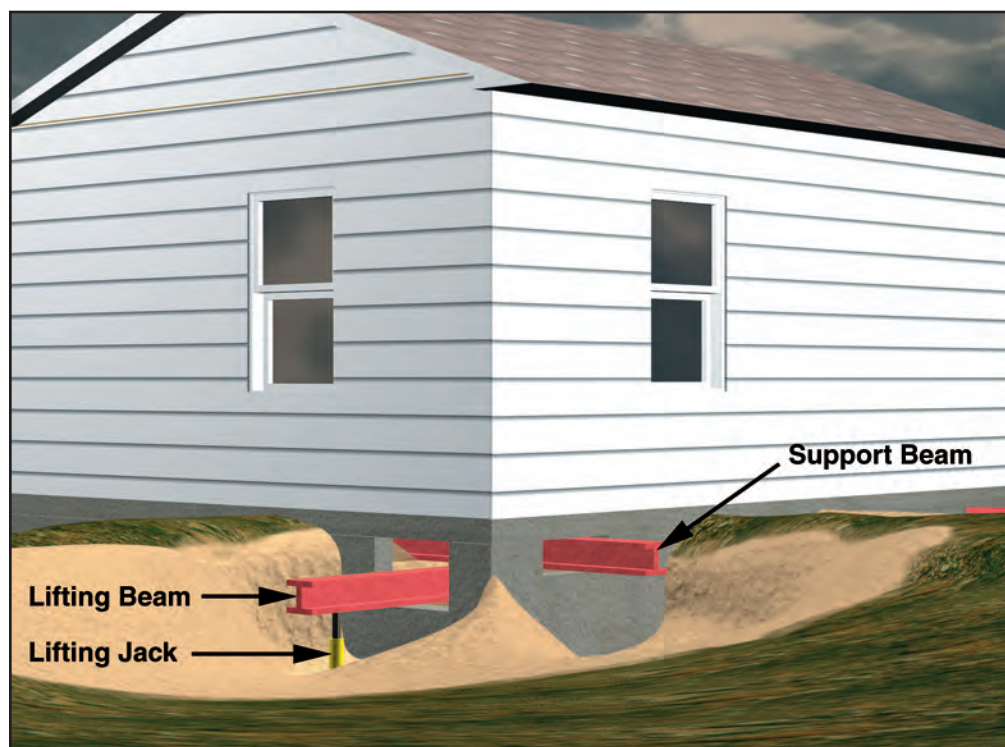
**Figure 18**  
With I-beams and jacks in place, the house is ready to be lifted.

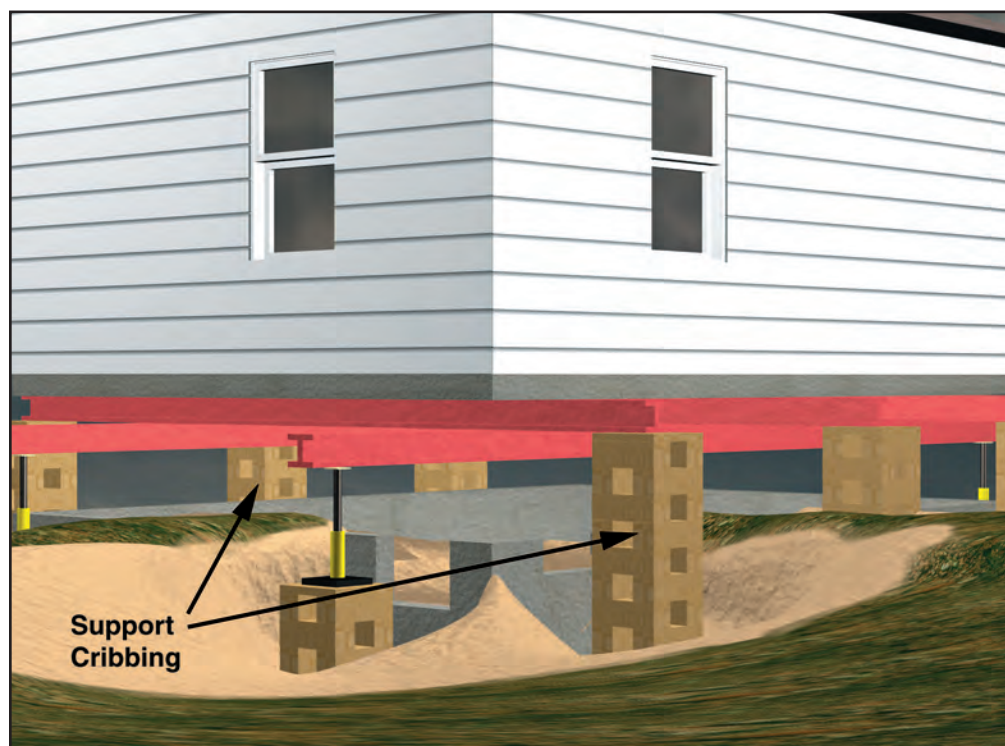
**Figure 19**  
The house is temporarily supported on cribbing.

The house is then jacked up. When the jacks have extended as far as possible, the house must be supported temporarily while the jacks are raised. Both the house and the jacks are usually supported on “cribbing”—temporary piles of crisscrossed timbers (Figure 19). The jacks are then used to raise the house higher.

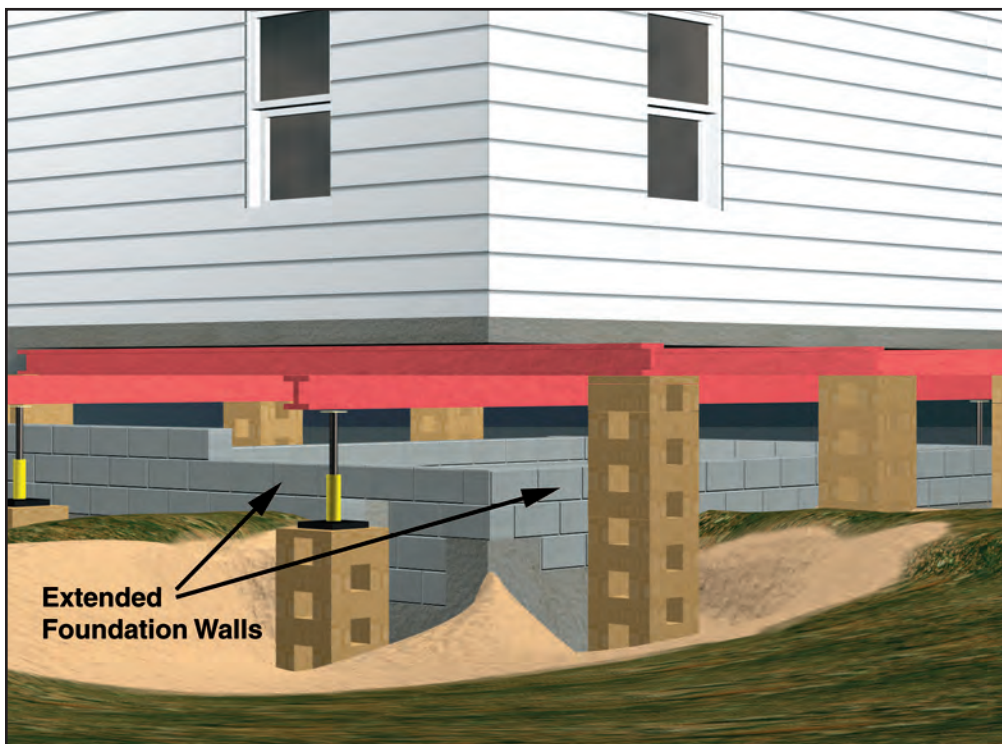
**Figure 20**  
New, extended  
foundation walls are  
constructed with  
concrete blocks.

This process is repeated until the house is raised to the desired height. The foundation walls are then extended upward with additional rows of concrete block (Figure 20). As in the previous techniques, openings are made in the walls within 1 foot of the ground so that flood waters will be able to flow into and out of the area below the elevated floor. The jacks and beams are removed, and the openings left around the beams are filled with blocks (Figure 21).

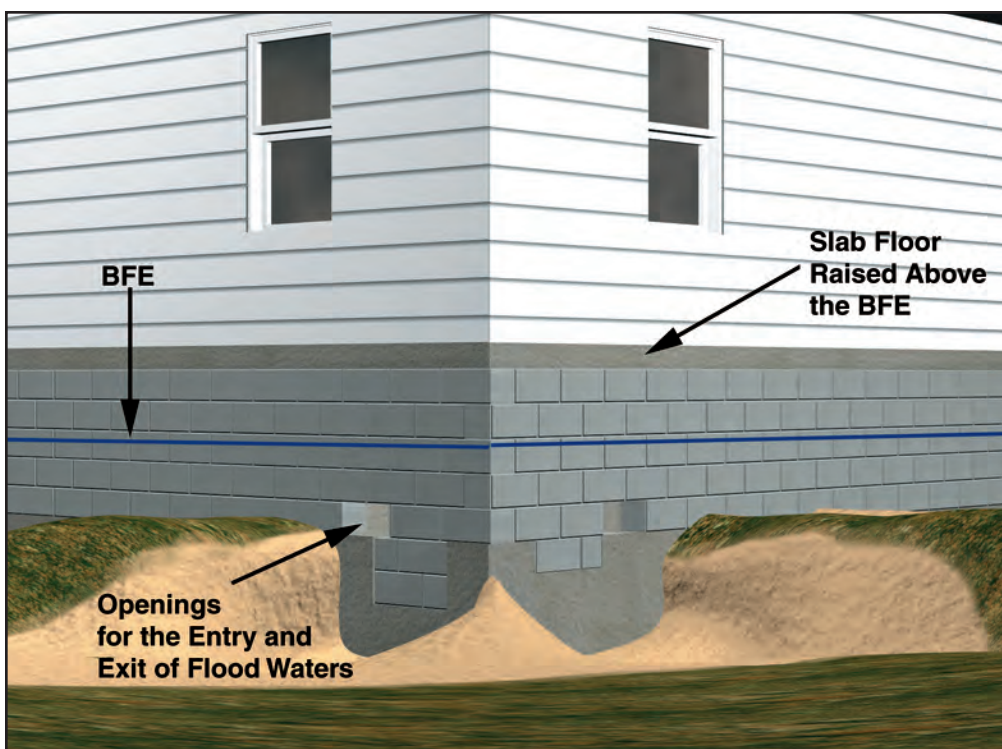
**Figure 21**  
Elevated house and  
slab on new, extended  
foundation walls.

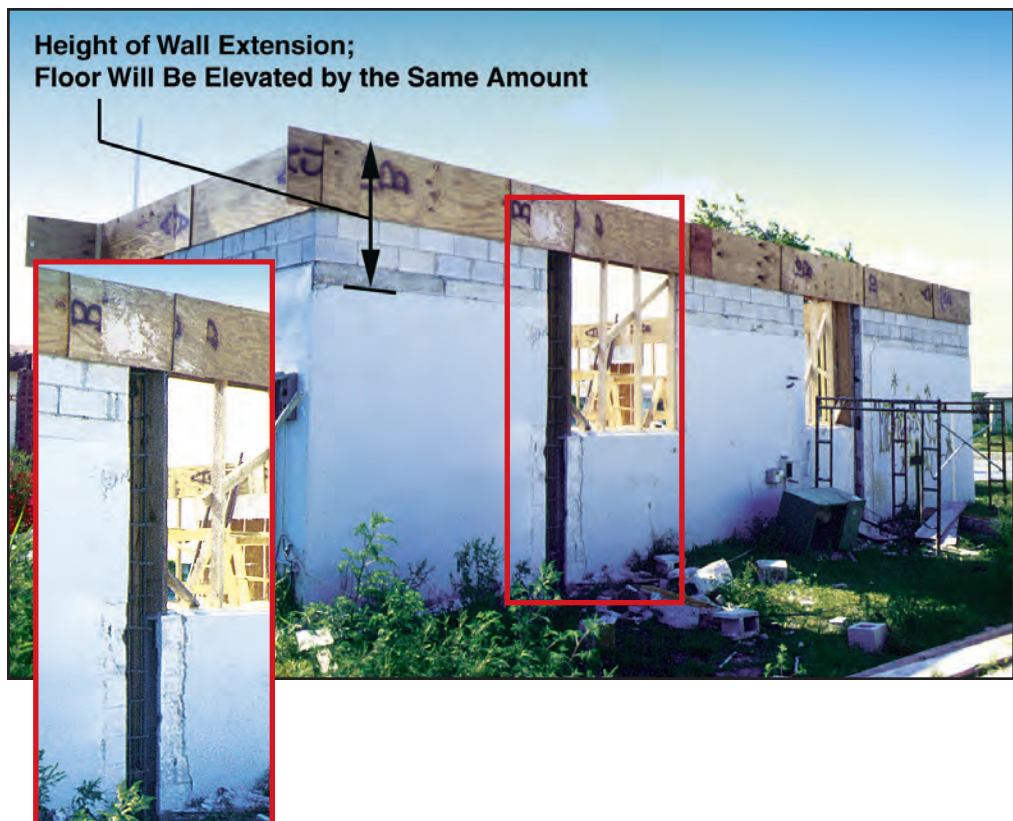
Another view of the extended walls. The vertical cuts in the walls next to the windows are for concrete tiedown columns that will be cast in place to further strengthen the extended walls against wind loads. The owner of this house was able to meet the elevation requirement by raising the floor only a few feet, as indicated by the amount that the walls have been extended.

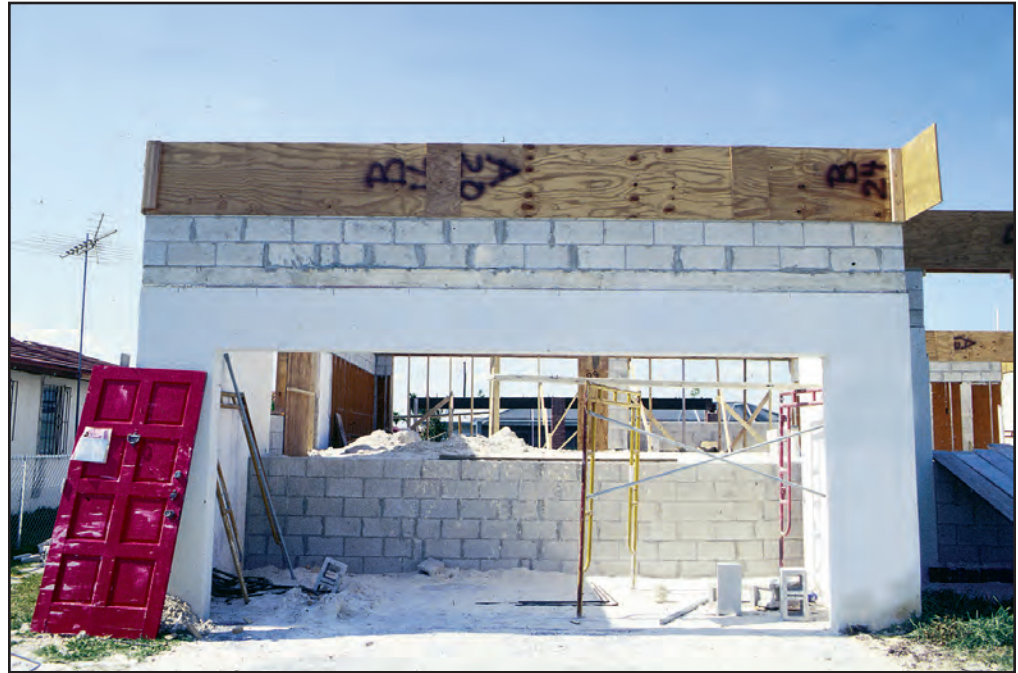
**Figure 25**

This view through the garage door reveals the different levels of the elevated slab floor, in the background, and the unelevated garage floor.

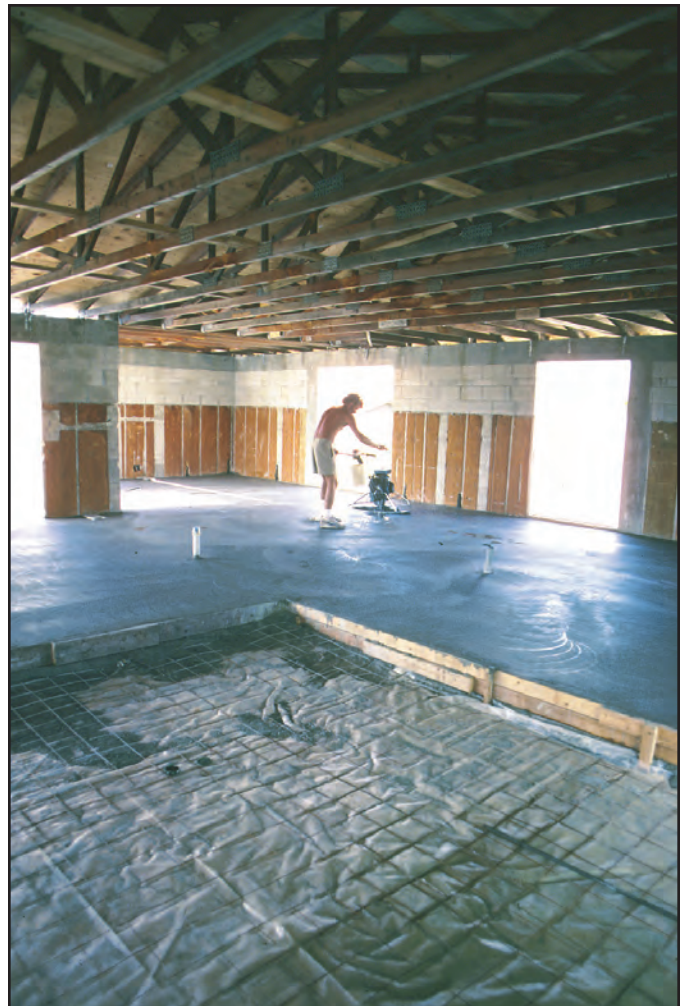
**Figure 26**

The roof has been rebuilt with the salvaged trusses, and most of the new concrete slab has been poured on top of the sand fill. The open area in the foreground, where plastic sheeting and wire reinforcement can be seen on top of the sand fill, is where the remaining part of the slab will be poured.

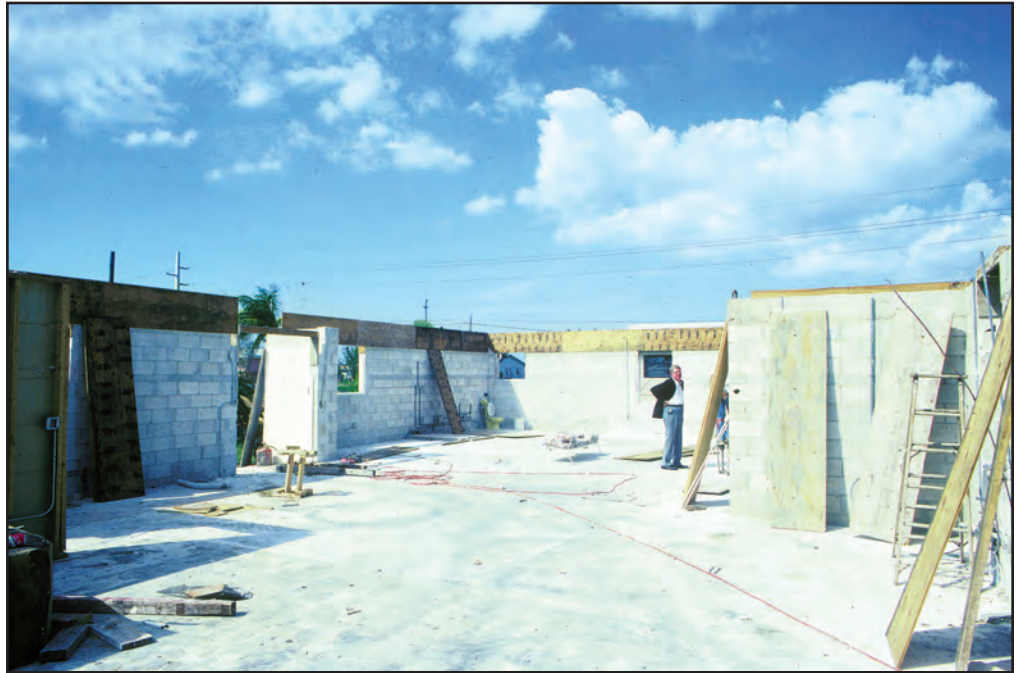
**Figure 40**

After the roof was removed and the storm-damaged interior gutted, the walls of the house were extended upward and a new bond beam added at the top.

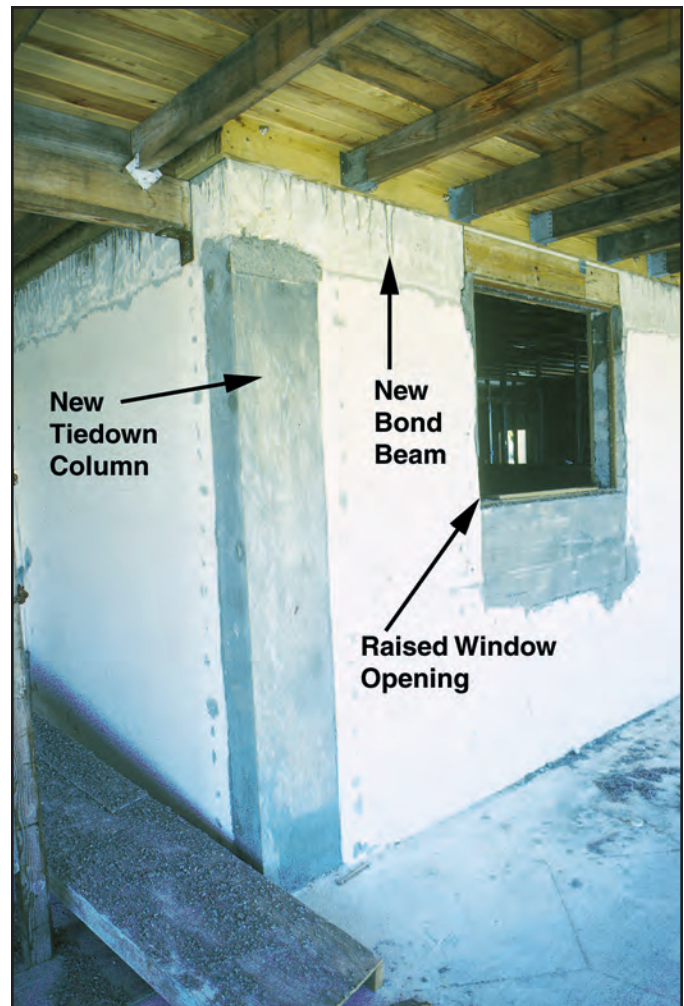
**Figure 41**

Note the new bond beam at the top of the extended wall, the new concrete tiedown column at the corner, and the raised window opening.

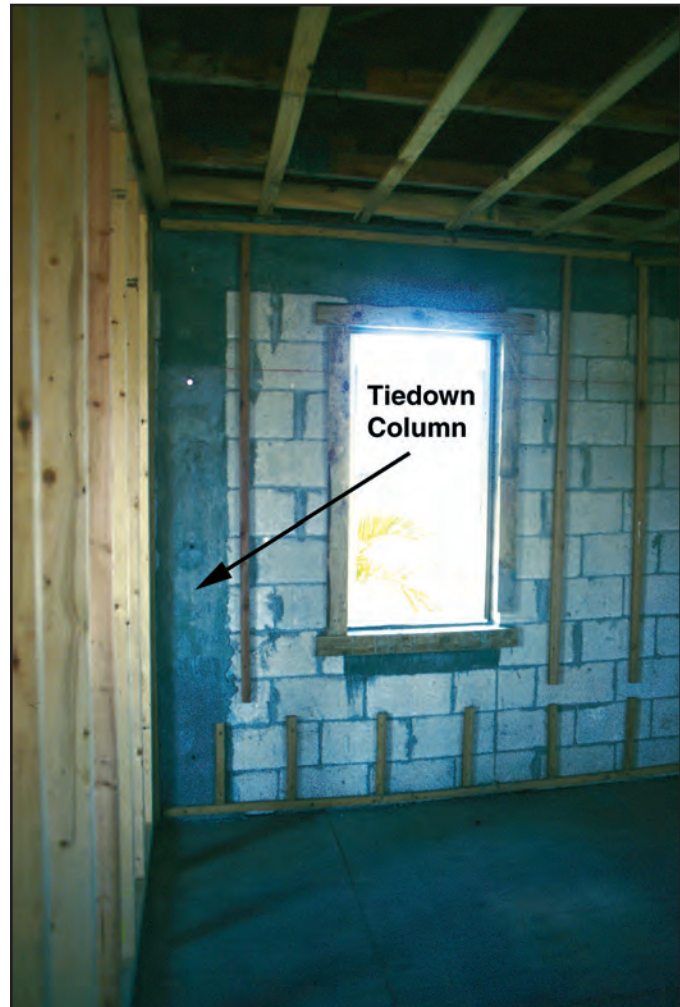
**Figure 46**  
Concrete tiedown columns, such as the one to the left of the window in this photograph, were also used in this house.

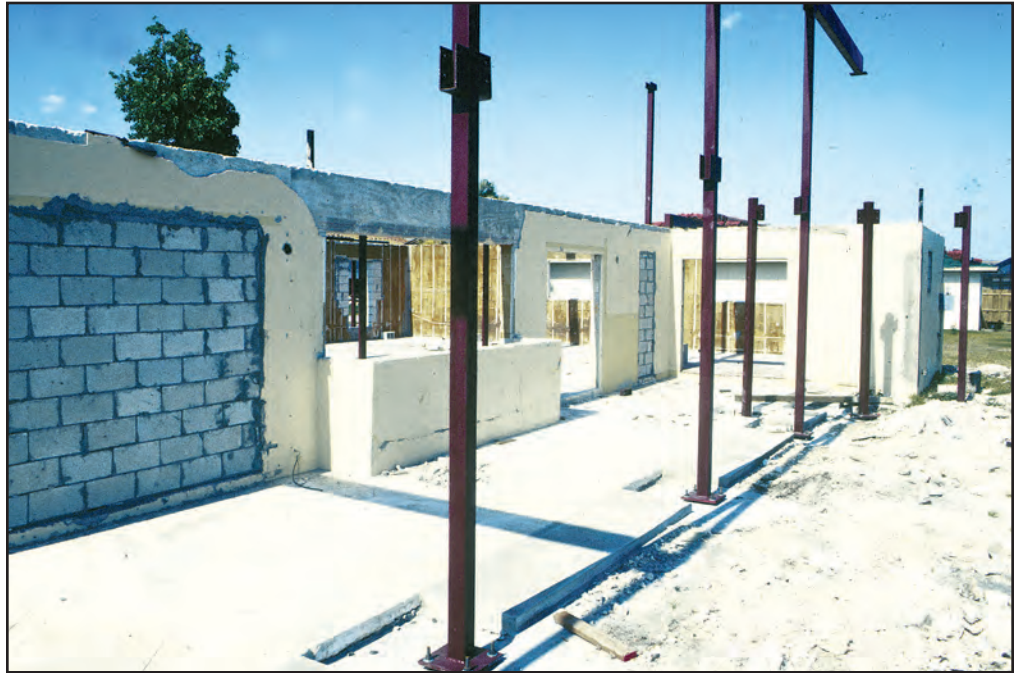
**Figure 52**

The existing first-story walls have been strengthened by the addition of concrete block. Metal columns and beams have been added to help support the new second story.

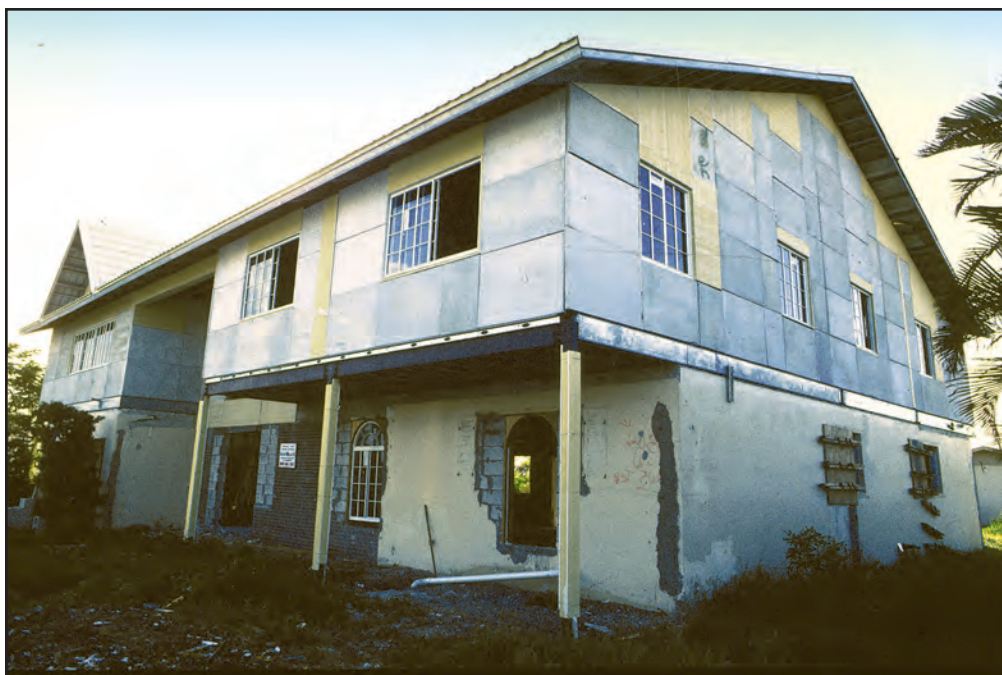
**Figure 59**

The exterior  
walls consist of  
prefabricated  
concrete panels.  
Innovative techniques  
such as those  
employed in this  
project are helping  
homeowners who  
need practical and  
economical methods  
of repairing and  
protecting their  
houses.

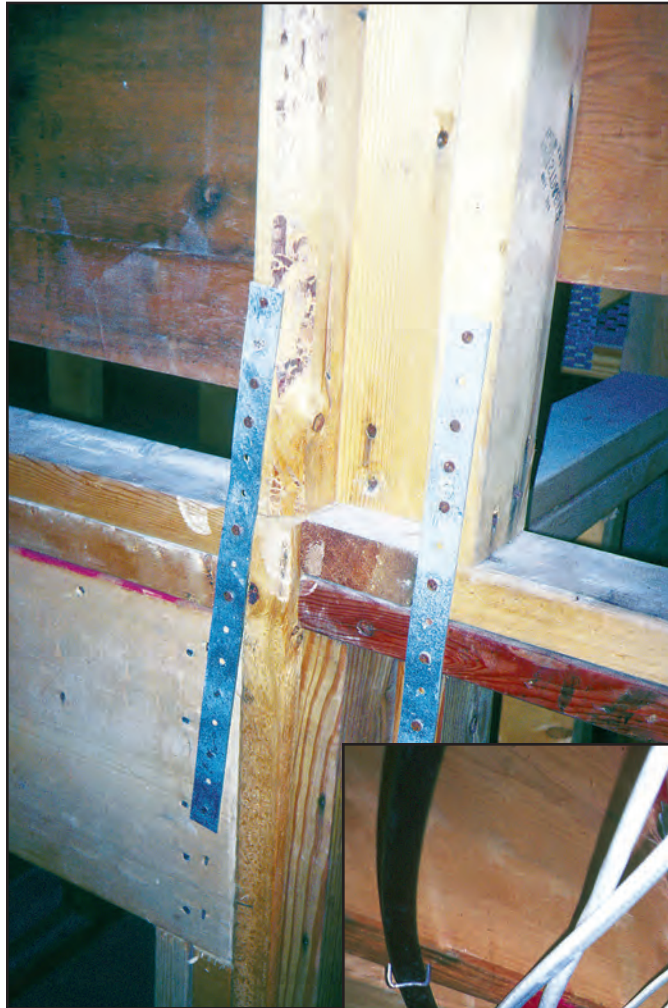
**Figure 70**

Metal hurricane straps are used to tie the structural members together and create a continuous load path from the roof to the foundation.

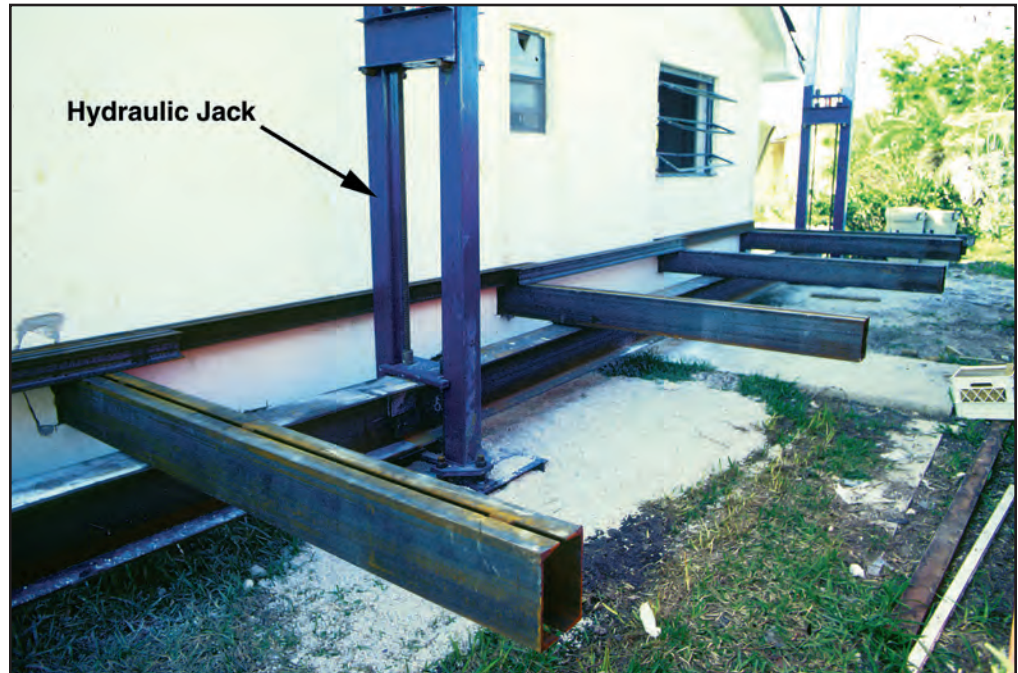
**Figure 74**

In this variation of Technique 3, steel beams are inserted through the walls of the house rather than under the slab. The beams span the length and width of the house and cross one another inside to create a grid. Outside the house, the beams rest on larger beams that will be raised with hydraulic jacks.
