INVESTIGATION REPORT

Report Date: 2/16/2021

Re: AltEn LLC-Mead

Topic: Release of Thin Stillage and Manure from Digester

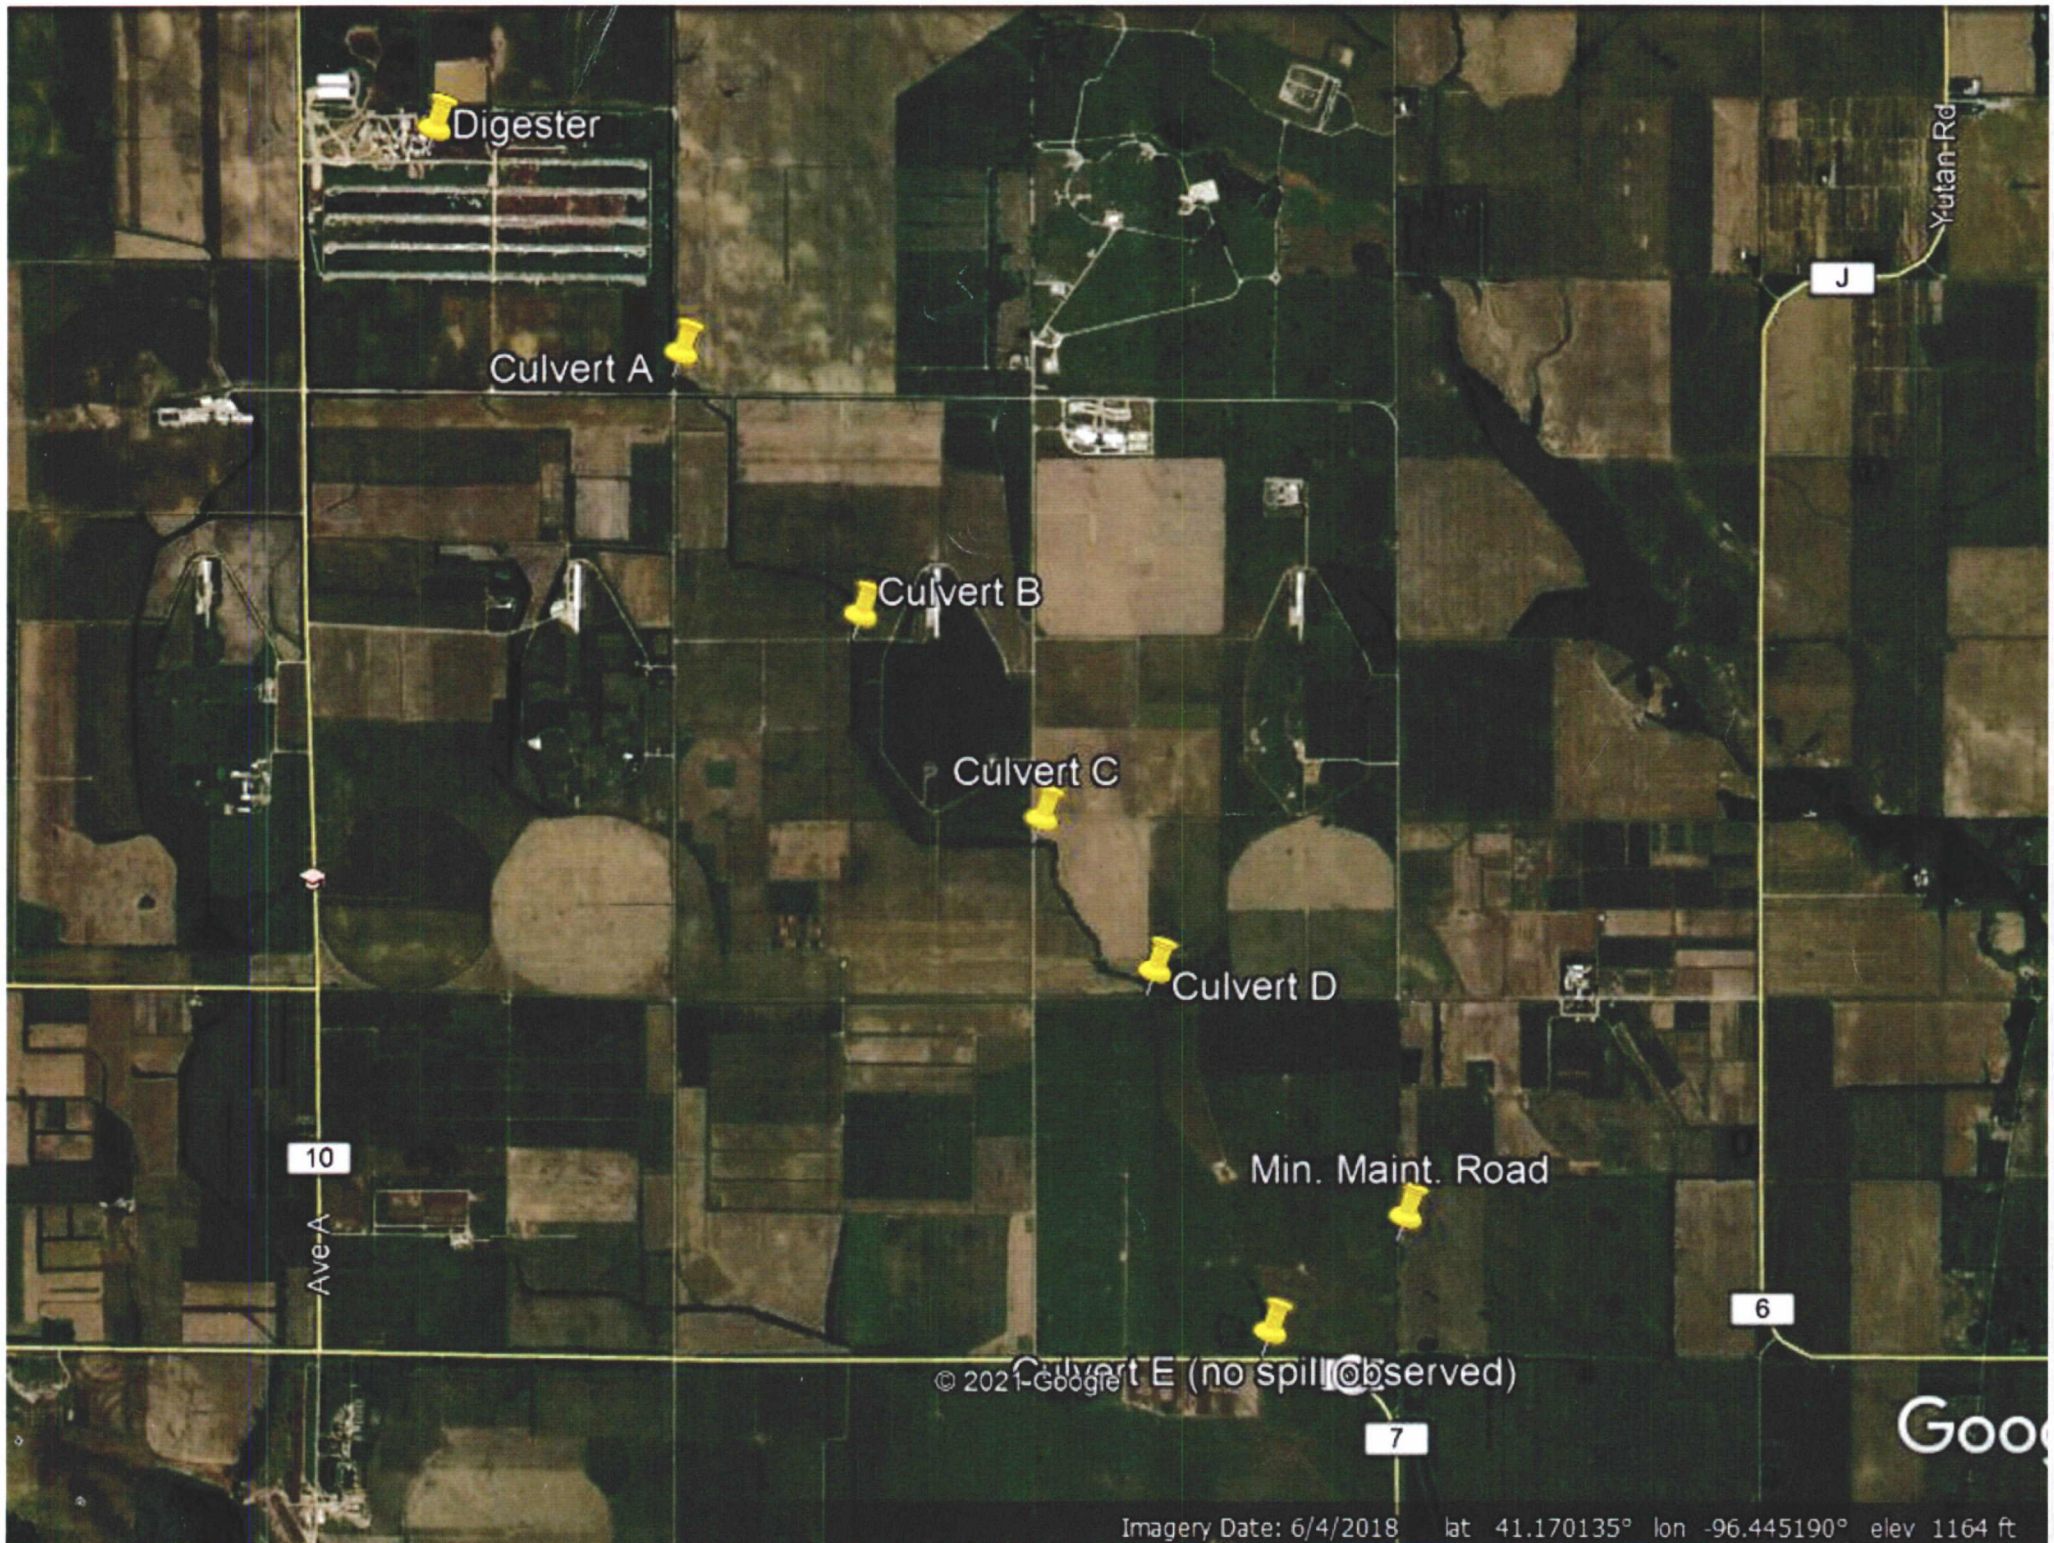
We returned to the AltEn facility to examine the digester that had not suffered a release. We observed a pile of Styrofoam insulation panels we presumed were covering the piping vault (see attached photo). We observed electrical wiring leading under the pile of insulation and presumed that to be for the heat lamp mentioned by Mr. Egr. We observed on the south side of the digester that had not suffered a leak a column of ice surrounded by caution tape (see attached photo). We could see a fitting above the column of ice actively releasing a liquid (which appeared to be freezing and creating the column of ice). We presumed this liquid was thin stillage and manure being released from the full or nearly full digester.

Spilling and leaking liquid from digester without leak
