Facility: AltEn
IIS: 84069
PCS: NE0137634

Site Visit Check list

AltEn LLC - Storm Water Temporary BMP Check Map

Site Visit Report

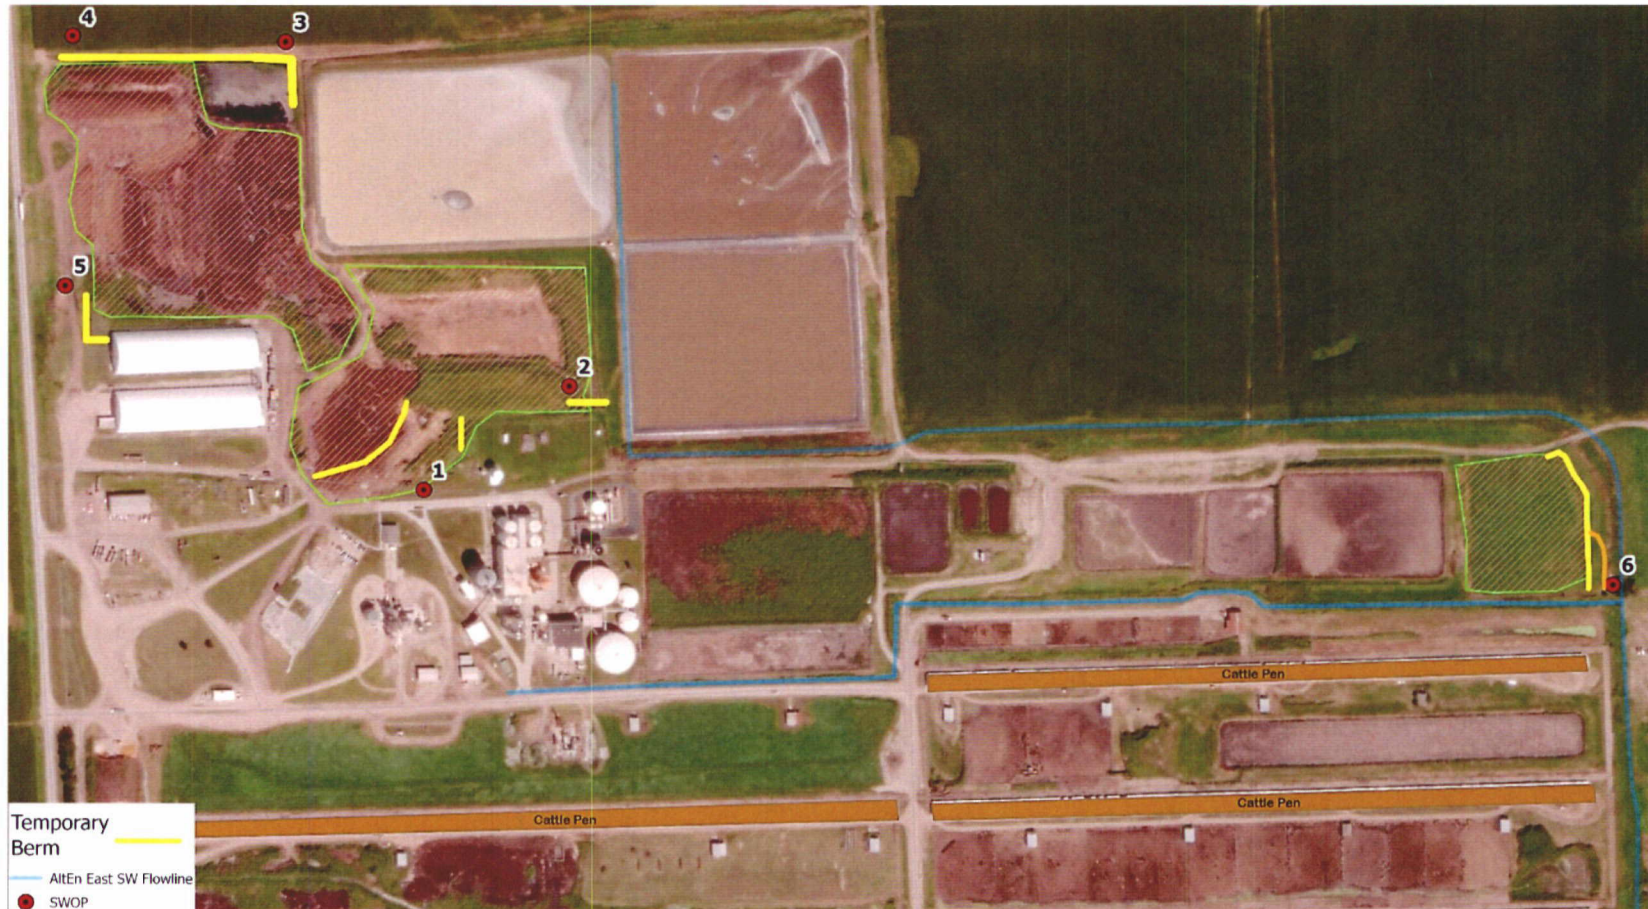
| 1. Northeast side of the administration building | <input checked="" type="radio"/> Yes | No (<input checked="" type="radio"/> pumped / not pumped) |
| 2. Southwest side of the south lagoon | <input checked="" type="radio"/> Yes | No (pumped / <input checked="" type="radio"/> not pumped) |
| 3. West side of the northwest lagoon | <input checked="" type="radio"/> Yes | No (pumped / <input checked="" type="radio"/> not pumped) |
| 4. North side of the north wet cake pile | <input checked="" type="radio"/> Yes | No - no accumulation of runoff |
| 5. County Road 10 (Hoop building). | <input checked="" type="radio"/> Yes | No (pumped / <input checked="" type="radio"/> not pumped) |
| 6. East wet cake pile | <input checked="" type="radio"/> Yes | No (pumped / <input checked="" type="radio"/> not pumped) |

Area - 1 - Berm in good condition & second berm added to reflect water from parking lot

2 - Raised earlier this week & completed. berm in good condition

3 - Berm in good condition & stable

5 - Berm in good condition
