Facility: AltEn
IIS: 84069
PCS: NE0137634

Jason Windhorst
4-12-2021

Site Visit Check list

AltEn LLC - Storm Water Temporary BMP Check Map

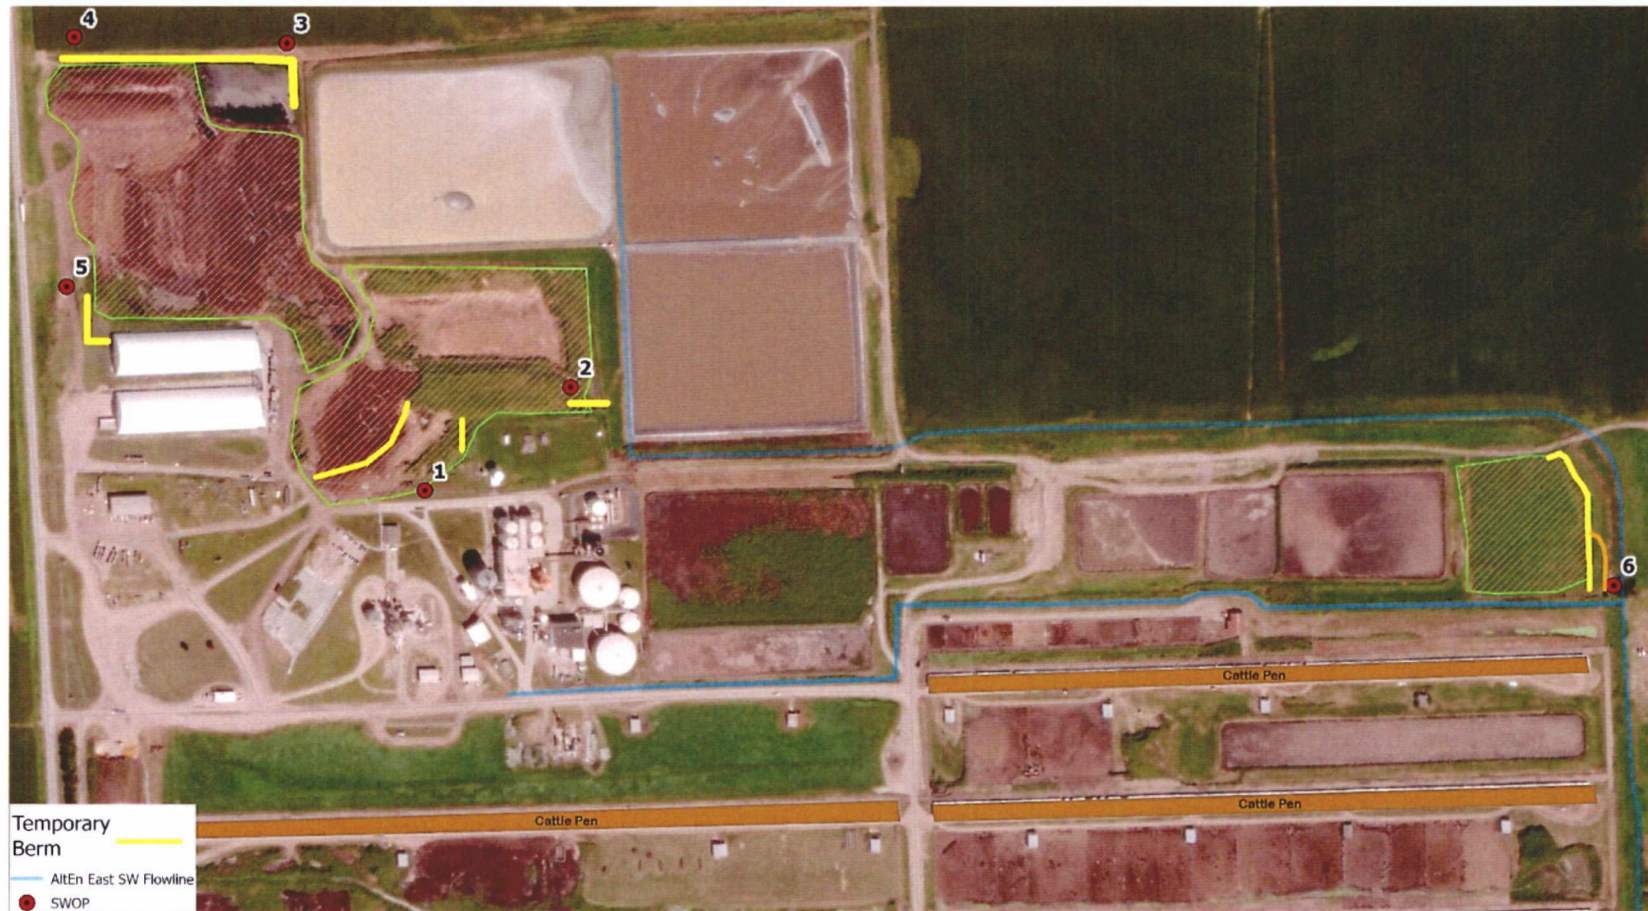
A. Berms (the numbers below match the attached map) Circling yes indicates the area was inspected.

Area 1 - Pumping to area 2 currently, berm holding
- 2 - Pumping to emergency lagoon, berm holding
- 3 - Berm holding some water, not enough to pump
- 4 - ~~berm~~ berm holding & no runoff
- 5 - Berm holding some runoff, most drained to area 2
- 6 - Berm has a lot of seepage & should be pumped
before berms completely fail
