Facility: AltEn
IIS: 84069
PCS: NE0137634

Site Visit Check list

AltEn LLC - Storm Water Temporary BMP Check Map

Site Visit Report

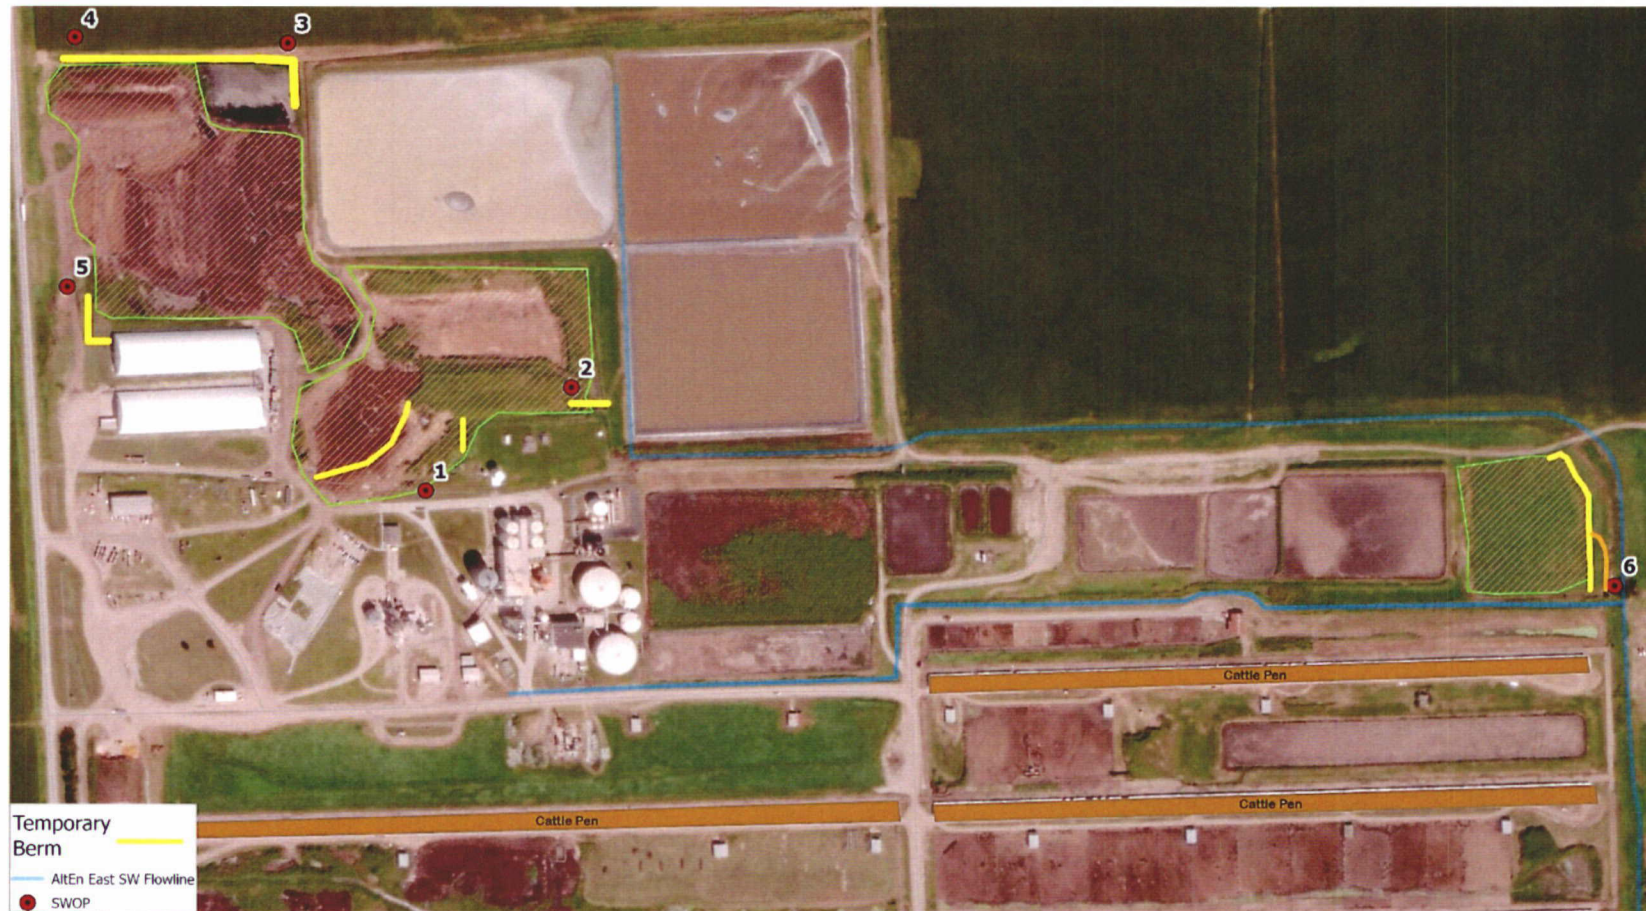
A. Berms (the numbers below match the attached map) Circling yes indicates the area was inspected.

- Little activity today due to rain. Berms are being maintained, but should be pumped soon
- Moving Biochar bags is on hold until the ground dries around the area where bags are stored. There are approximately 60 bags on the ground and 26 bags on flatbed truck parked south of grain receiving.
- There was active pumping from the southeast lagoon to the treatment building adjacent to the digesters. There was also active discharge from a sump-pump in distillation which was being drained to the ground on the east side of the distillation platform.

- Pump out berm areas ASAP before potential breach or failure of berm.
- Provide process diagram & description of treatment system used for water. Primarily method using ethanol plant system.
- Provide information on fluid being discharged from distillation area.
