Facility: AltEn
IIS: 84069
PCS: NE0137634

Site Visit Check list

AltEn LLC - Storm Water Temporary BMP Check Map

Site Visit Report

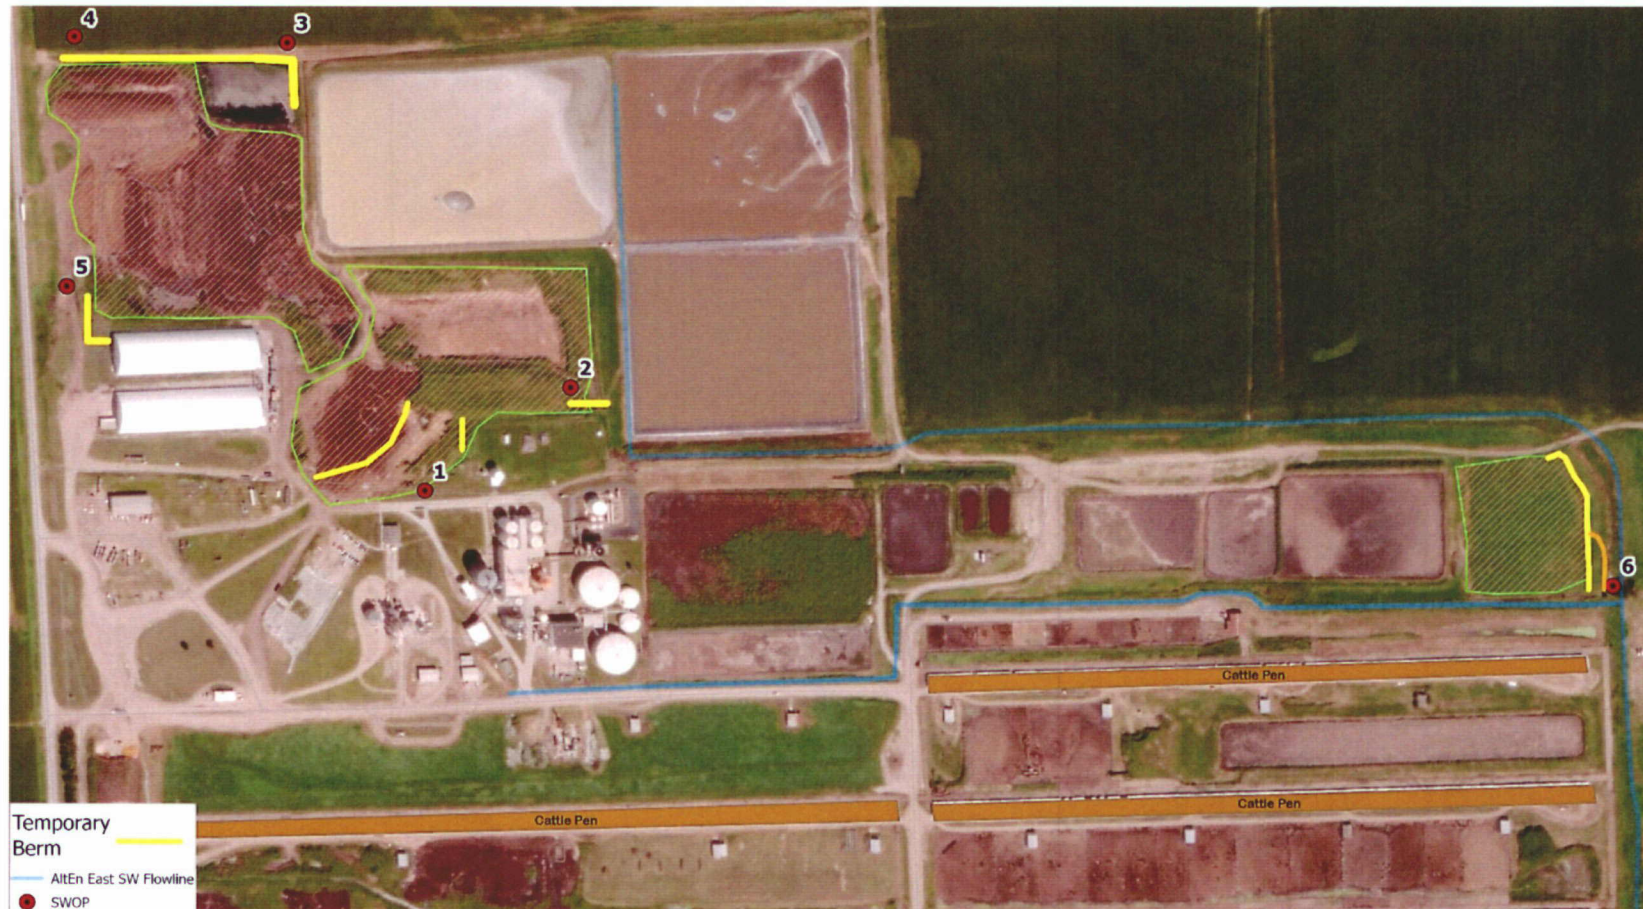
Area 1 - Berm in good condition & pumped
2 - Berm raised & compacted & pumped most of water
3 - Berm in good condition not pumped
4 - No concerns
5 - Berm in good condition not pumped but diking East
6 - Berms seeping & need to be pumped

- Pump out Area 6 berms & repair berms
- Finish moving Biochar to hoop building
