Facility: AltEn
IIS: 84069
PCS: NE0137634

Jason Windhorst
4-2-2021

Site Visit Check list

Site Visit Report

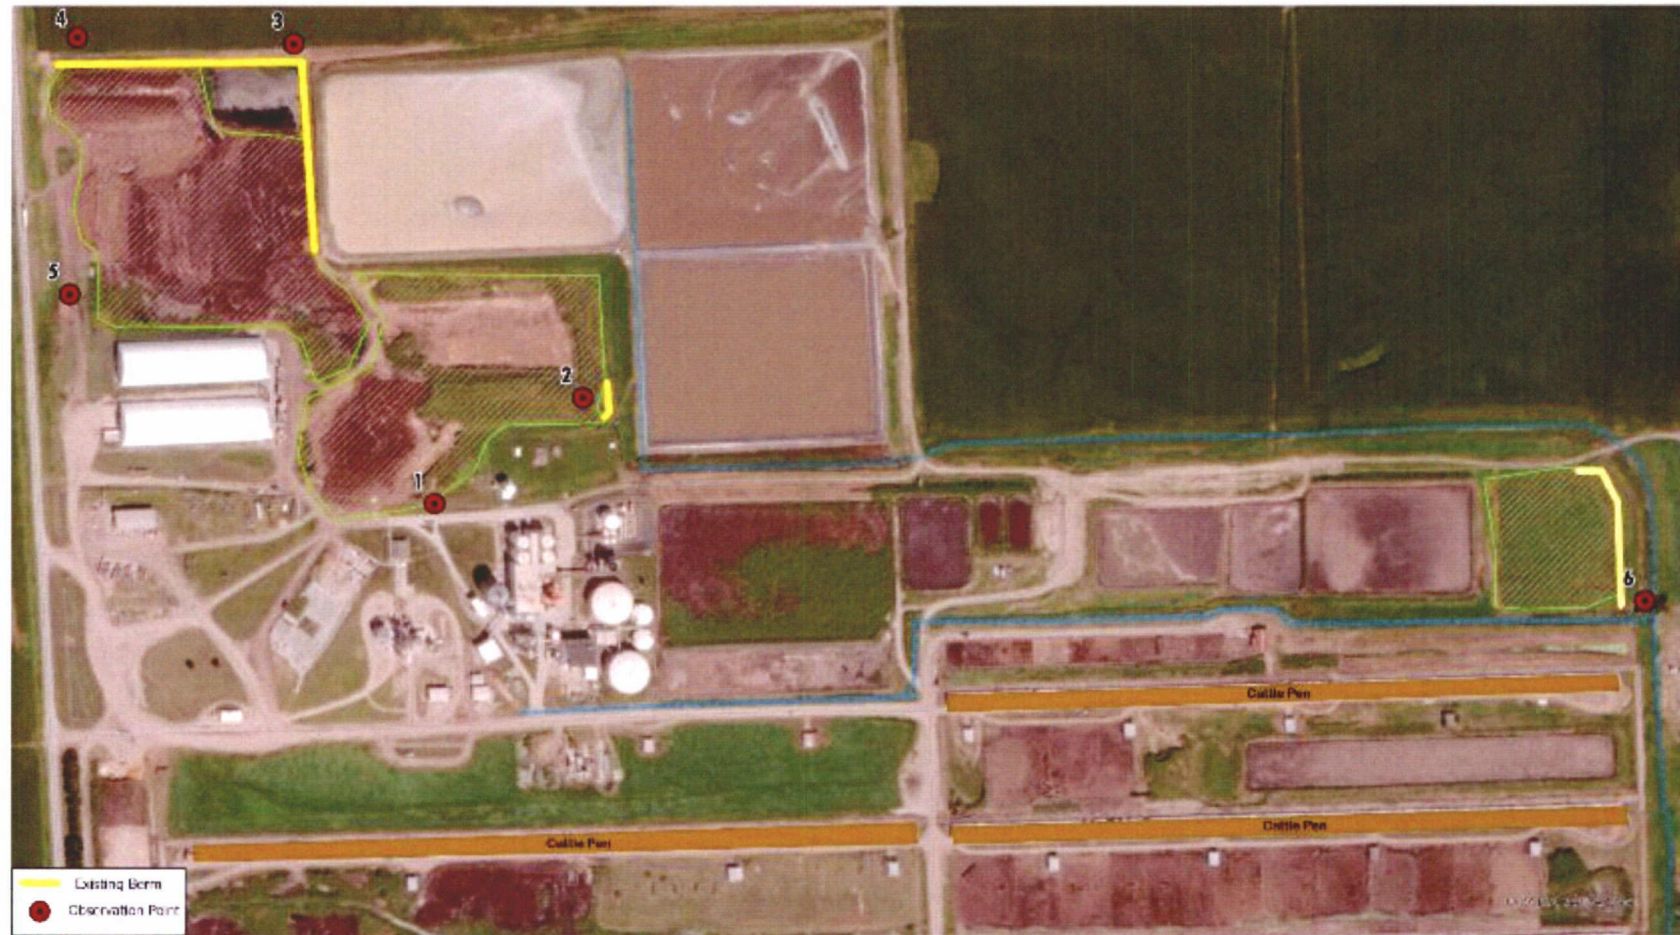
AltEn LLC - Storm Water Temporary BMP Check Map

A. Berms (the numbers below match the attached map) Circling yes indicates the area was inspected.

- The facility is actively working on grading in the area north of the admin building.
- All three Poseidon tanks are put together and have liquid in them. The east and west tank have a small amount of liquid pumped from the emergency lagoon and the middle tank is filled to within 3' from the top.
- Trucks are bringing in loads of wetcake from fields previously delivered to in 2020.
- The east wetcake area has not been pumped yet.
- Biochar is being loaded onto a flatbed truck and taken to the south hoop building.
- Levels in all three lagoons appear to be dropping.

- 1 - muddy next to berm w/ no water visible
- 2 - Pumped down but still has some water & berm holding
- 3 - Some water behind berm & no seepage
- 4 - Good condition & no water present
- 5 - Berm in good condition & trench cut to drain to East
- 6 - No seepage but should be pumped as soon as possible
