Facility: AltEn
IIS: 84069
PCS: NE0137634

Jason Windhorst
3-19-2021

Site Visit Check list

AltEn LLC - Storm Water Temporary BMP Check Map

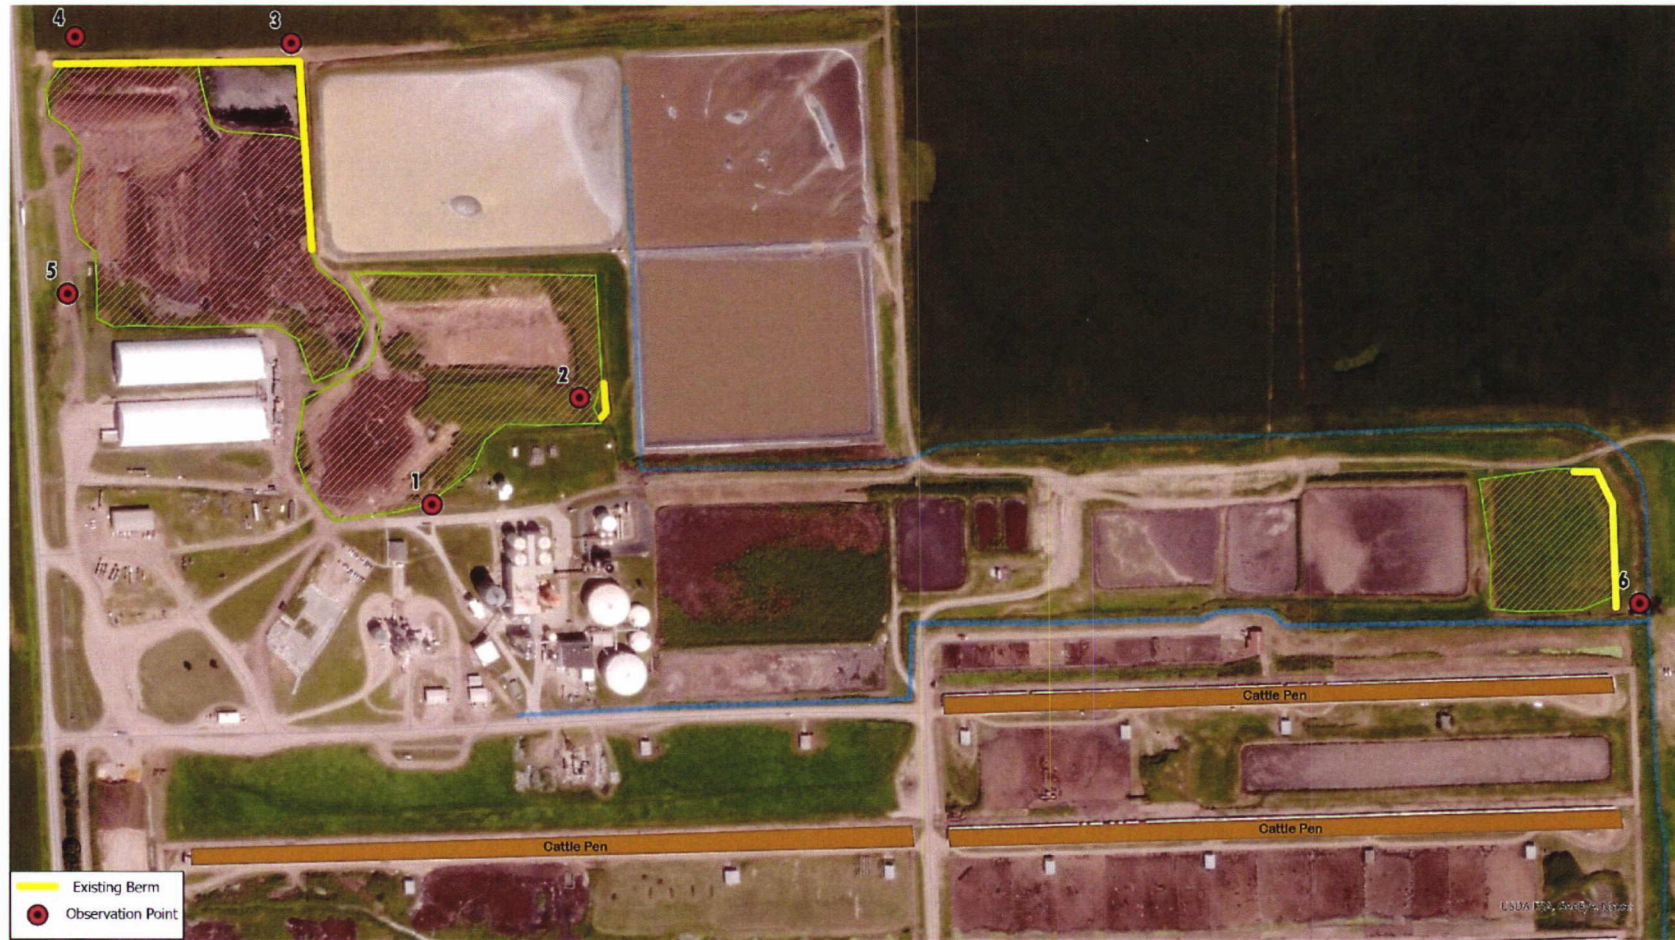
A. Berms (the numbers below match the attached map) Circling yes indicates the area was inspected.

- The bermed area at location 1 was being pumped out while I was onsite.
- The bermed area at location 2 was full and was going to be pumped out later today or tomorrow.

- The bermed area at location 3 appeared to have liquid seeping through the berm and was pooling outside of the containment. I requested that they repair this area as soon as possible.

- The bermed area at location 4 was repaired and no wetcake was on the berm. The bermed area at location 5 was being pumped out while I was onsite.
- The bermed area at location 6 was holding while I was onsite but was getting very full toward the SW corner. On the east side of location 6 there was dark liquid pooled from an unknown source. It did not appear that the berm at location 6 had seep passing through from the wetcake are and may have been from the previous rain event.
