Facility: AltEn
IIS: 84069
PCS: NE0137634

Jason Windhorst
3-31-2021

Site Visit Check list

AltEn LLC - Storm Water Temporary BMP Check Map

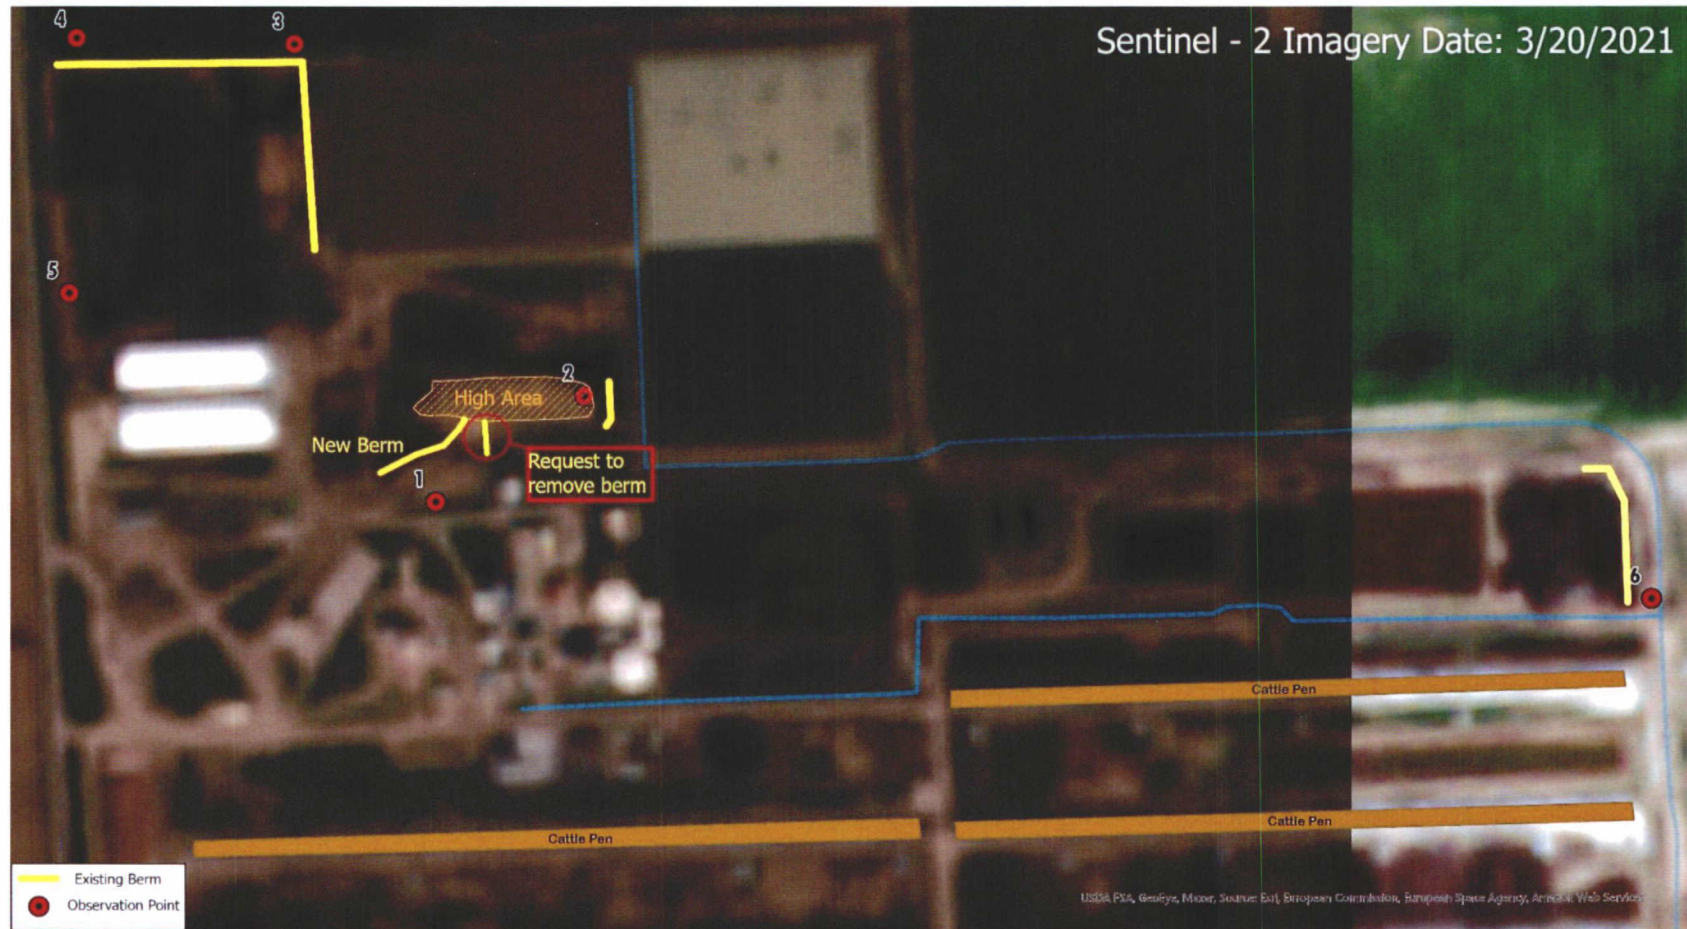
- Area 6 continues to seep through the primary berm and appears to be holding at the lower berm. Mr. Peterson plans to pump out the berm once they gain access to more hose.

- Area 3 will need to be pumped after they finish stabilizing the berm and area outside the berm.
- The second Poseidon tank frame has been constructed but not in use currently. The wind is problematic and unsafe currently to install the inside liner and will be completed late this week depending upon the weather. The third Poseidon tank area is being graded to the west of the Biochar area and should be completed this week. Assembly of the third tank is likely to begin in early April.

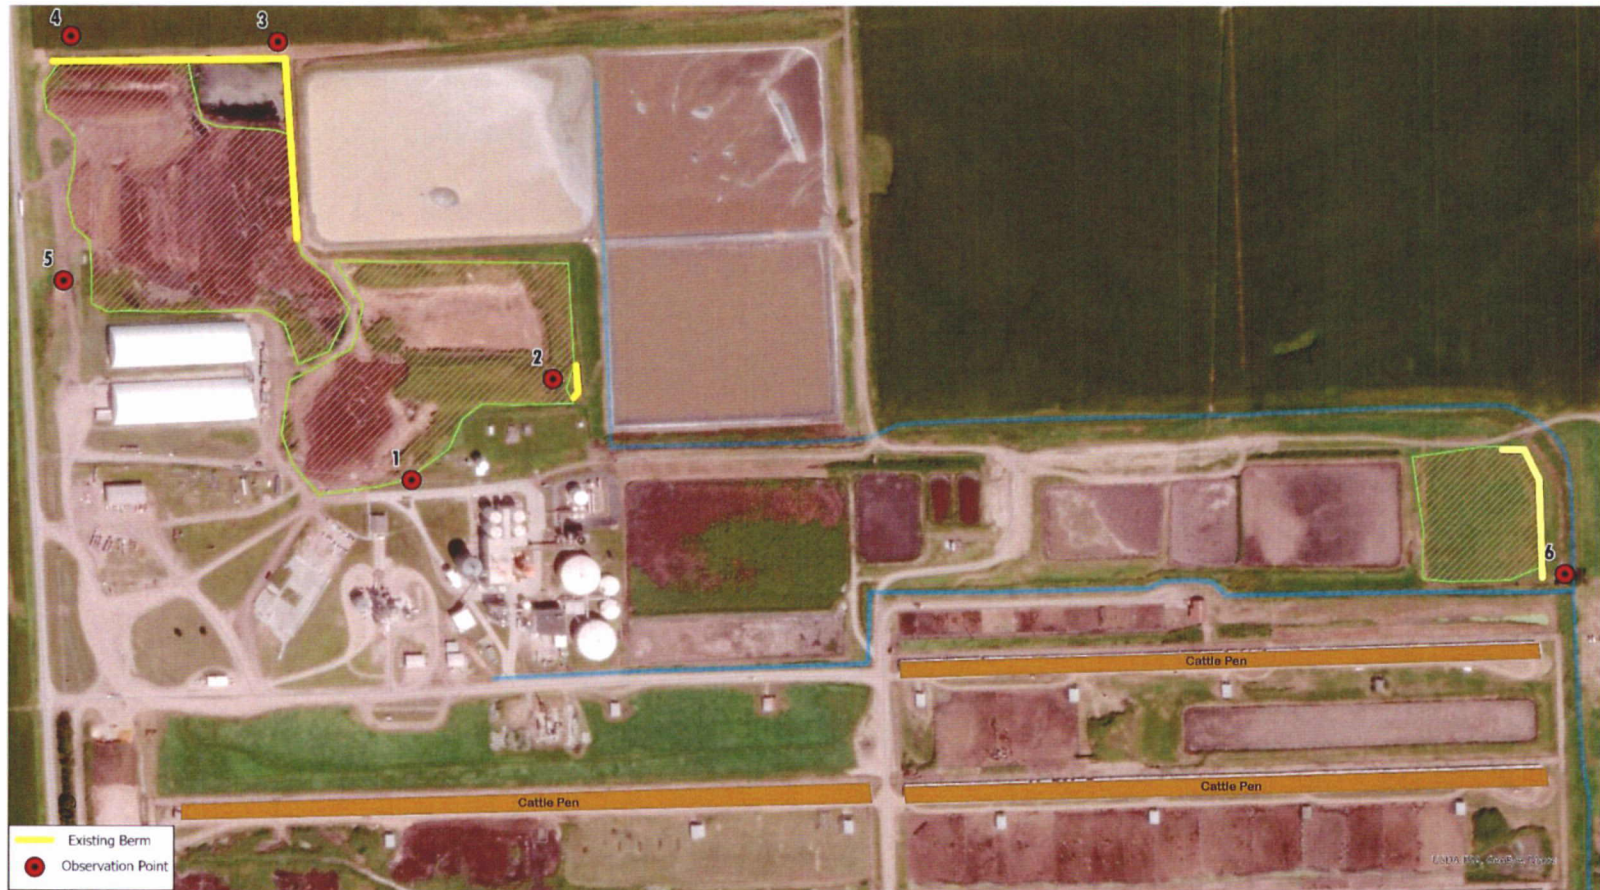
AltEn LLC - Storm Water Temporary BMP Check Map

Area: 1 - Dry & face of wet cake, berm is muddy but no ponding ✓
 2 - recently pumped & berm in good condition ✓
 3 - repaired recently & try to dry area out ✓
 4 - Good condition ✓
 5 - Berm in good condition & area graded to drain east ✓
 6 - Berm holding & no seepage ✓
