Facility: AltEn
IIS: 84069
PCS: NE0137634

Mark Pomajzl
3-29-2021

Site Visit Check list

Site Visit Report

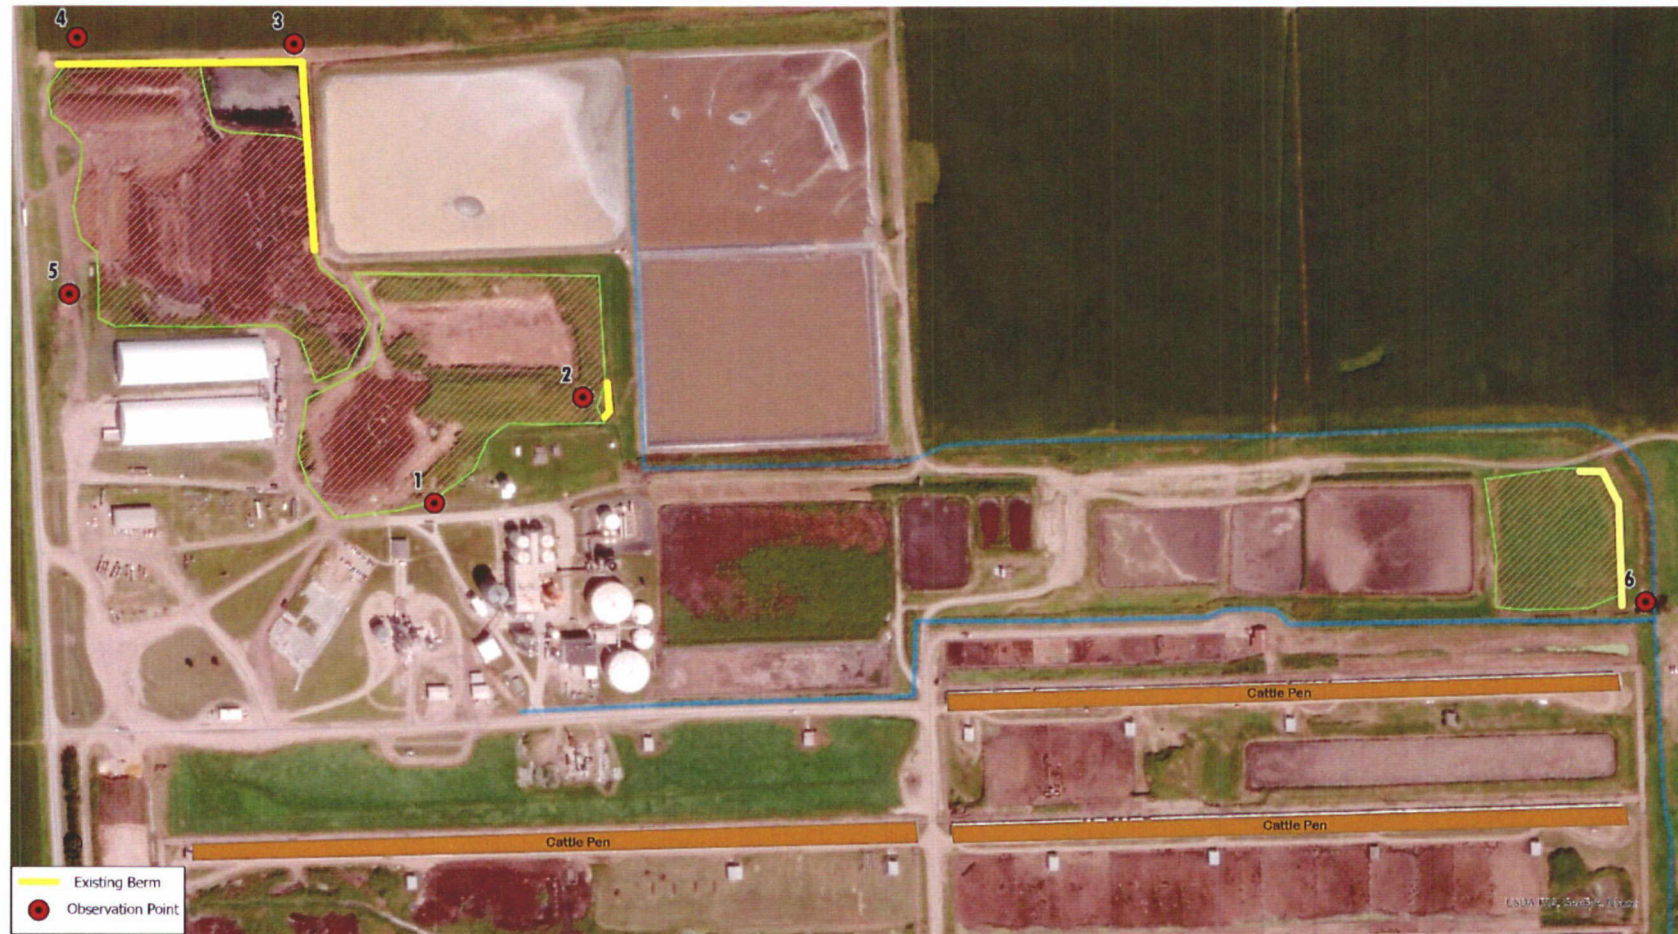
AltEn LLC - Storm Water Temporary BMP Check Map

- The facility is constructing berms north of the administrative building.
- Area 6 is seeping. The facility is in process of adding material. To control seepage, I instructed Mr. Peterson to pump out the berm.
- Area 3 is seeping. Prior to my departure, I observed the facility adding additional material.
