Facility: AltEn
IIS: 84069
PCS: NE0137634

Site Visit Check list

Site Visit Report

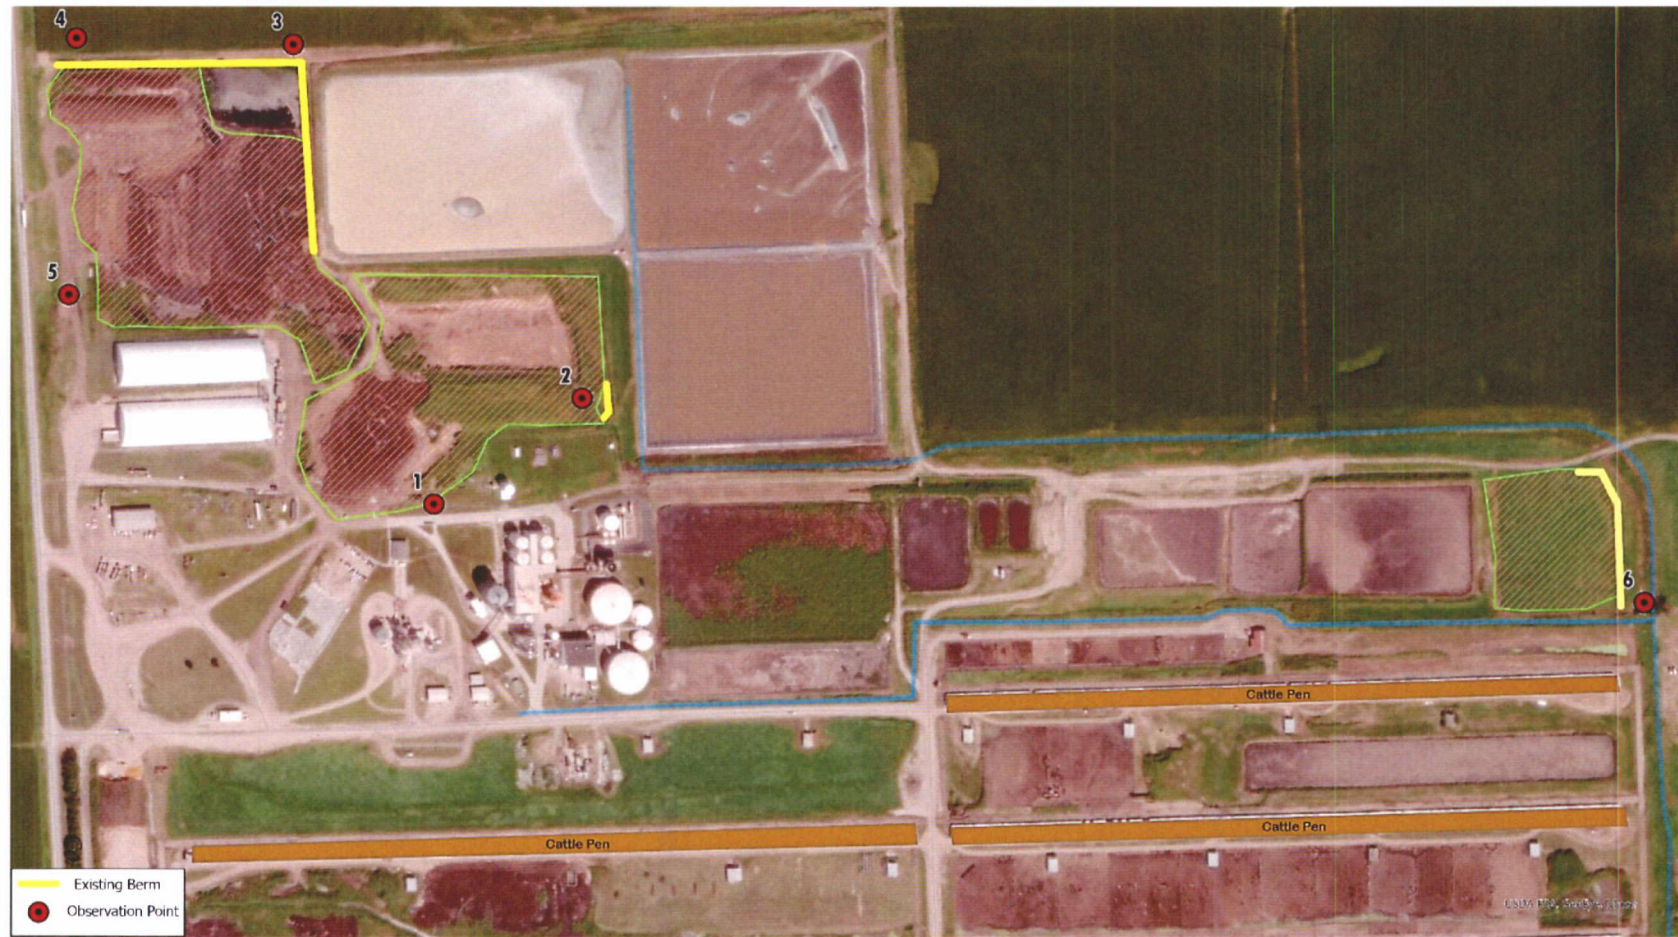
AltEn LLC - Storm Water Temporary BMP Check Map

A. Berms (the numbers below match the attached map) Circling yes indicates the area was inspected.
