Facility: AltEn  
IIS: 84069  
PCS: NE0137634

### Site Visit Check list

Site Visit Report

Facility Name/ Project Name: AltEn LLC

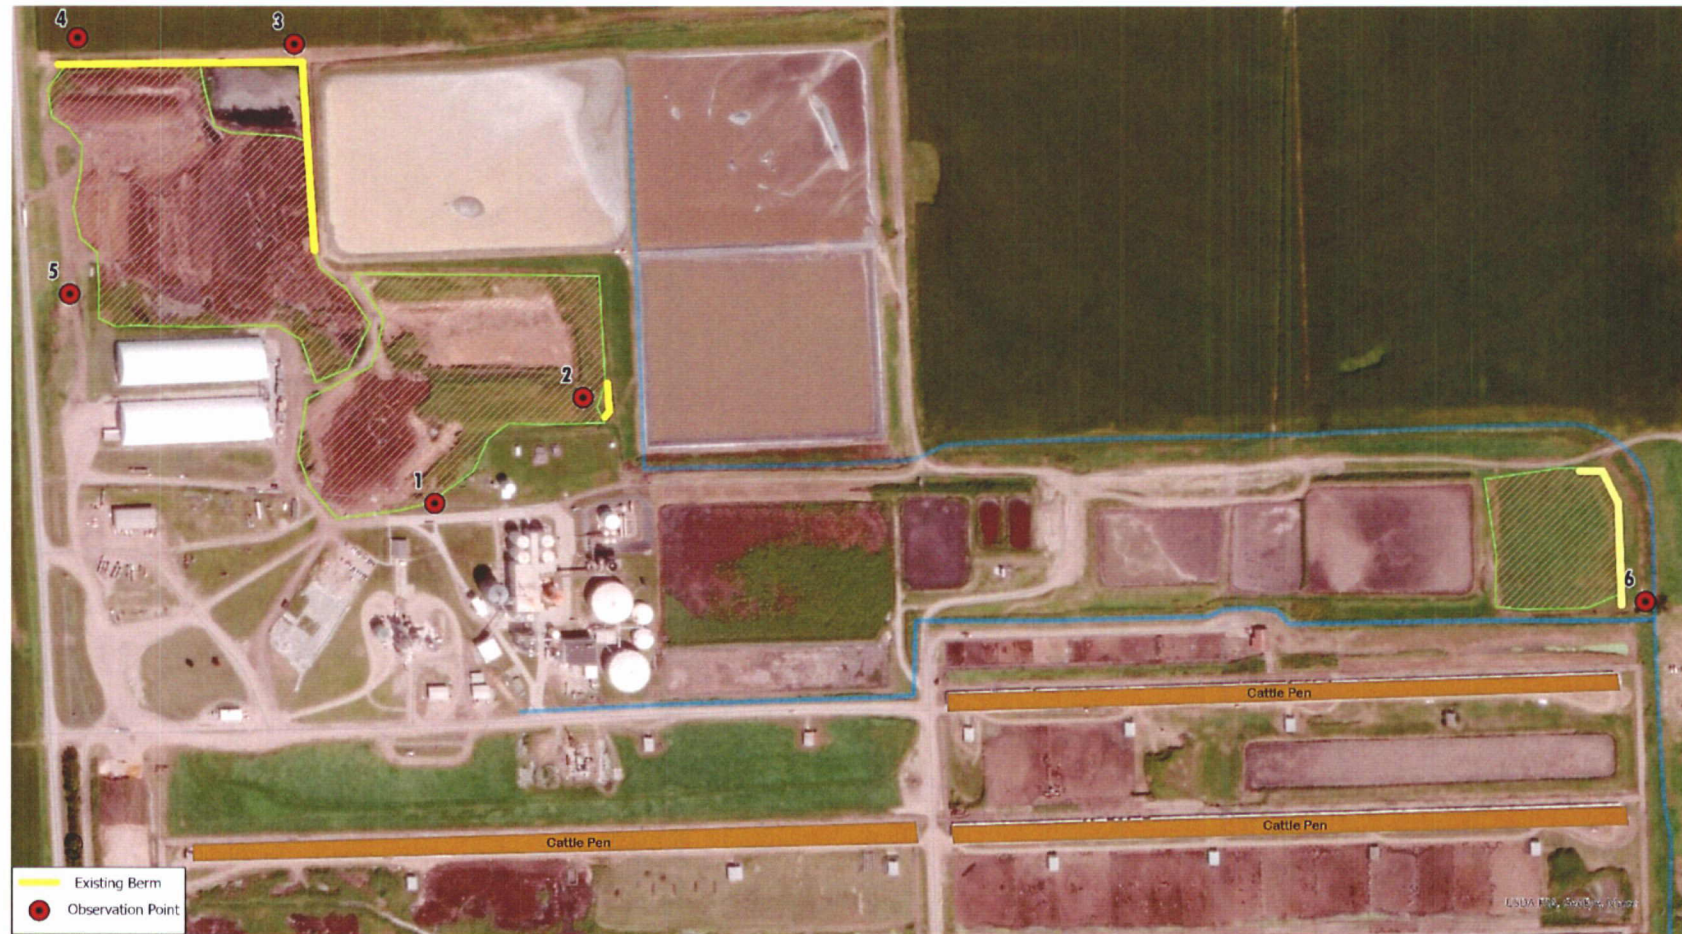
# AltEn LLC - Storm Water Temporary BMP Check Map

**A. Berms (the numbers below match the attached map) Circling yes indicates the area was inspected.**

- Mr. Peterson stated they are actively pumping from berms. Mr. Peterson also stated they only have two general laborers and it is becoming difficult to get all the work completed.
- The facility is constructing more berms north of the administrative building (Area 1) on the map.
- Area 3 berm appears to be seeping. The facility will be adding material today.
