Site Visit Inspection Form

Facility Name AltEn, LLC					
Industrial Storm Water (ISW) NER910444				NDEQ ID / Program ID 84069	
INSPECTOR (s) Mark Pomajzl					
ADDRESS 1344 County Road 10		CITY Mead	COUNTY Saunders	STATE NE	ZIP CODE 68041
INSPECTION DATE 3-15-21	TIME/ARRIVAL 10:00am	TIME DEPARTURE 1:40pm	WEATHER Clear, cool		TEMP 50F

AltEn LLC - Storm Water Temporary BMP Check Map

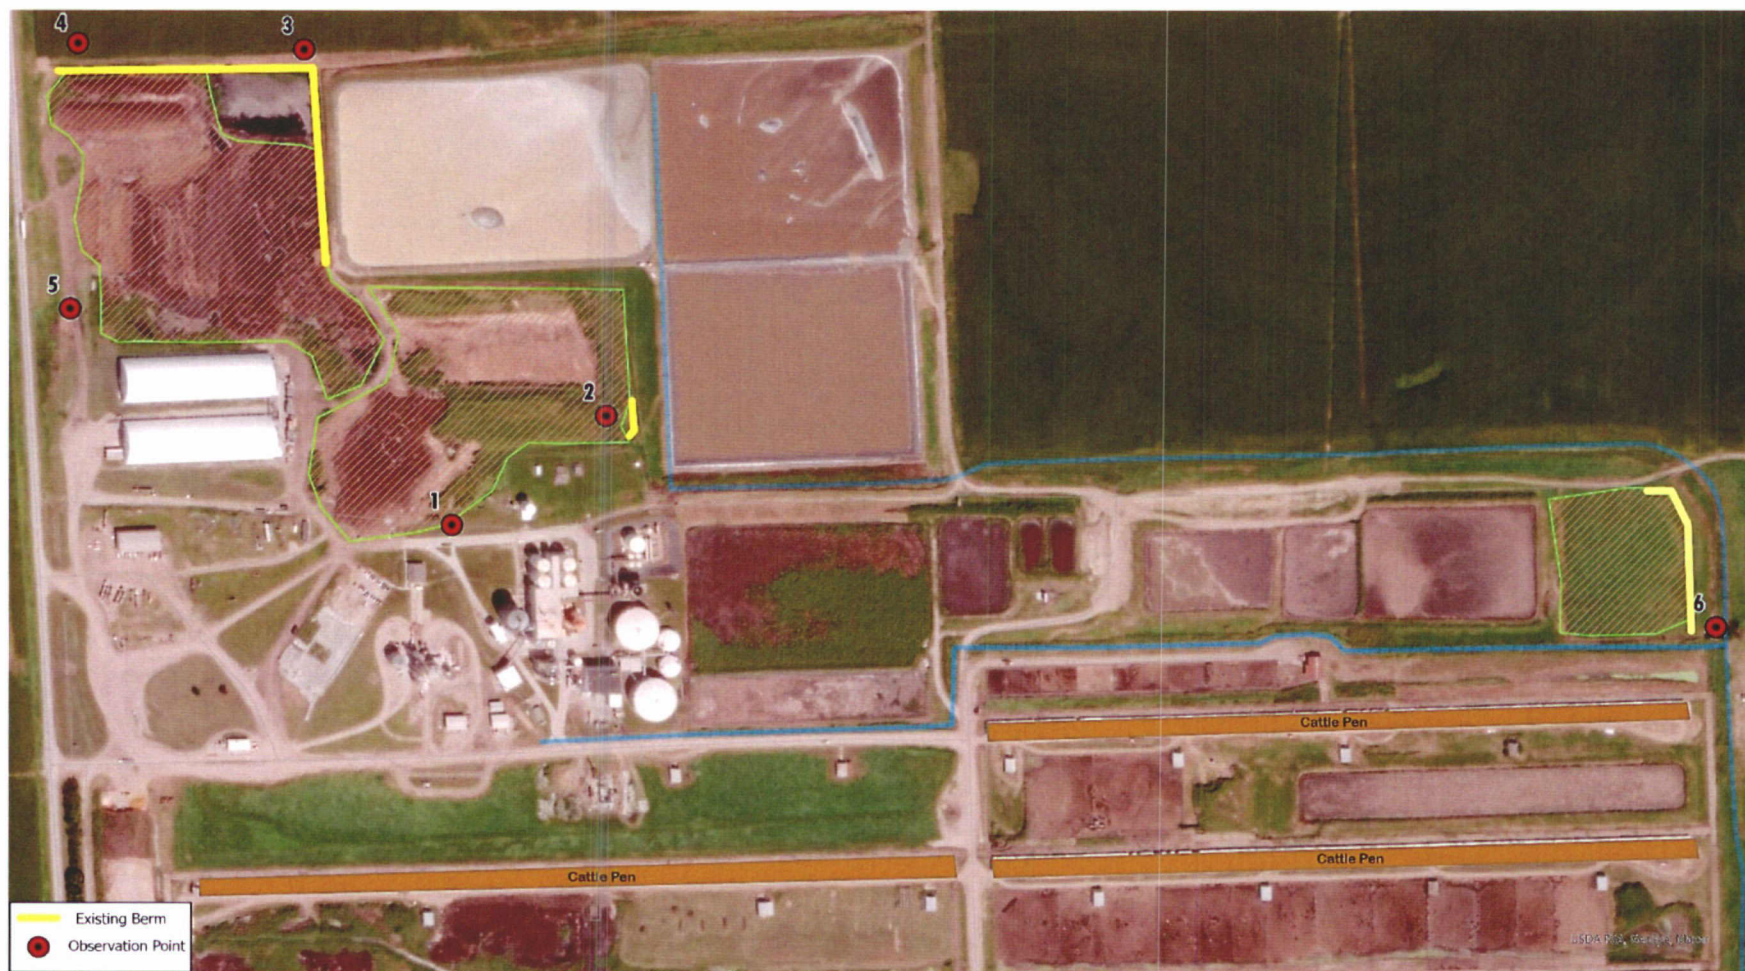
Observation Point 1 (OP1), Map 1

OP1 is northeast of the main office building. The berm is overloaded with storm water and discharging around the south side, photo 1.
