Facility: AltEn
IIS: 84069
PCS: NE0137634

Site Visit Check list

Site Visit Report

Facility Name/ Project Name: AltEn LLC

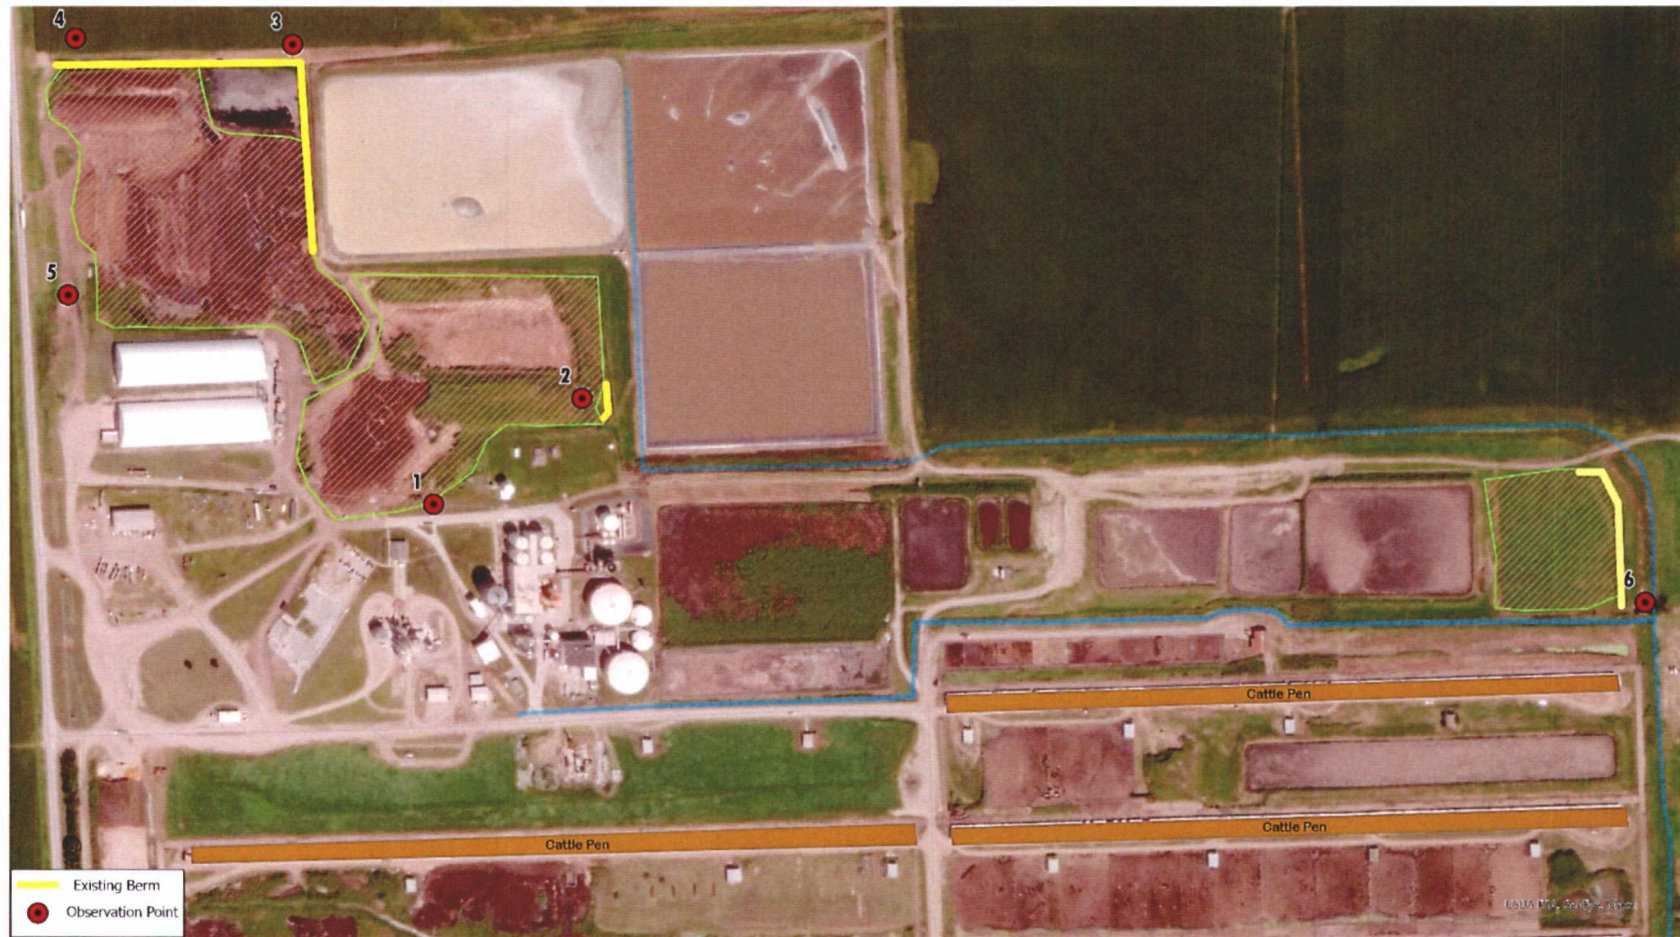
AltEn LLC - Storm Water Temporary BMP Check Map

A. Berms (the numbers below match the attached map) Circling yes indicates the area was inspected.
