Facility: AltEn, LLC
IIS: 84069
PCS: NE0137634

Jason Windhorst
6/4/2021

Site Visit Check list

Site Visit Report

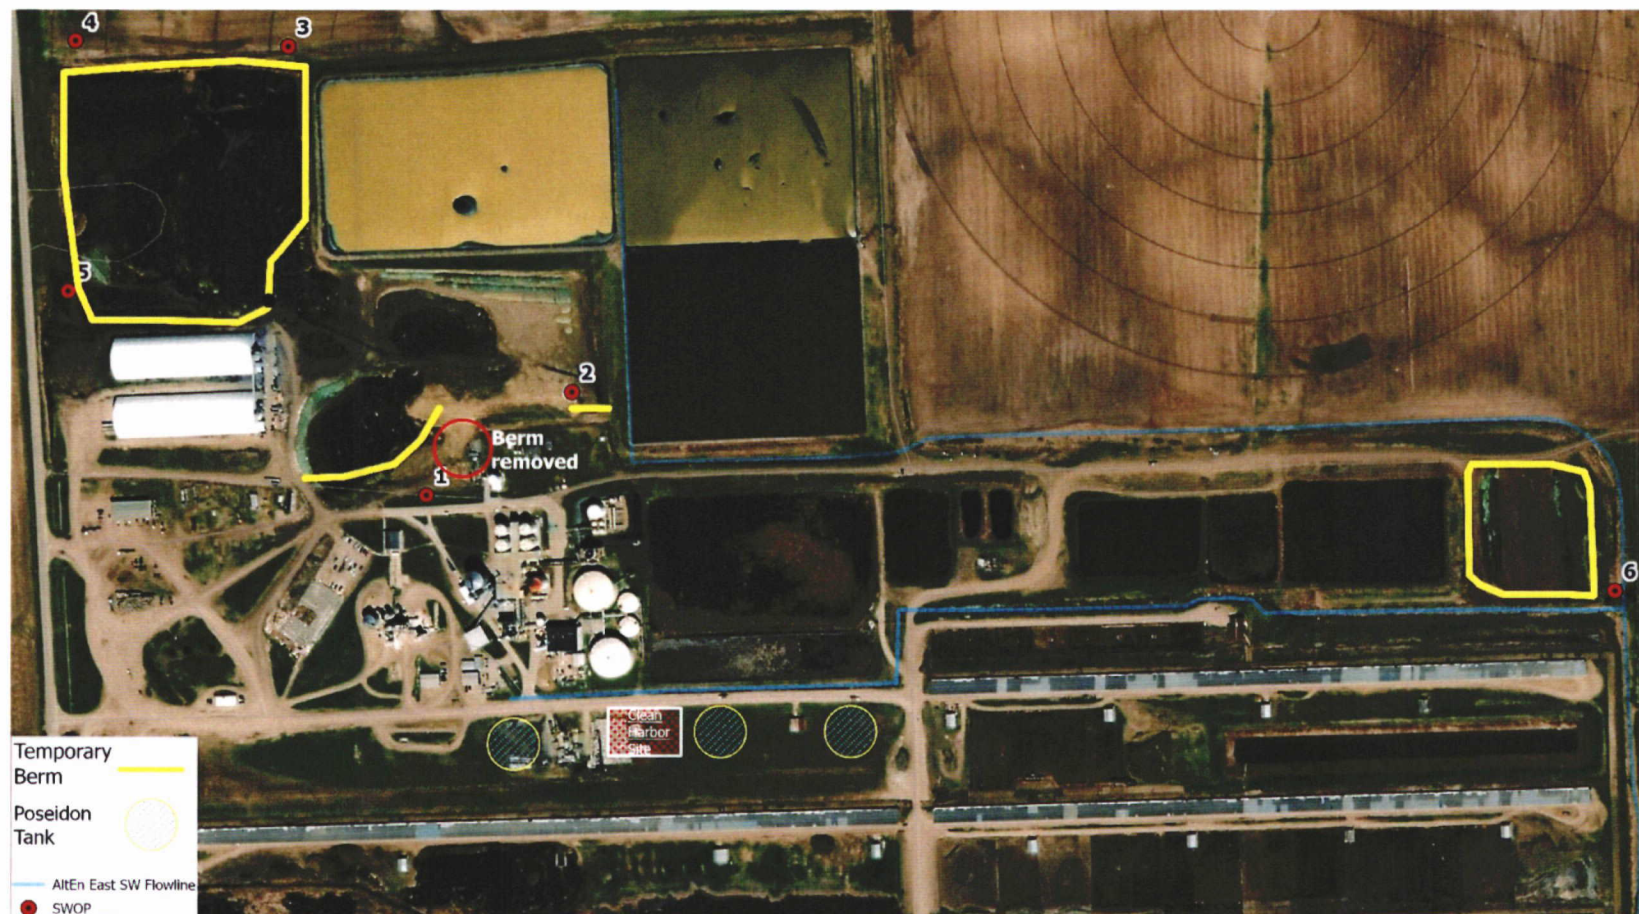
AltEn LLC - Storm Water Temporary BMP Check Map

A. Berms (the numbers below match the attached map) Circling yes indicates the area was inspected.

| 1. Northeast side of the administration building | <input checked="" type="radio"/> Yes | No (pumped / <input checked="" type="radio"/> not pumped) |
| 2. Southwest side of the south lagoon | <input checked="" type="radio"/> Yes | No (<input checked="" type="radio"/> pumped / not pumped) |
| 3. West side of the northwest lagoon | <input checked="" type="radio"/> Yes | No (pumped / <input checked="" type="radio"/> not pumped) |
| 4. North side of the north wet cake pile | <input checked="" type="radio"/> Yes | No - no accumulation of runoff |
| 5. County Road 10 (Hoop building). | <input checked="" type="radio"/> Yes | No (pumped / <input checked="" type="radio"/> not pumped) |
| 6. East wet cake pile | <input checked="" type="radio"/> Yes | No (pumped / <input checked="" type="radio"/> not pumped) |
