Facility: AltEn, LLC
IIS: 84069
PCS: NE0137634

Mark Pomajzl / Amanda Woita
5/12/2021

Site Visit Check list

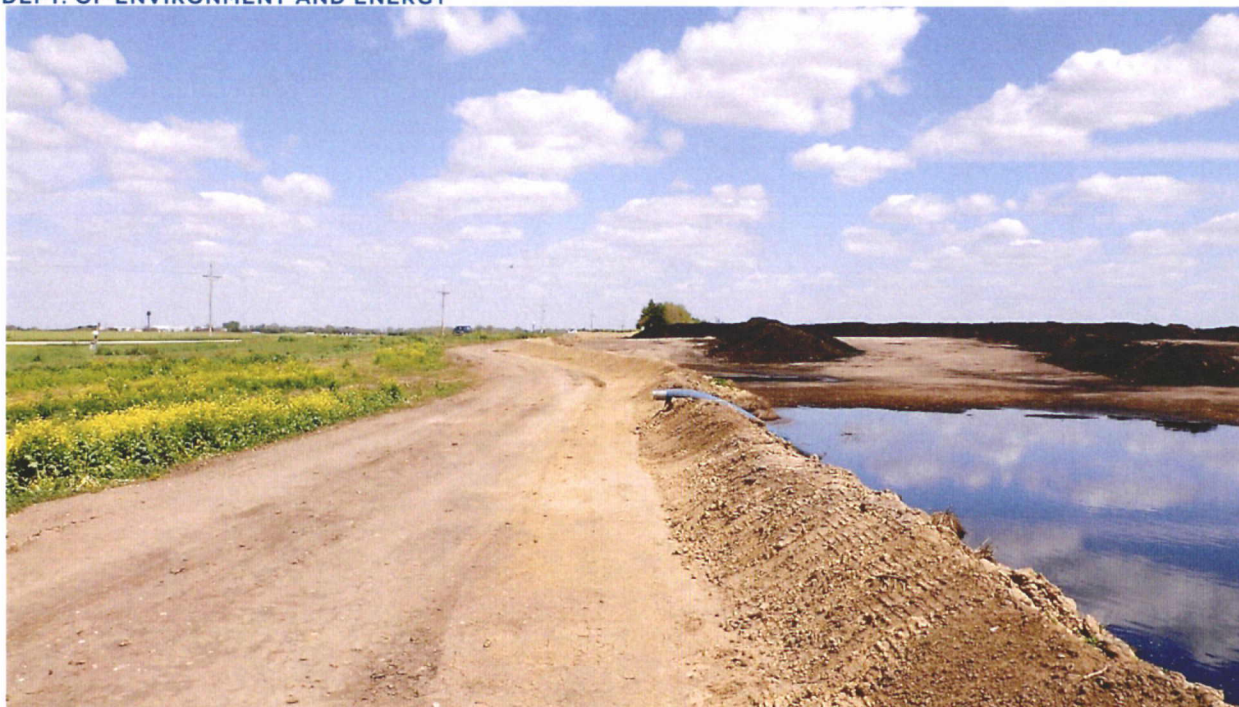
Photo: 12

Description: This photo is a new berm east of the original Area 5 berm. The berm surrounds the south side of the north wet cake pile to the east side of the north hoop building. There is accumulated rainwater on the south side of the berm.

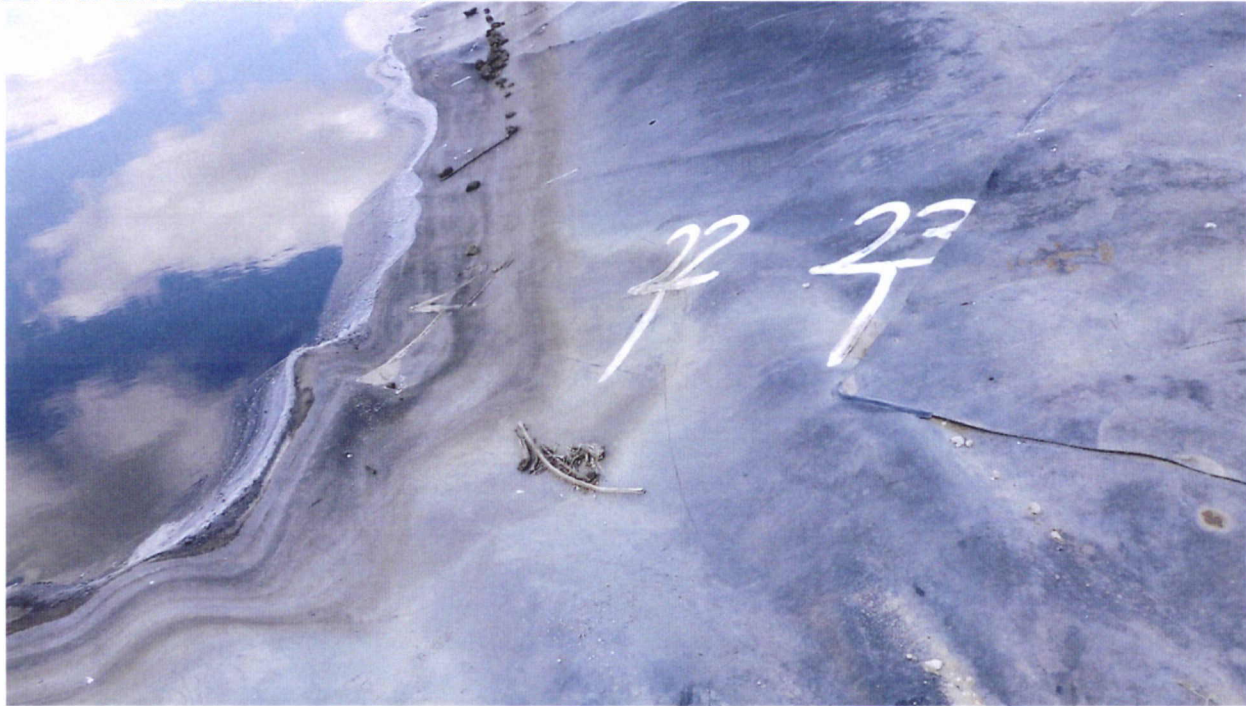
Photo: 21

Description: This photo depicts that the lagoons are continuing to lower.

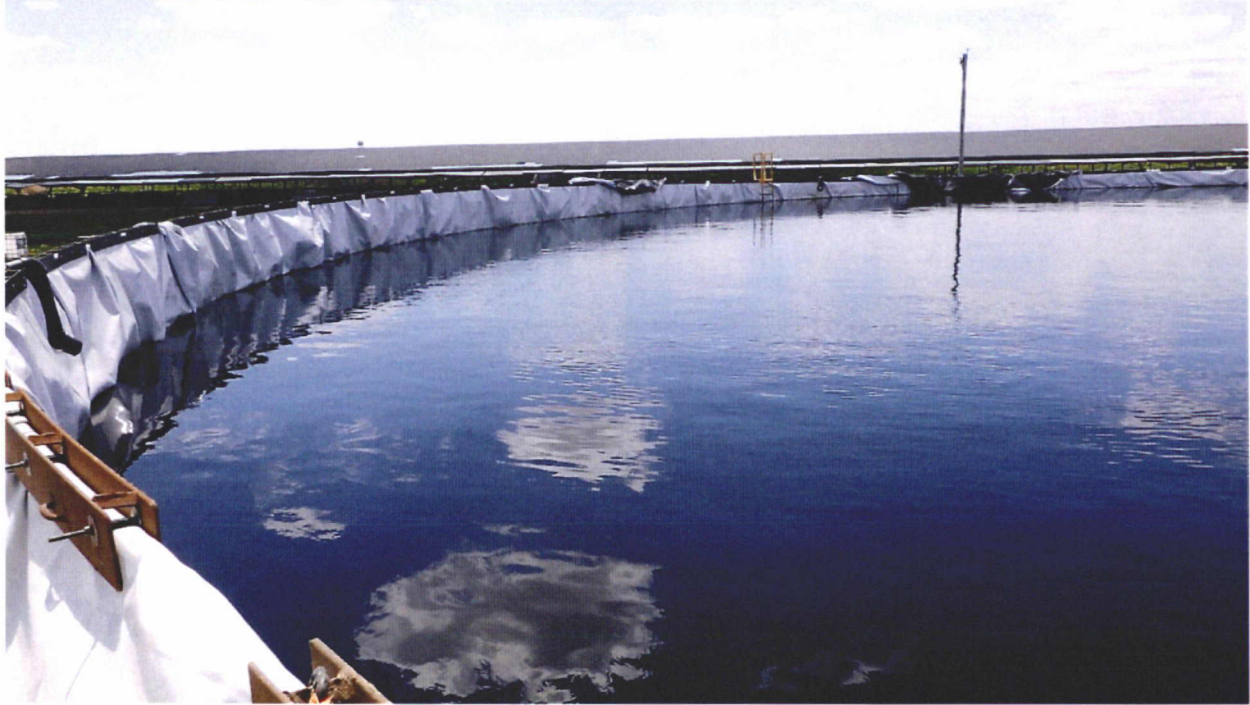
Photo: 31

Description: The east Poseidon tank is near capacity.

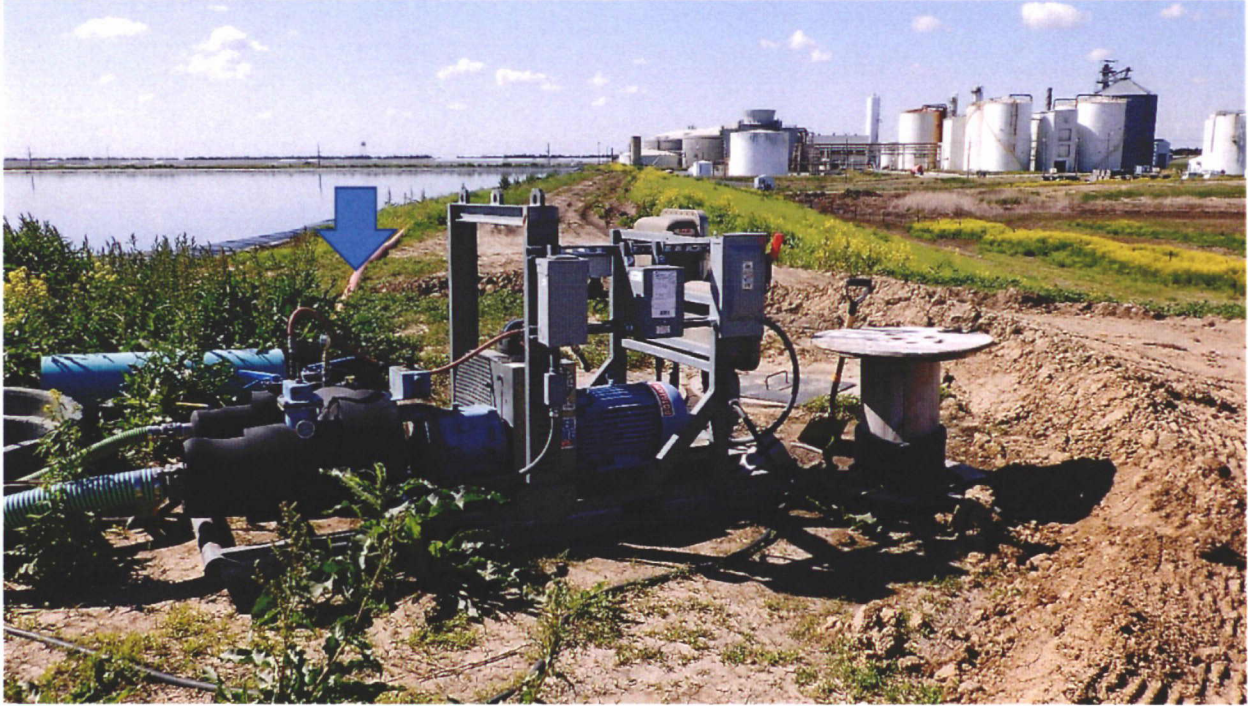
Photo: 35

Description: This photo depicts a discharge into the northeast lagoon. After investigation the line depicted here (orange arrow) is a recirculation hose. Mr. O'Brien stated that this hose is just allowing some water back into the lagoon to help with pressure. Mr. O'Brien confirmed that the line is not pumping from the emergency lagoon. The larger hose (blue arrow) is pumping from the south lagoon.

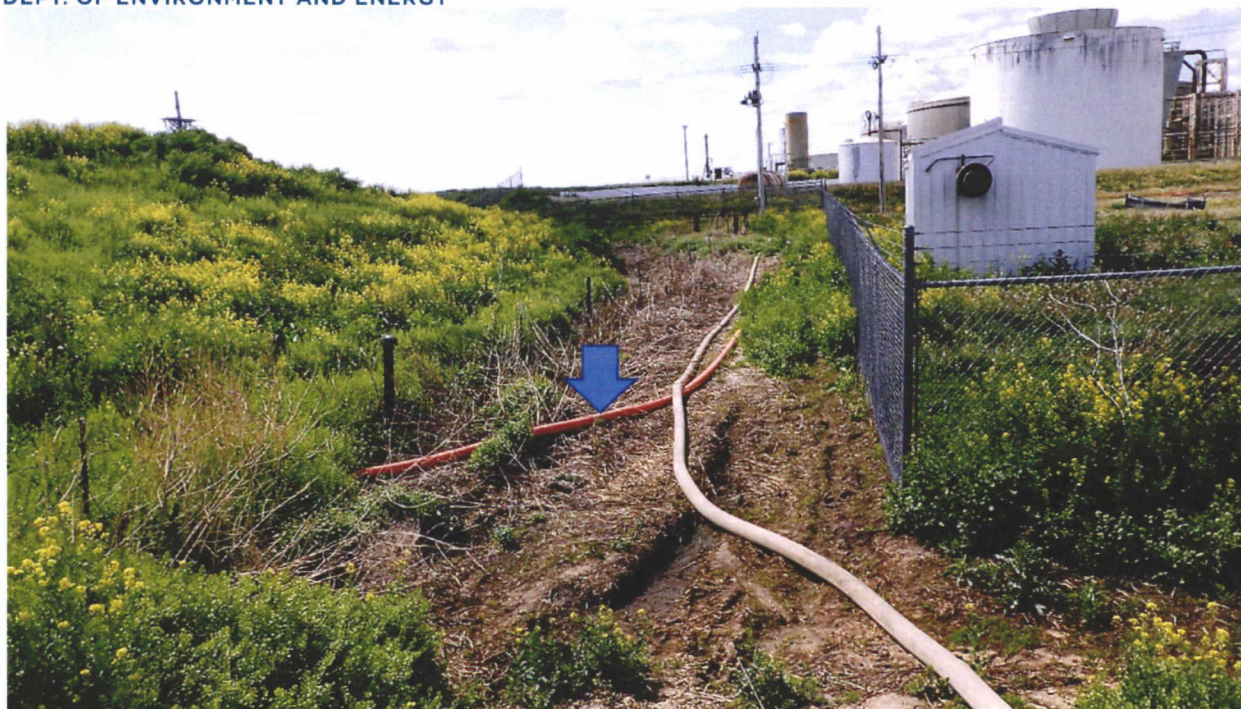
Photo: 36

Description: This photo depicts the orange hose that transfers water to the treatment system (arrow).

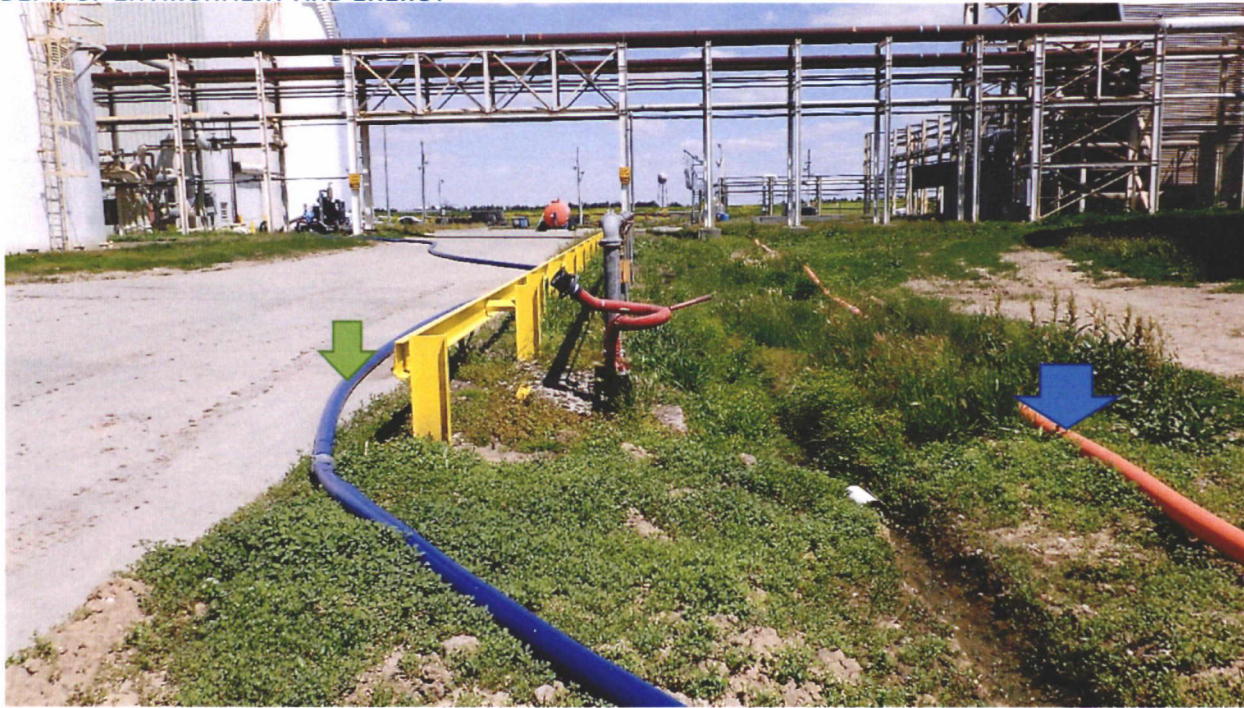
Photo: 37

Description: This photo depicts the orange line that was mentioned in photo 35.

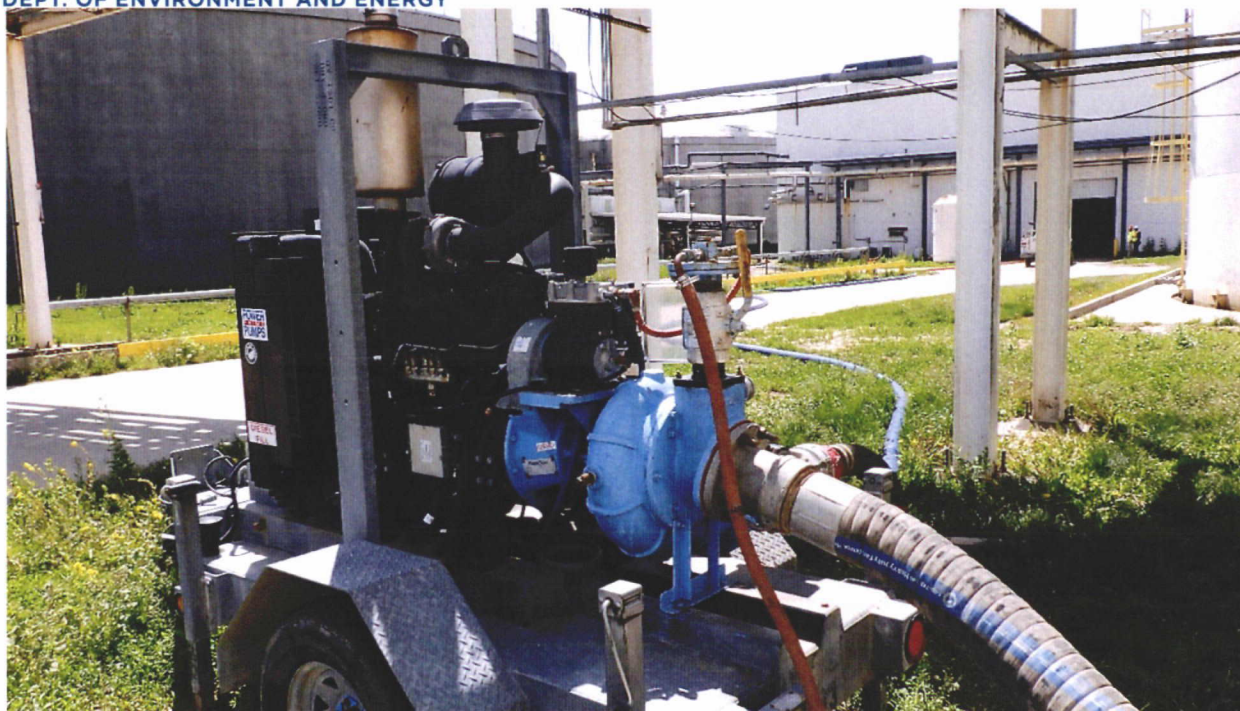
Photo: 38

Description: This photo depicts the orange line depicted in photos 35 and 36 (blue arrow). This hose connects to the treatment system. The blue hose (green arrow) is the from the industrial sump. Mr. O'Brien stated that they made the sump pumping station inoperable. The facility will be manually pumping from the industrial sump to the emergency lagoon.
