Facility: AltEn, LLC

Site Visit Check list

Site Visit Report

Inspection and Assistance Exit Summary

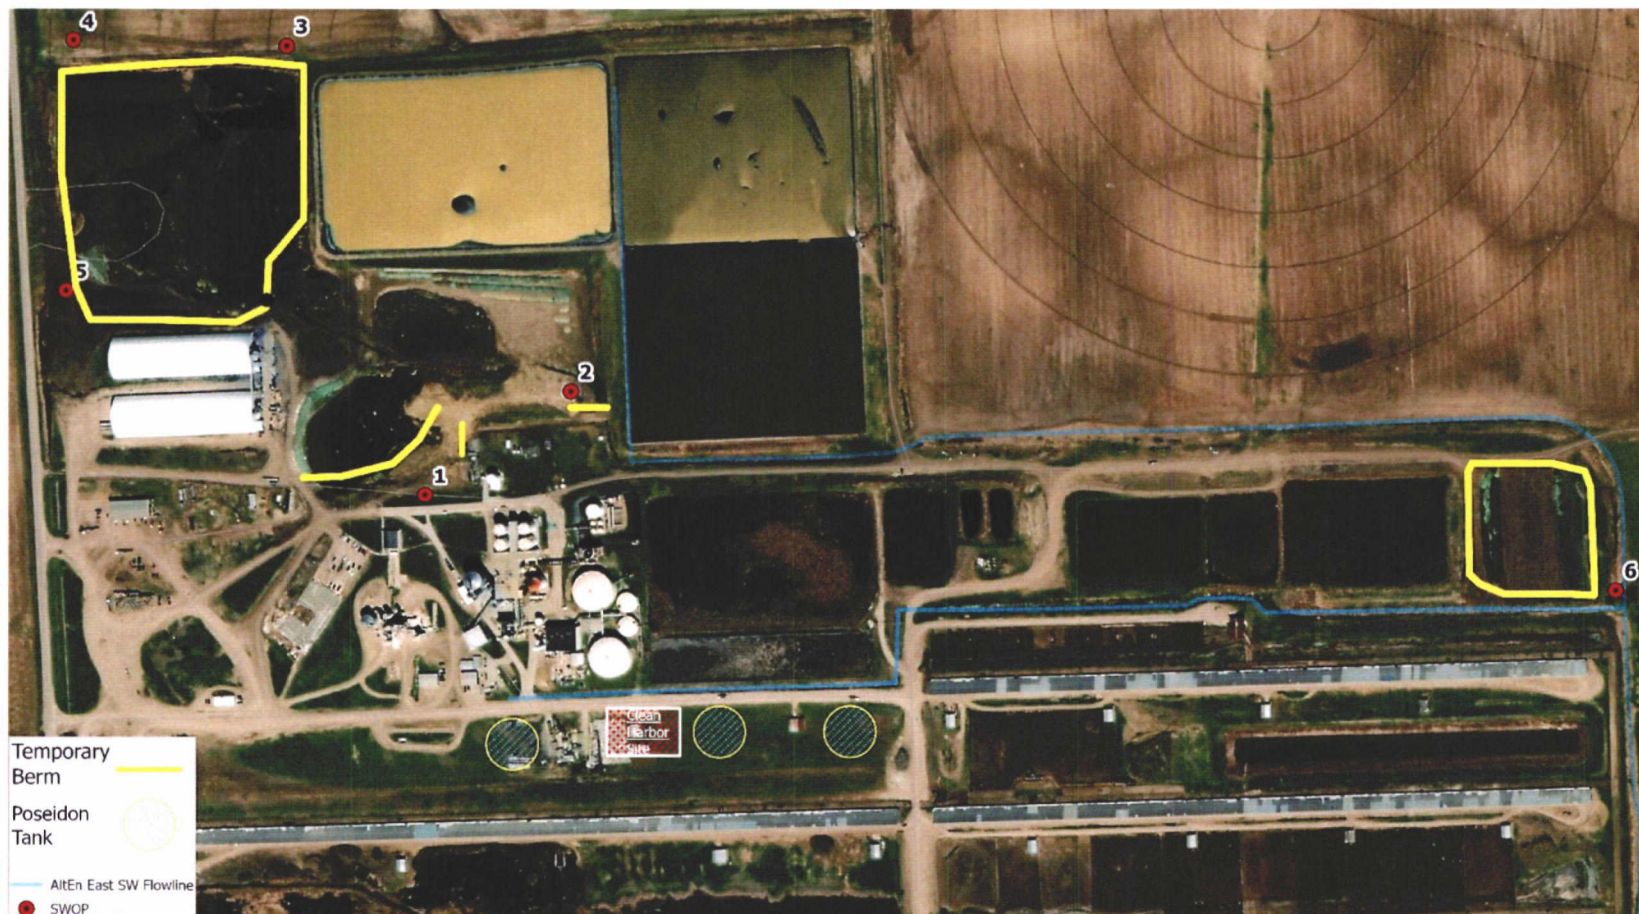
AltEn LLC - Storm Water Temporary BMP Check Map

| 1. Northeast side of the administration building | <input checked="" type="radio"/> Yes | No (pumped / <input checked="" type="radio"/> not pumped) |
| 2. Southwest side of the south lagoon | <input checked="" type="radio"/> Yes | No (<input checked="" type="radio"/> pumped / not pumped) |
| 3. West side of the northwest lagoon | <input checked="" type="radio"/> Yes | No (pumped / <input checked="" type="radio"/> not pumped) |
| 4. North side of the north wet cake pile | <input checked="" type="radio"/> Yes | No - no accumulation of runoff |
| 5. County Road 10 (Hoop building). | <input checked="" type="radio"/> Yes | No (pumped / <input checked="" type="radio"/> not pumped) |
| 6. East wet cake pile | <input checked="" type="radio"/> Yes | No (pumped / <input checked="" type="radio"/> not pumped) |

2 - berm holding in good condition w/ no sign of seepage.

3 - berm holding in good condition w/ no seepage. very little runoff there

5 - berm in good condition w/ no sign of seepage. ditch conveys runoff east
