Facility: AltEn, LLC

5/3/2021

Site Visit Check list

Site Visit Report

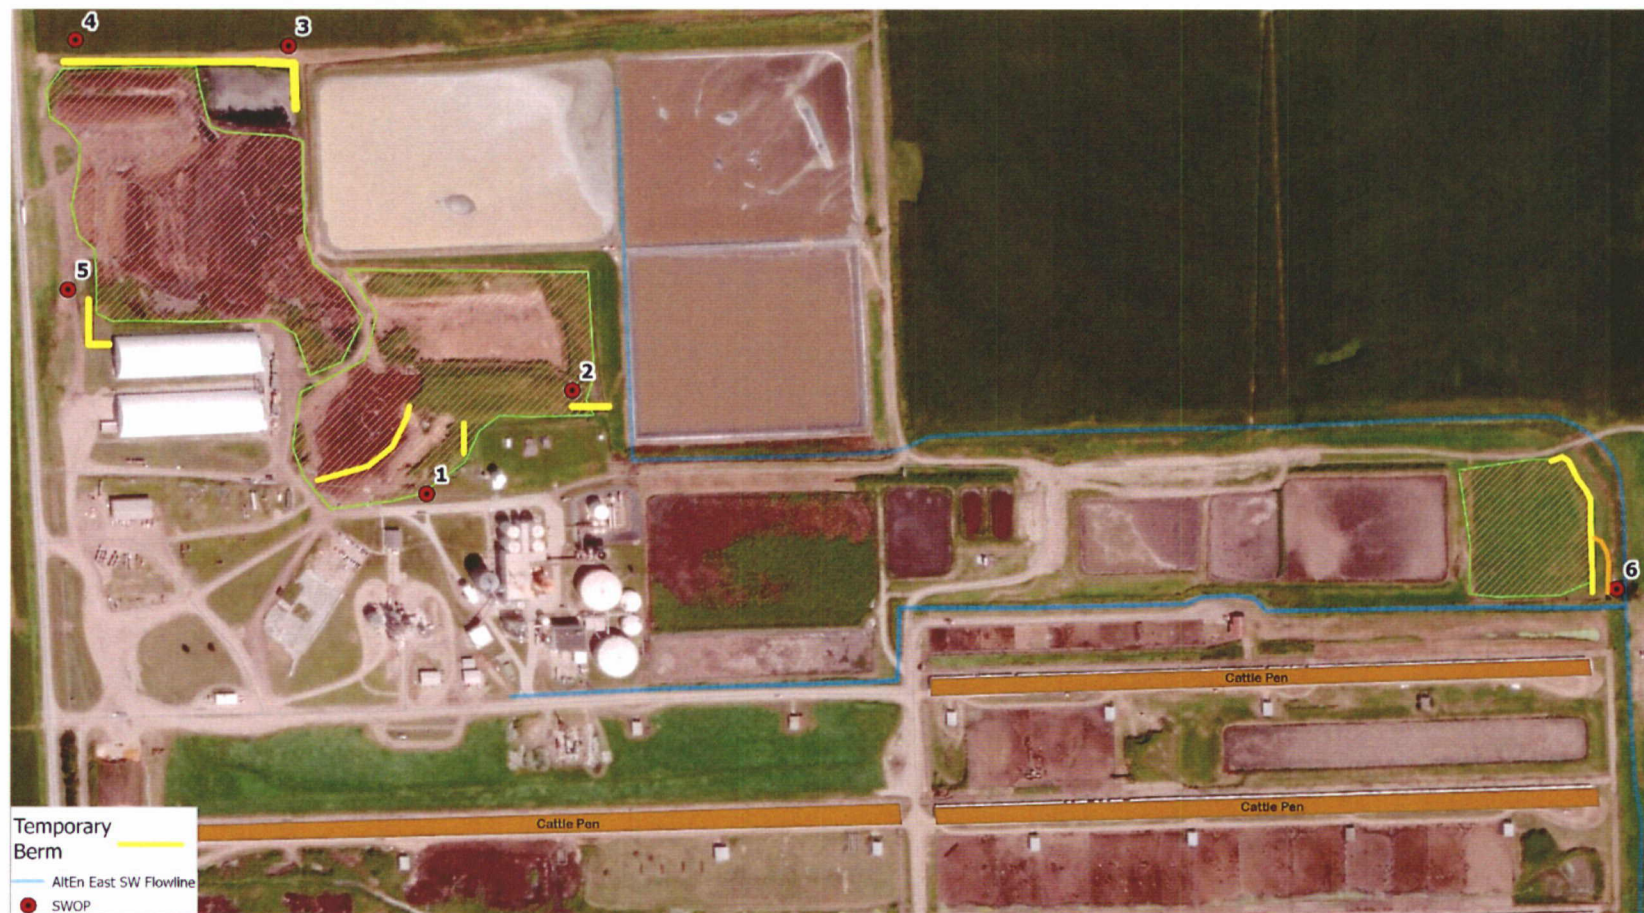
AltEn LLC - Storm Water Temporary BMP Check Map

- Area 1 contains two berms. The east berm has been expanded to prevent parking lot water from entering the berm area. There is minimal water accumulation.
- Areas 2, 3, 4 and 5 has some water accumulation. No seepage observed.
- Area 6 is containing water. There is some seepage observed.
