Facility: AltEn, LLC

IIS: 84069

5/24/2021

## Site Visit / Sampling Event Report

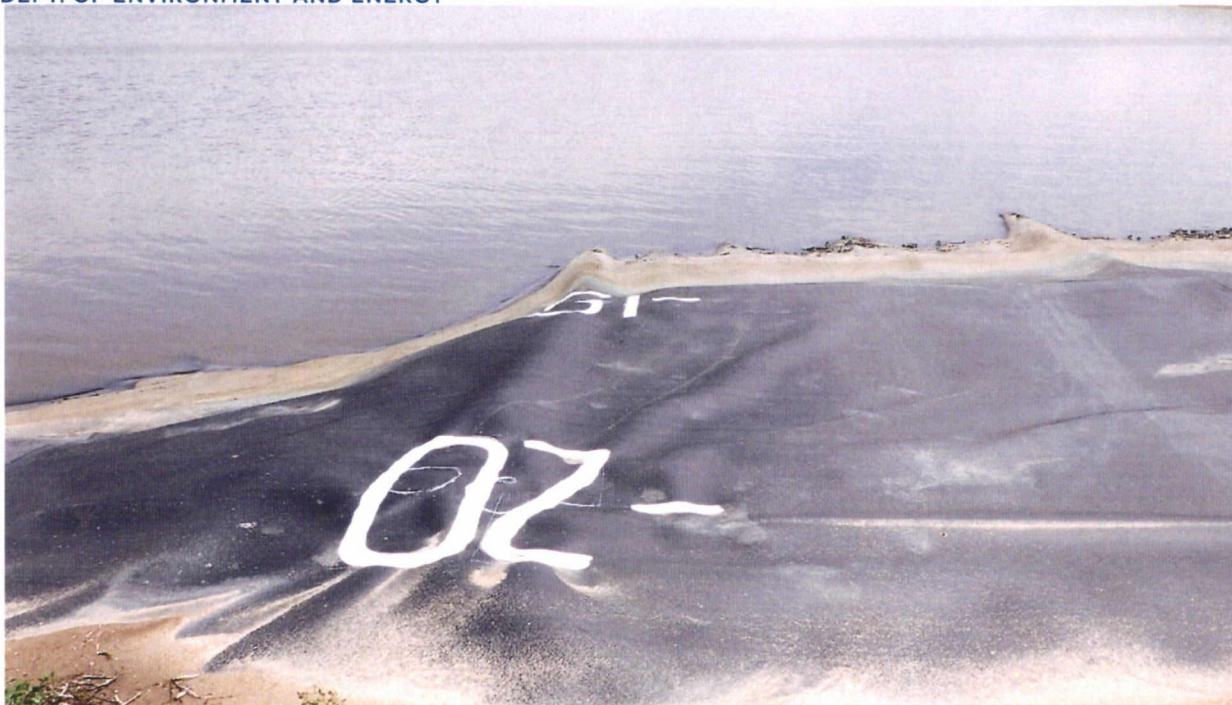
Photo: 11

Location: Northwest lagoon

Description: Depth gauge

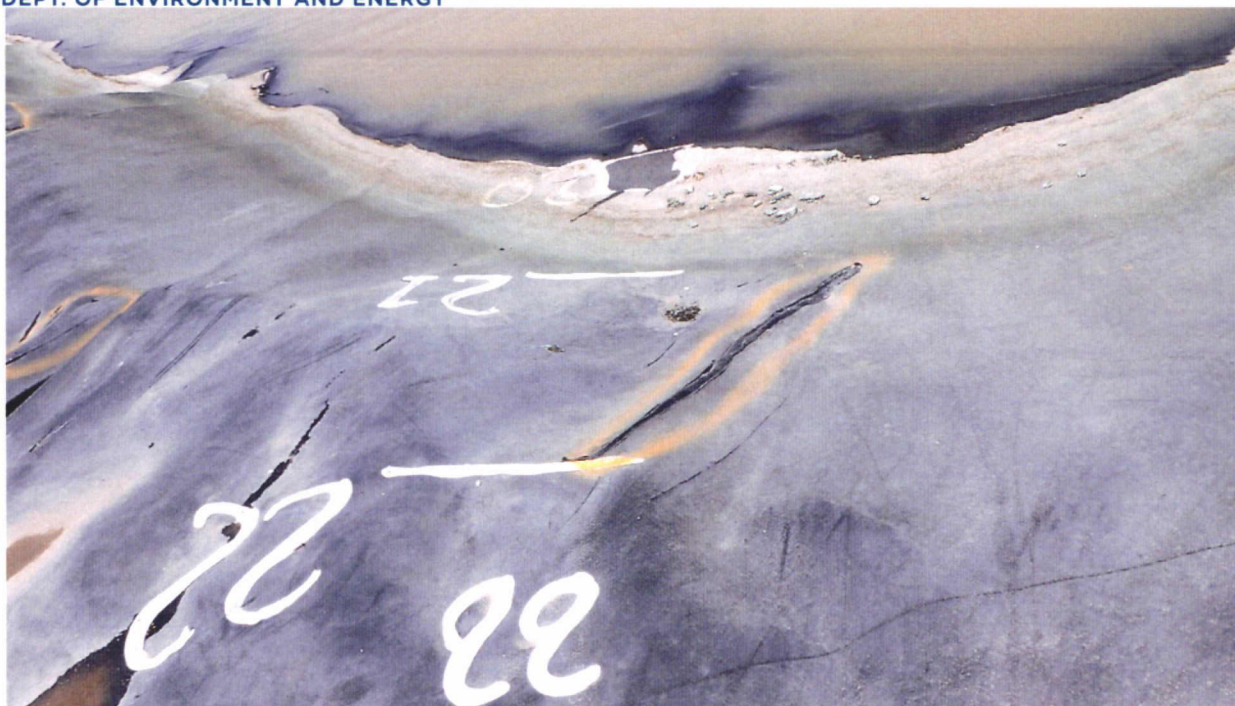
Photo: 14

Location: South lagoon

Description: This is the south lagoon depth gauge.

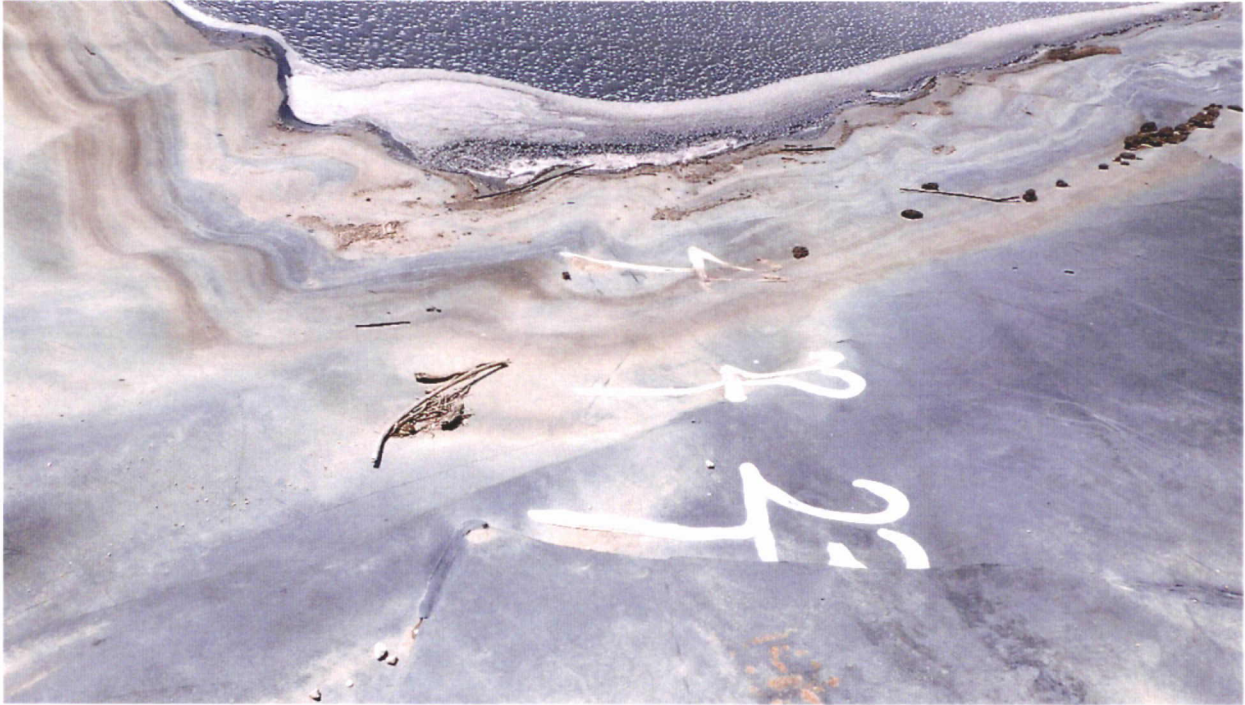
Photo: 15

Location: Northeast lagoon

Description: This is the northeast lagoon depth gauge.

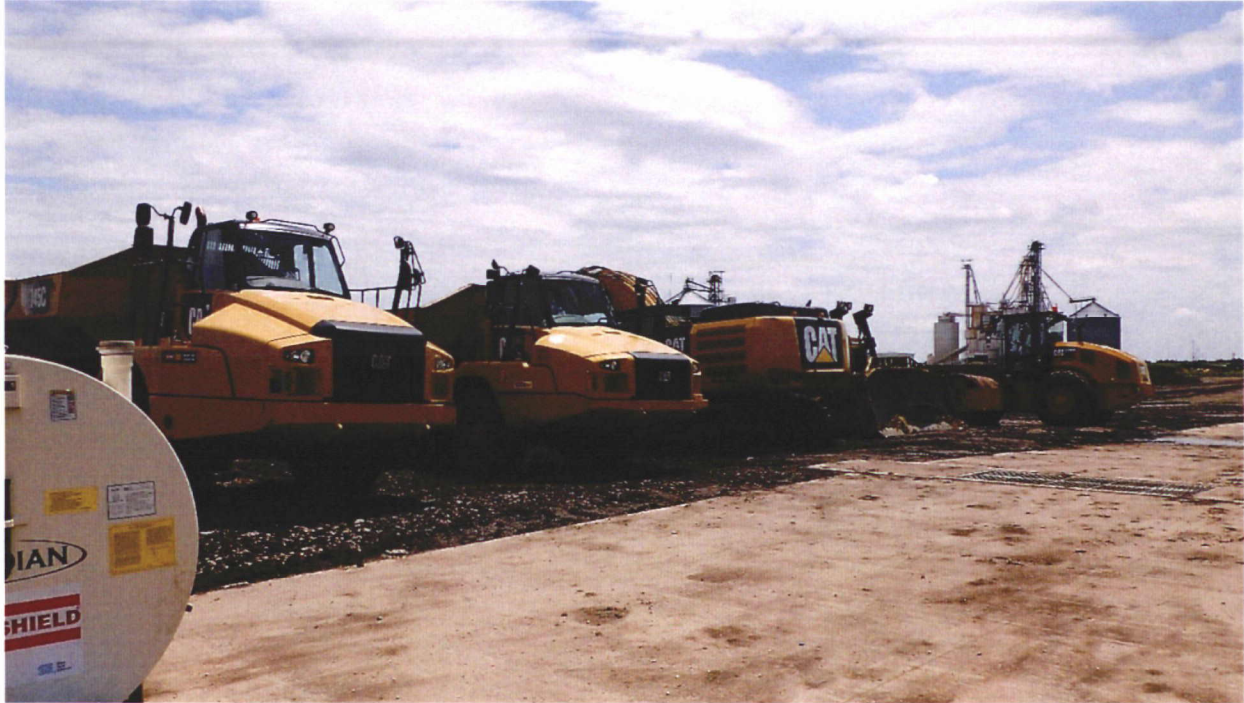
Photo: 18

Location: Hoop Buildings

Description: This photo depicts the heavy equipment Clean Harbors is using to move soil and wet cake.

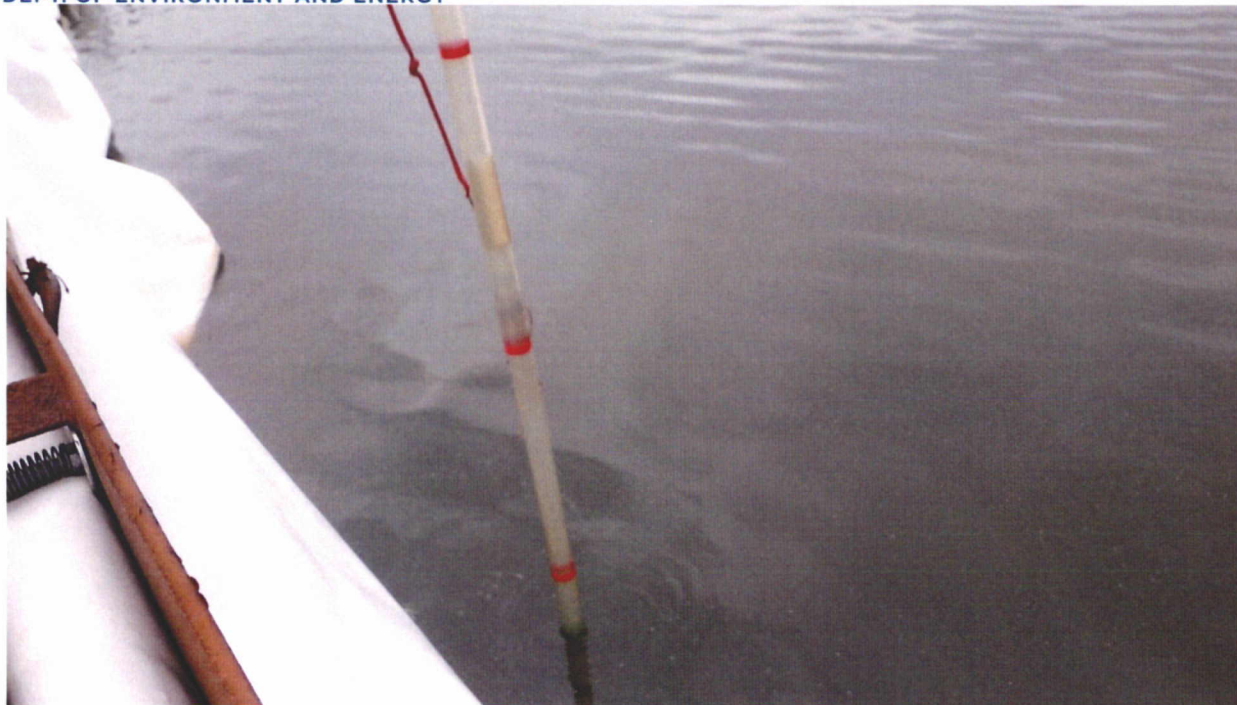
Photo: 20

Description: After the tube reaches the bottom it is removed with a solid column of water as depicted here and photo 21.

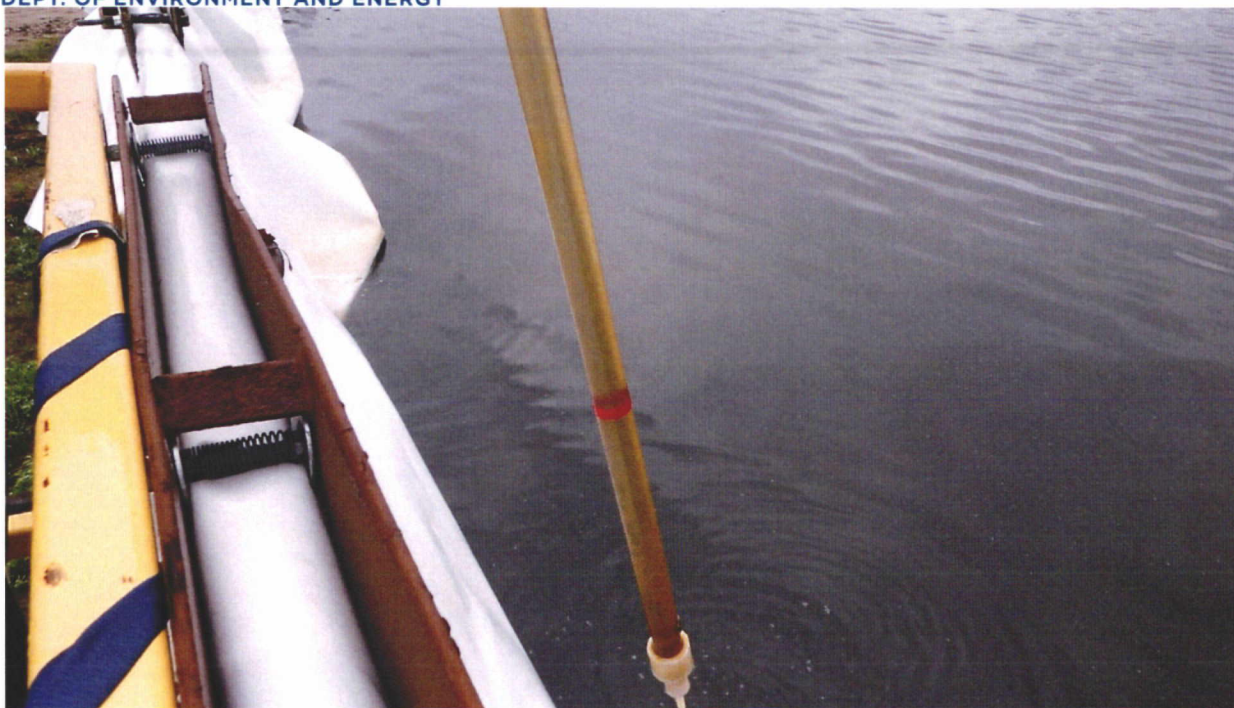
Photo: 21

Description: This photo depicts after collection. The sampler then takes the column and transfers water into a collection vessel. All samples are collected the same and composted in the same vessel.

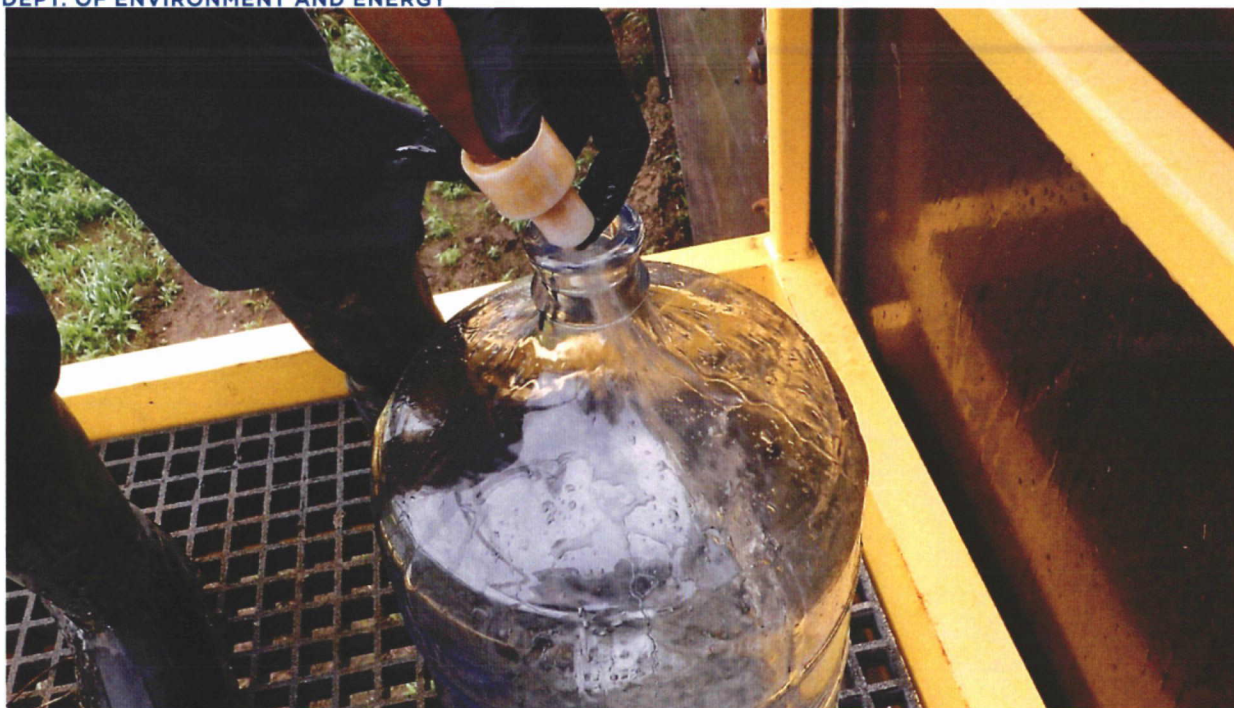
Photo: 22

Description: This photo depicts the sampler transfer a sample into the collection vessel. The samples were collected and composited with the same technique.

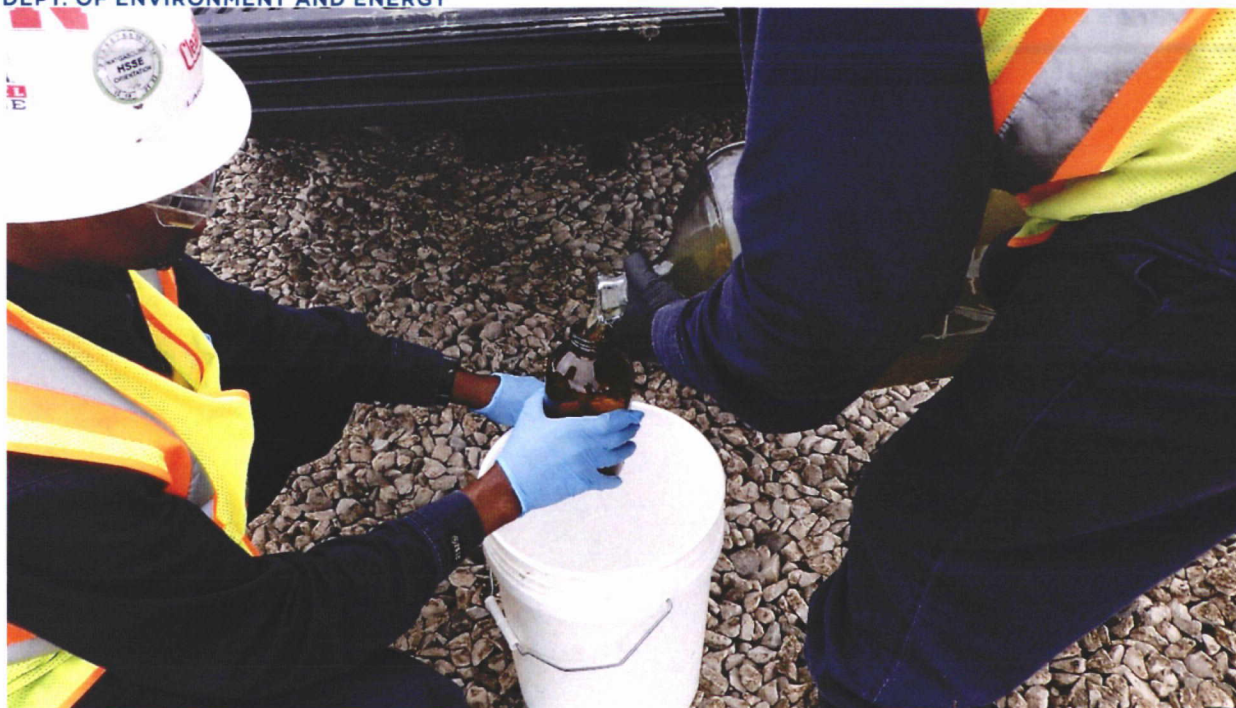
Photo: 23

Description: This photo depicts samplers transferring water into sample bottles.

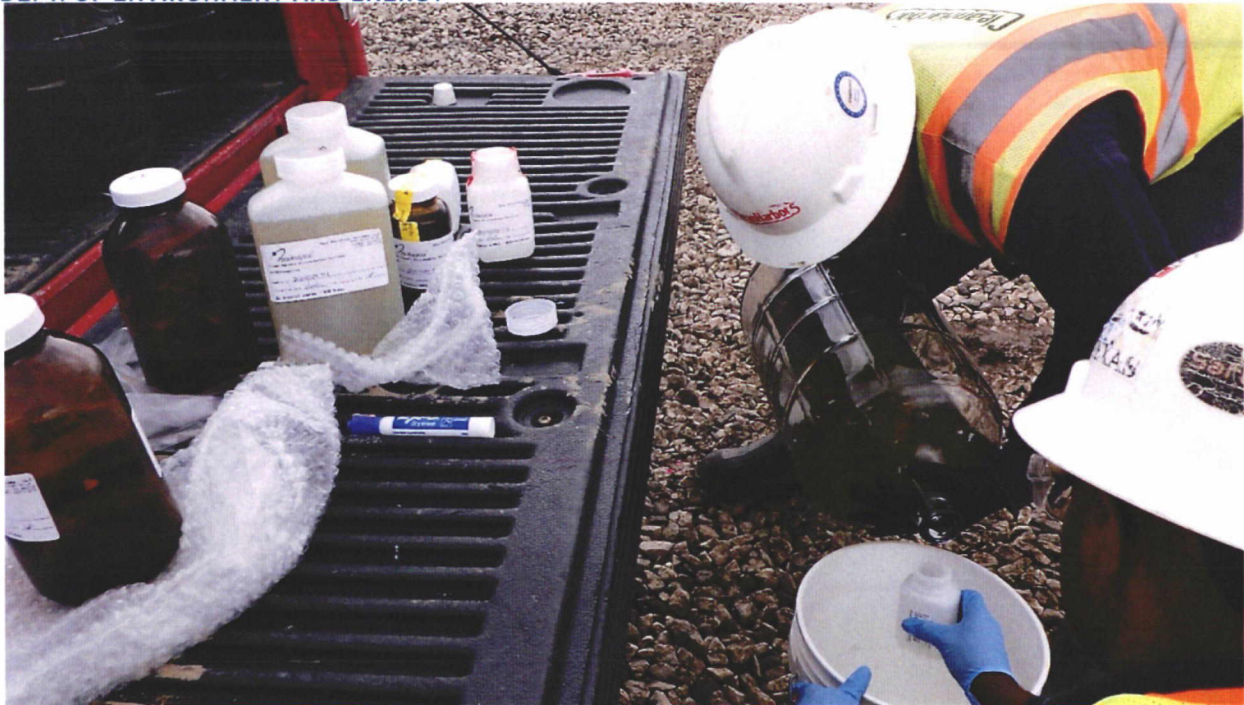
Photo: 24

Description: This photo depicts samplers transferring water into sample bottles.

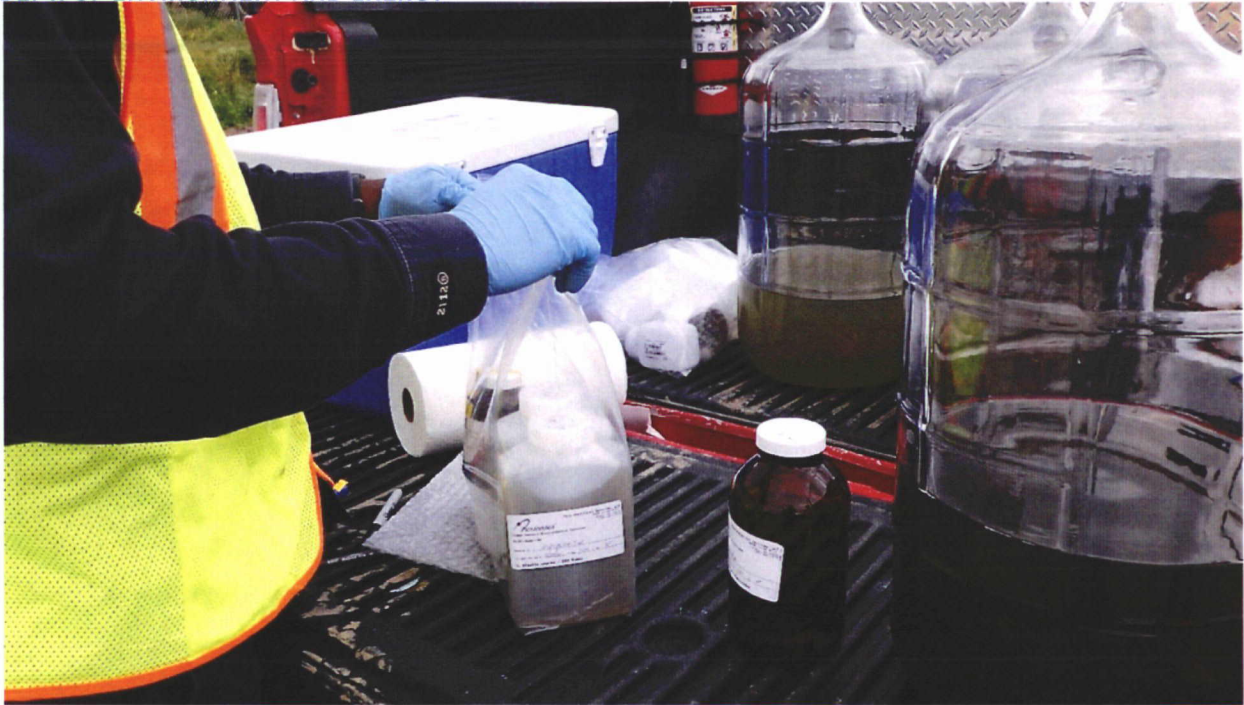
Photo: 25

Description: This photo depicts samplers placing filled sample bottles into bags in preparation of sending to the laboratory.

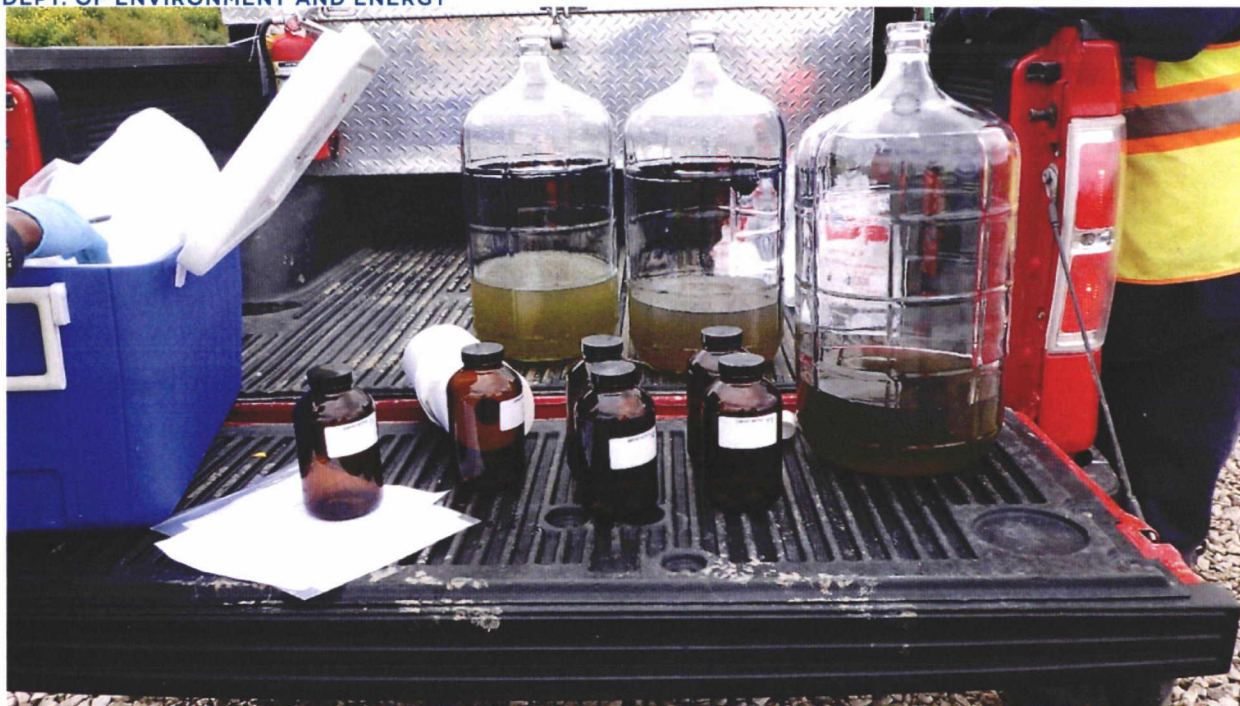
Photo: 26

Description: This photo depicts the samples collected today. Left to right is east, middle and west Poseidon tanks.

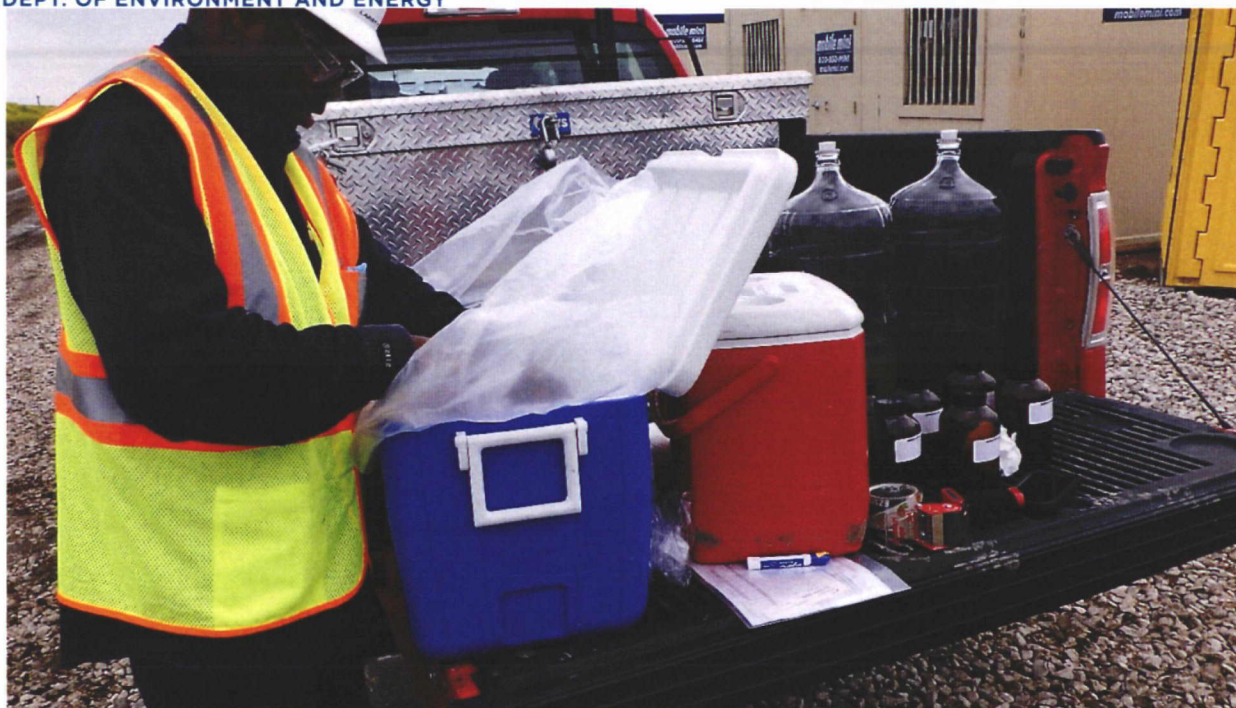
Photo: 27

Description: This photo depicts a Clean Harbors worker packing samples in ice and preparing for shipment.

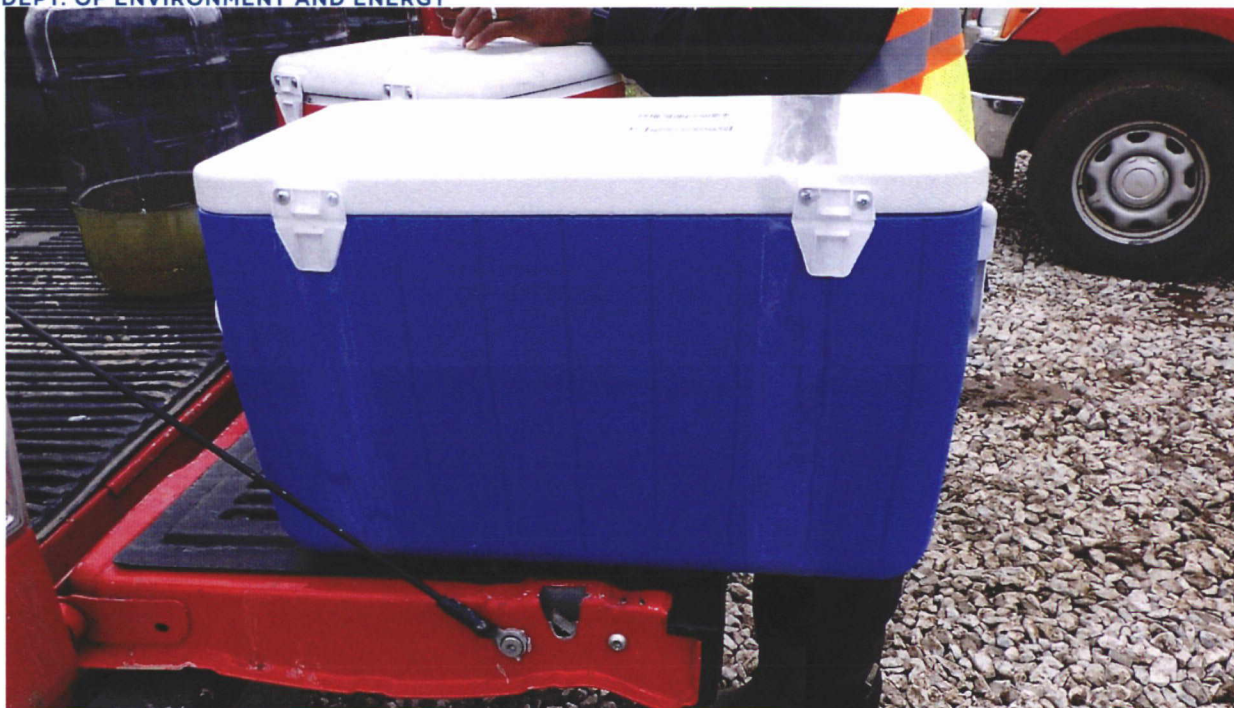
Photo: 28

Description: This photo depicts a cooler, ice and samples ready to ship to the laboratories.
