Facility: AltEn, LLC
IIS: 84069
PCS: NE0137634

Jason Windhorst
5/14/2021

Site Visit Check list

Site Visit Report

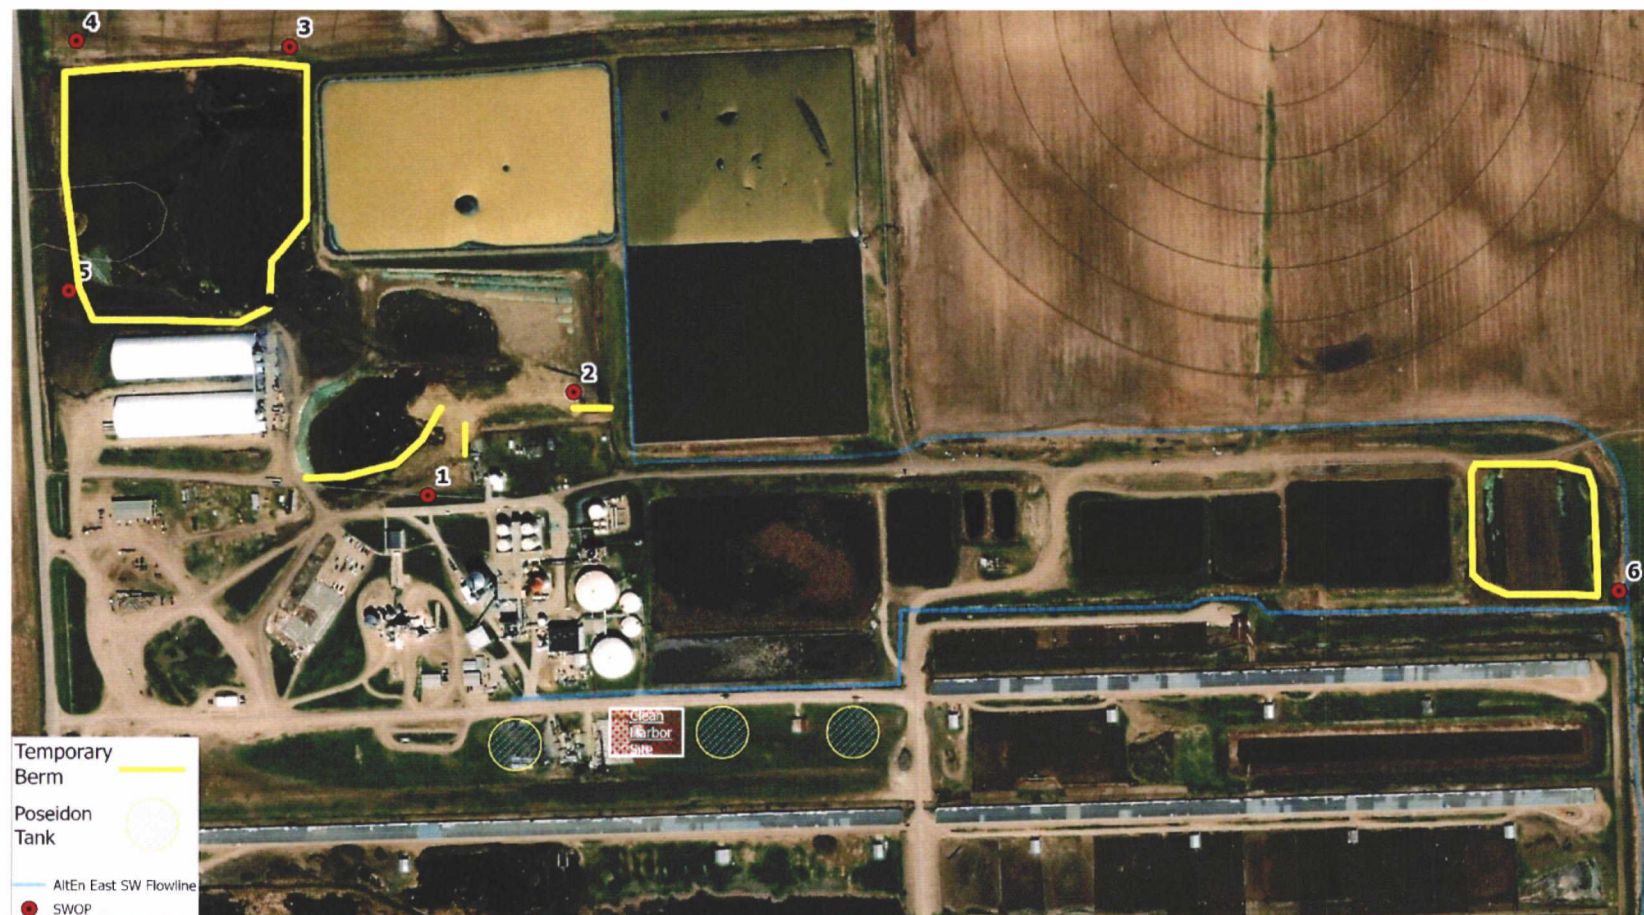
AltEn LLC - Storm Water Temporary BMP Check Map

Area - 1 - Berm is holding & no sign of seepage - can be pumped
2 - Berm was pumped & still in good condition
3 - Berm reinforced more & no sign of seepage - not enough to pump
4 - no concern
5 - Berm moved North further & reinforced/compacted - no pumping needed
6 - lower berm removed & most of runoff pumped out.
