Facility: AltEn  
IIS: 84069  
PCS: NE0137634

## Site Visit Check list

Site Visit Report

### Inspection and Assistance Exit Summary

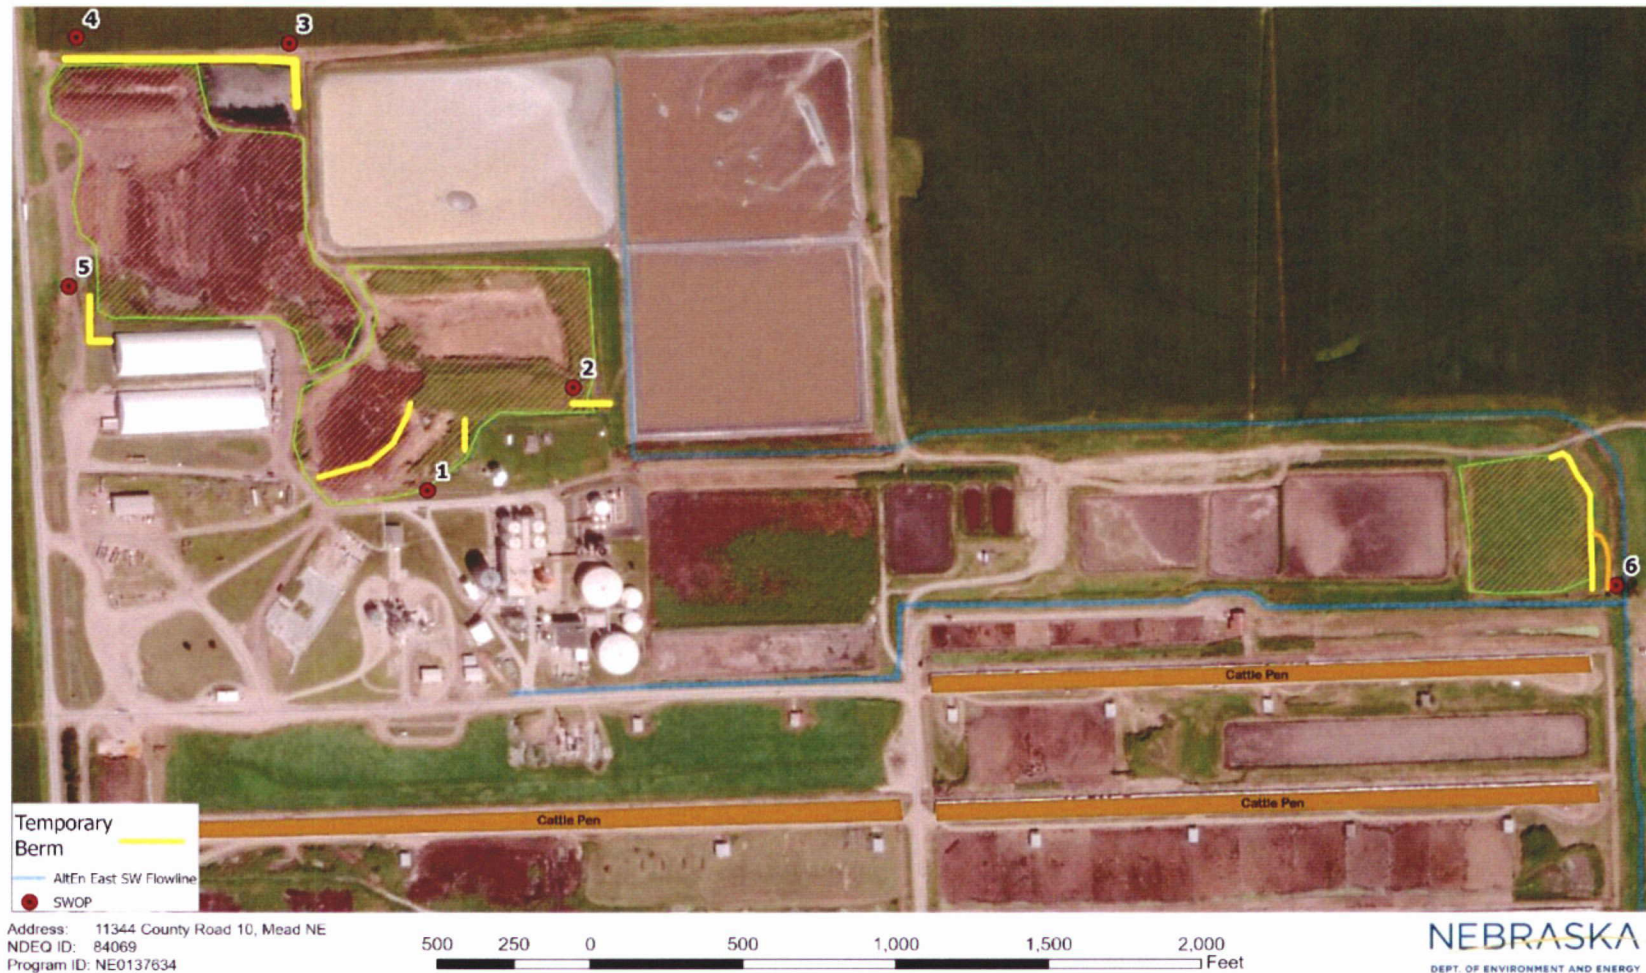
AltEn LLC - Storm Water Temporary BMP Check Map

- Clean Harbors has begun work on reinforcing and raising the berm in area 5 of the site map.
- Office space is slowly being cleaned out by Mary Tingelhoff with the exception of Matt O'Brien retaining his office.
- Area 6 or East wetcake storage area continues to seep through berms.
- Both hoop buildings have small leaks in the roof allowing materials to get wet which has caused sprouting and decomposition in the north building and potential decomposition of materials exposed in the south building.

Area 1 - Berm good condition & some water ponded  
2 - Berm good condition & can be pumped, No seepage  
3 - Berm good condition & can be pumped, no seepage  
4 - no concern  
5 - Berm holding & draining to the east  
6 - Berm has seepage in top & bottom berm, Bottom  
berm should be pumped ASAP
